CORROSION-MECHANICAL STATE OF THE HEAT PIPELINE AFTER LONG-TERM OPERATION

**P. Yukhymets¹, L. Nyrkova¹, R. Dmytriienko¹, H. Kaminski², C. Zaruba²,
P. Linhardt², G. Ball², V. Yehorenko³**

¹E.O. Paton Electric Welding Institute of the NASU
11 Kazymyr Malevych Str., 03150, Kyiv, Ukraine

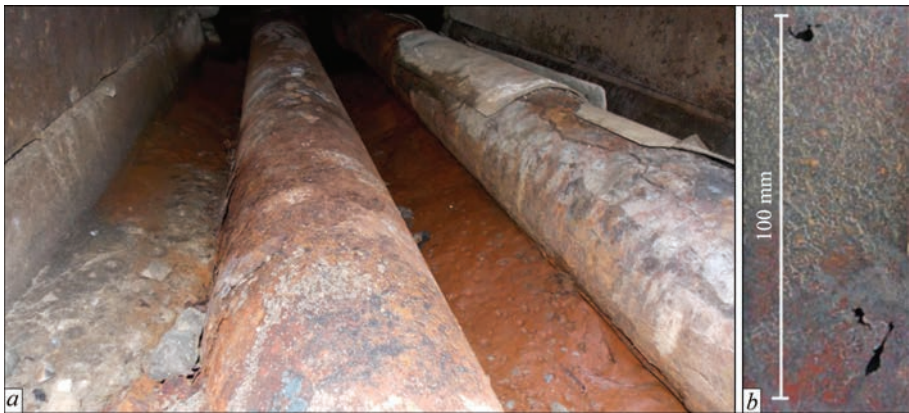
For conducting research were used two significantly corroded fragments, each ~2 m length, cut from feeding and return pipelines of the D325 main heating line laid in non-passable channel (Figure 1). Both fragments according to the results of periodic hydraulic test were recognized by the operating organization — KP Kyivteploenergo as unfit for further operation and transferred to PWI.

Figure 1. Feeding and return pipelines in a non-passable channel (a); through corrosion defects in the feeding pipeline (b)

with high-frequency currents. At the time of inspection protective cover is practically absent. The outer surface of both pipes is covered with a layer of brown corrosion products, there are remnants of a protective coating, probably bituminous. Local corrosion damage detected on the surface of the pipes identified according to [9] as corrosion spots and pits of various sizes. The inner surface is covered with a layer of brown corrosion products that are easily separated from the pipe wall and fall apart. Corrosion of the inner surface is continuous and uniform. The corrosion state of the pipe fragments is unsatisfactory, while the corrosion damage of the feeding pipe is more significant. The thickness of the wall of the feeding pipe is unevenly reduced, probably due to corrosion, in the range from 7–8 to 1–2 mm; the thickness of the remains of the protective cover is 280–470 μm . Visually, the pits on the outer surface have a greater depth than on the inner surface — it should be assumed that the outer corrosion is more intense than the inner one. Corrosion pits on the outer surface vary in size: from 3×3 mm to 25×50 mm; in the region of the smallest wall thickness three through corrosion defects with dimensions of ~7×5, 6×5 and 13×7 mm were found (see Figure 1, *b*). Corrosion destruction probably started from side of the outer surface. Wall thickness of the return pipe varies from 7–8 mm to 3–4 mm, the thickness of the remains of protective cover is 0.25–6.7 mm.

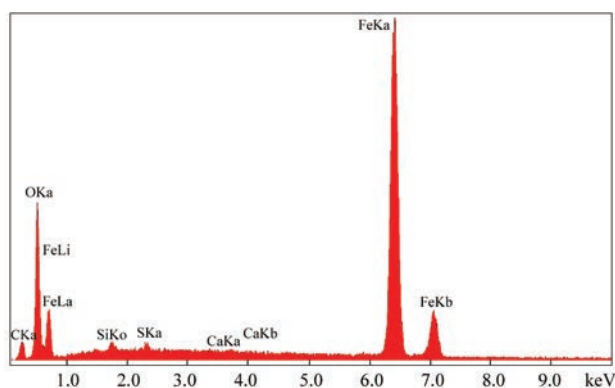
Figure 5 shows the results of EDS microanalysis of the oxide layer of the feeding pipeline. As can be seen, the main component of the layer is iron, presumably in the form of FeO and Fe₂O₃ oxides, which were formed as a result of the electrochemical reaction between iron and water.

Figure 5. EDS spectrum of the oxide layer on the surface of feeding pipe

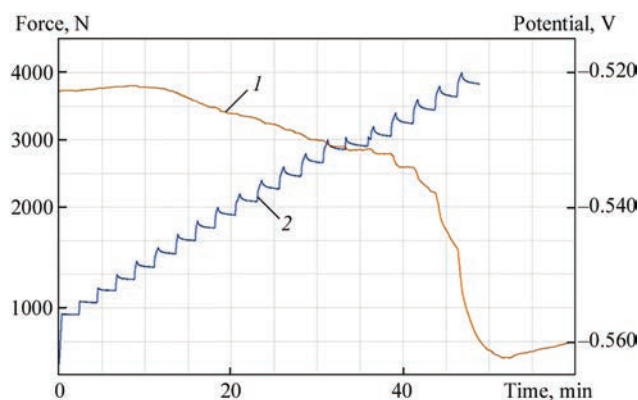
A synopsis of force and OCP over time (Figure 6) shows that there is a critical elastic load $S \sim 3000$ N (corresponding to an internal pressure $P \approx 1.3$ MPa),

where the OCP rapidly decreases with each subsequent increase in tension. This indicates the beginning of the formation of deep cracks in the oxide layer, which significantly activate local corrosion processes.

The synopsis of force and OCP over time (Figure 6) reveals that there is a critical elastic load $S \sim 3000$ N (which corresponds to the internal pressure $P \approx 1.3$ MPa in the D325 pipeline with a thickness of $a = 2$ mm in the thinning zone), where OCP decreases rapidly and instantaneously with each further step in force. This indicates the onset of formation of deep cracks in the oxide layer, activating corrosion processes to a significant degree.

Figure 6. Change in the potential of the open circuit (*I*) of the sample under applied tensile force (*2*)

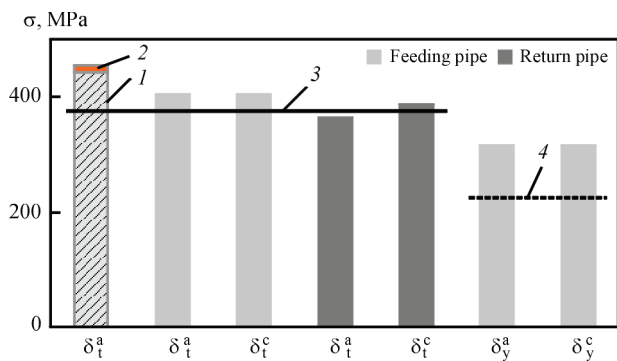
Figure 7. Tensile (σ_t) and yielding (σ_{02}) strength of metal of feeding and return pipes; upper indexes: a — axial direction; c — circumferential direction. 1 — certificate data; 2 — range of values; 3, 4 — minimal values of σ_t , σ_{02} according to [7], correspondingly

Comparing of the results of tensile tests with the data of the certificate (Figures 7, 8) shows that after long-term operation (more than 40 years), the value of tensile strength in the axial direction σ_t^a of material of feeding pipeline decreased by ~10 % and return pipeline by ~18 %. Strength characteristics σ_t and σ_{02} of metal of feeding and return pipelines in circumferential and axial directions are practically the same and meet the minimum requirements of regulatory documentation, that generally agrees with the results [4] obtained in the absence of residual deformation. Reduction in plasticity of material of feeding pipeline in circular and axial direction does not exceed 10% and meets requirements [7]. Decrease in plasticity of material of return pipeline is more significant, especially in longitudinal direction, where it is lower than the

minimum regulatory value by ~50 % which is probably a consequence of strain aging in the conditions of local bending of the pipeline and increases the susceptibility to brittle failure, including under explosive loading.

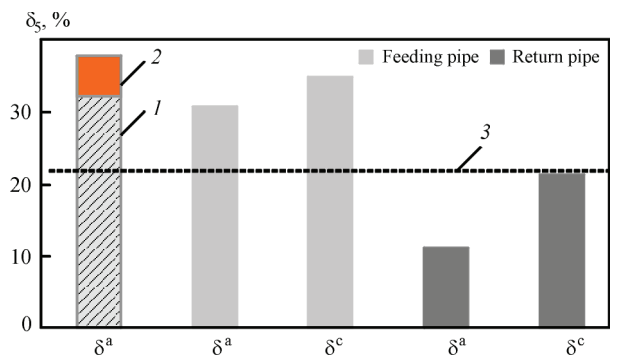
Figure 8. Elongation after fracture δ_s of metal of feeding and return pipes; upper indexes: a — axial direction; c — circumferential direction. 1 — certificate data; 2 — range of values; 3 — minimal value of δ_s according to [7]

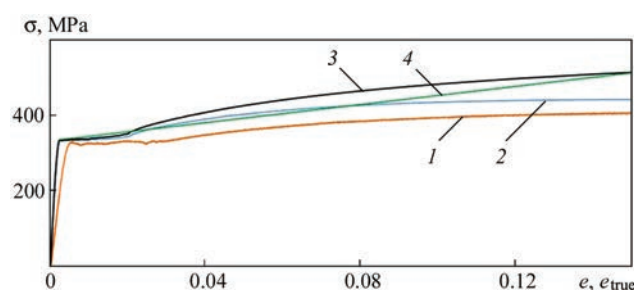
Results of tensile tests on material of feeding pipeline are given in Table 4 and Figure 9.

The increased strength and plasticity characteristics of the material of the significantly thinned zone of the pipe are explained by selection of samples No. 3, D1-1, D1-2 for tensile tests from the least damaged layer adjacent to the inner surface of the pipe, the properties of which are specific due to the pipe manufacturing technology, as well as the influence of scale factor (the thickness of the samples differs by ~6 times).

Figure 9. Tensile stress diagrams of samples Nos 1 and 3 within the limits of uniform thinning; 1 — specimen No. 1, regular diagram ($e = \Delta l_e / l_e$ (l_e — initial calculated length according to the strain gauge, Δl_e — elongation of initial calculated length according to the strain gauge), $\sigma = S / F_0$, (S — tensile force; F_0 — area of specimen cross-section); 2 — specimen No. 3, regular diagram; 3 — true stress-strain diagram of specimen No. 3 ($e_{true} = \ln(1 + e)$); $\sigma_{true} = \sigma(1 + e)$; 4 — approximated bilinear hardening diagram of specimen No. 3

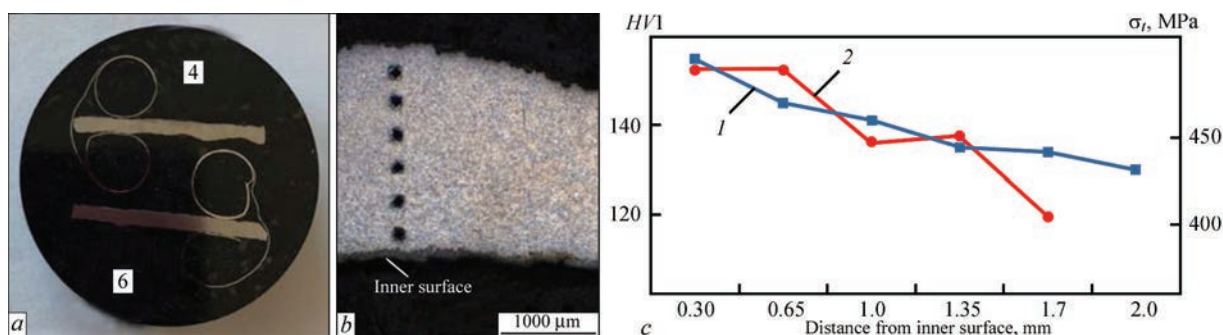
The trends of hardness change across thickness of blanks Nos 4 and 6 (Figure 10, c) agree with the results (Table 4.) The increase in hardness near the inner surface of the pipe indicates technological strengthening of the metal during the pipe manufacturing process, as well as the insignificance of internal corrosion. The hardened near-surface layer on the outside, apparently due to more intense corrosion, was not preserved.

Figure 10. Measurement of hardness along the wall thickness of a pipe with significant corrosion thinning: a — measurement template, the numbers indicate the blank numbers (see Table 3); b — specimen from blank No. 4 after indentation; c — hardness HV1 and tensile strength σ_t across the thickness of the specimens No. 4 (1) and No. 6 (2); calculation of σ_t values according to [11]

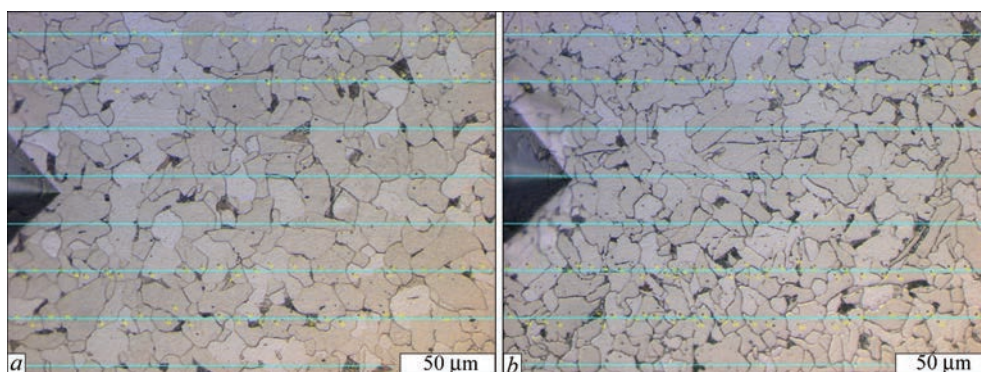
Stated above can be confirmed also by the results of grain size measurements (Figure 11). The average grain size near the inner surface of the pipe is ~2 (blank No. 6)

and 10 % (blank No. 4) smaller than in the middle part of the cross-section across the thickness.

Figure 11. Measurement of grain size of sample No. 4 at the: a — middle of wall thickness; b — near the inner surface

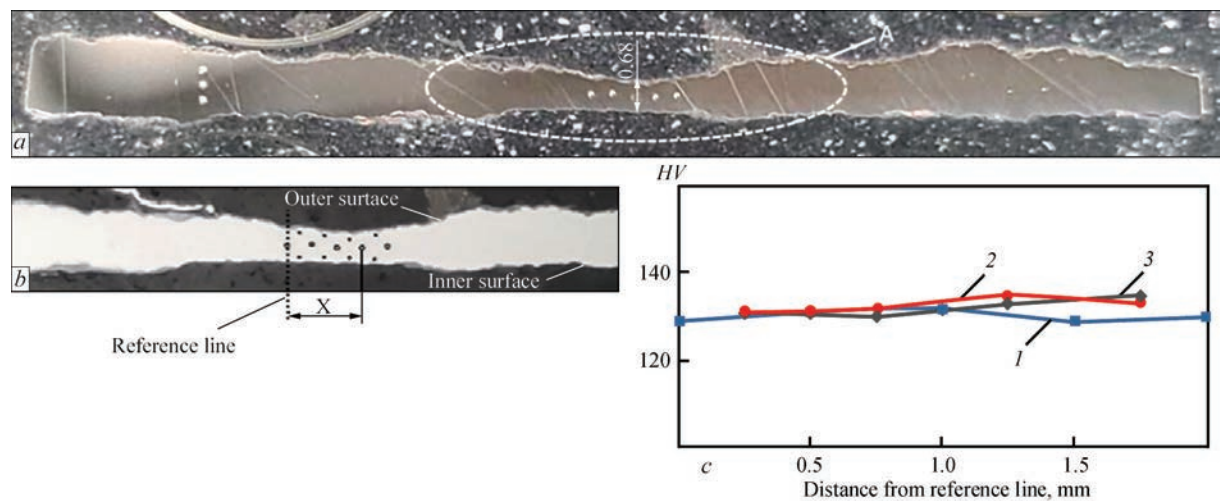
In Figure 12 are shown the results of hardness measurements in the zone of significant thinning of No. 4 blank, performed on the side face (in the direction of maximum tensile stresses caused by internal pressure). Despite the fact that the minimum thinning thickness $a_{min} = 0.68$ mm is significantly lower than the threshold value of the thickness $a_{max}^{CTA} = 0.97$ mm, which is calculated by substituting the mechanical properties of sample No. 1 (Table 4) in (1) and determines the beginning of the plastic deformation of

the obtained values are practically the same in the middle of the thickness and in the near-surface layers of the metal. This indicates the absence, as a result of intensive corrosion of the original technologically strengthened layers of the outer and inner surfaces, as well as the absence of accumulated residual deformations, which is confirmed by FEA calculations and measurements of the hardness on the side surface of the sample after tensile test.

Figure 12. Measurement of hardness along the thickness of a significantly thinned wall: *a* — template after *HV1* measurements; *b* — zone A after *HV1* and *HV0.3* measurements; \times — distance from the reference line to the measurement point; *c* — hardness along wall thickness: 1 — middle of the thickness, 2 — outer surface; 3 — inner surface

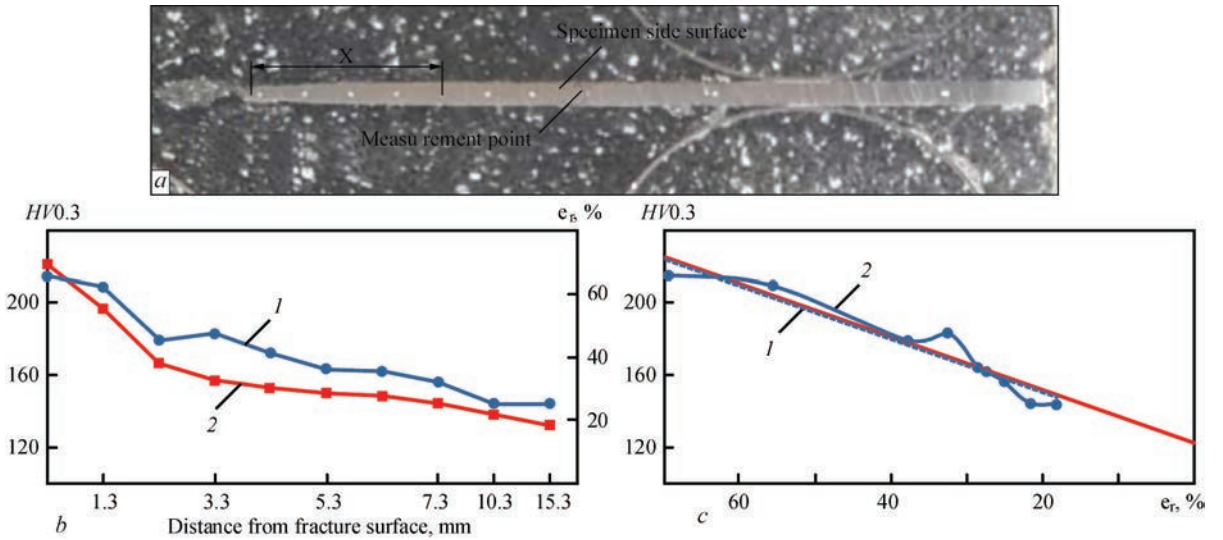
The results of Vickers hardness measurement under a load of 0.3 kg (*HV0.3*) on the side surface of

sample D1-1 after its tensile test are shown in Figure 14.

The given data (Figure 14, *c*) confirm that the values of the maximum plastic deformations $e_r < 0.1$ % of the template with the minimum thickness $a_{\min} = 0.68$ mm do not significantly affect the hardness.

Figure 14. Hardness along the length of the side surface of sample D1-1 after tensile testing: *a* — side surface of the sample; \times — the distance of the measurement point from the fracture surface; *b* — results of hardness measurement (1) as a function of the distance from the fracture surface and residual plastic deformation ϵ_r (2); *c* — linear approximation of hardness values *HV* (1) depending on residual deformation ϵ_r (2)

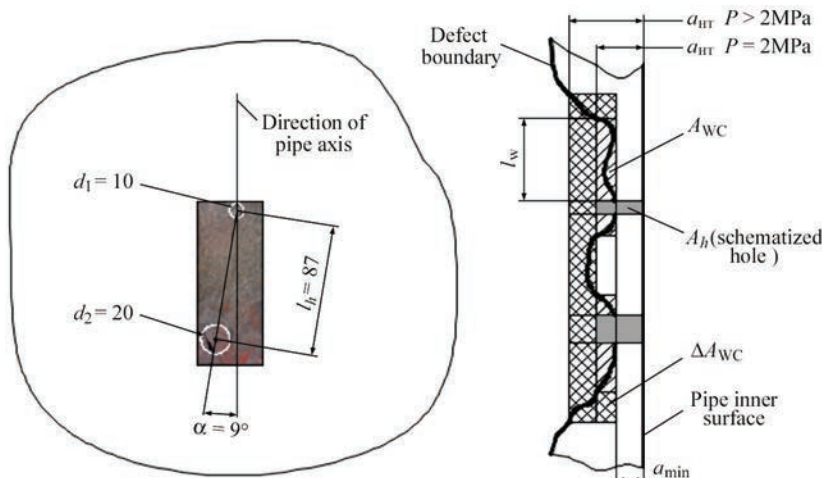
Figure 15. Schematization of through hole defects: *a* — top view: d_1, d_2 — diameters of defects circumscribing holes; *b* — calculation scheme: a_{HT} — minimal allowable thickness under pressure P ; l_w — length of adjacent weakened zone; a_{min} — minimal remain thickness; A_{wc} — calculated area of adjacent weakened zone; A_h — area of schematized hole; ΔA_{wc} — increase of weakened area

fects by circumscribing holes with diameter d_1 and d_2 (Figure 15, a). As far as (Figure 15, b):

we will consider these holes as lying in the same cross-section and belonging to the same defect of complex shape. Since no destruction occurred during the hydraulic test ($P = 2$ MPa), it can be stated in relation to the specified defect that:

Thus, hydraulic test does not guarantee planned destruction of the pipeline in the presence of relatively small through defects. Accordingly, the insignificant leakage of water caused by them, makes it difficult their detection, especially when pipeline lays in an impassable channel.

It should be noted that at the time of conducting hydraulic test information on the presence of through defects and their characteristic geometric parameters, as a rule, is not available, therefore preliminary determination of the destructive pressure of the damaged pipeline is impossible. At the same time with an increase of the test pressure the probability of failure of pipeline with through defects become large due the raising of weakened area ΔA_{WC} (Figure 15, b).
