CALCULATION PREDICTION OF FATIGUE LIFE OF FREIGHT CAR SIDE FRAME UNDER ALTERNATING CYCLIC LOADS

V.I. MAKHNENKO and I.Yu. ROMANOVA

E.O. Paton Electric Welding Institute, NASU, Kiev, Ukraine

An example of calculation prediction of fatigue crack growth in a side frame of freight cars at a preset range of random cyclic loads is considered. Relationship between exceeding design conditions of operation of the car and probable cause of its fracture was studied.

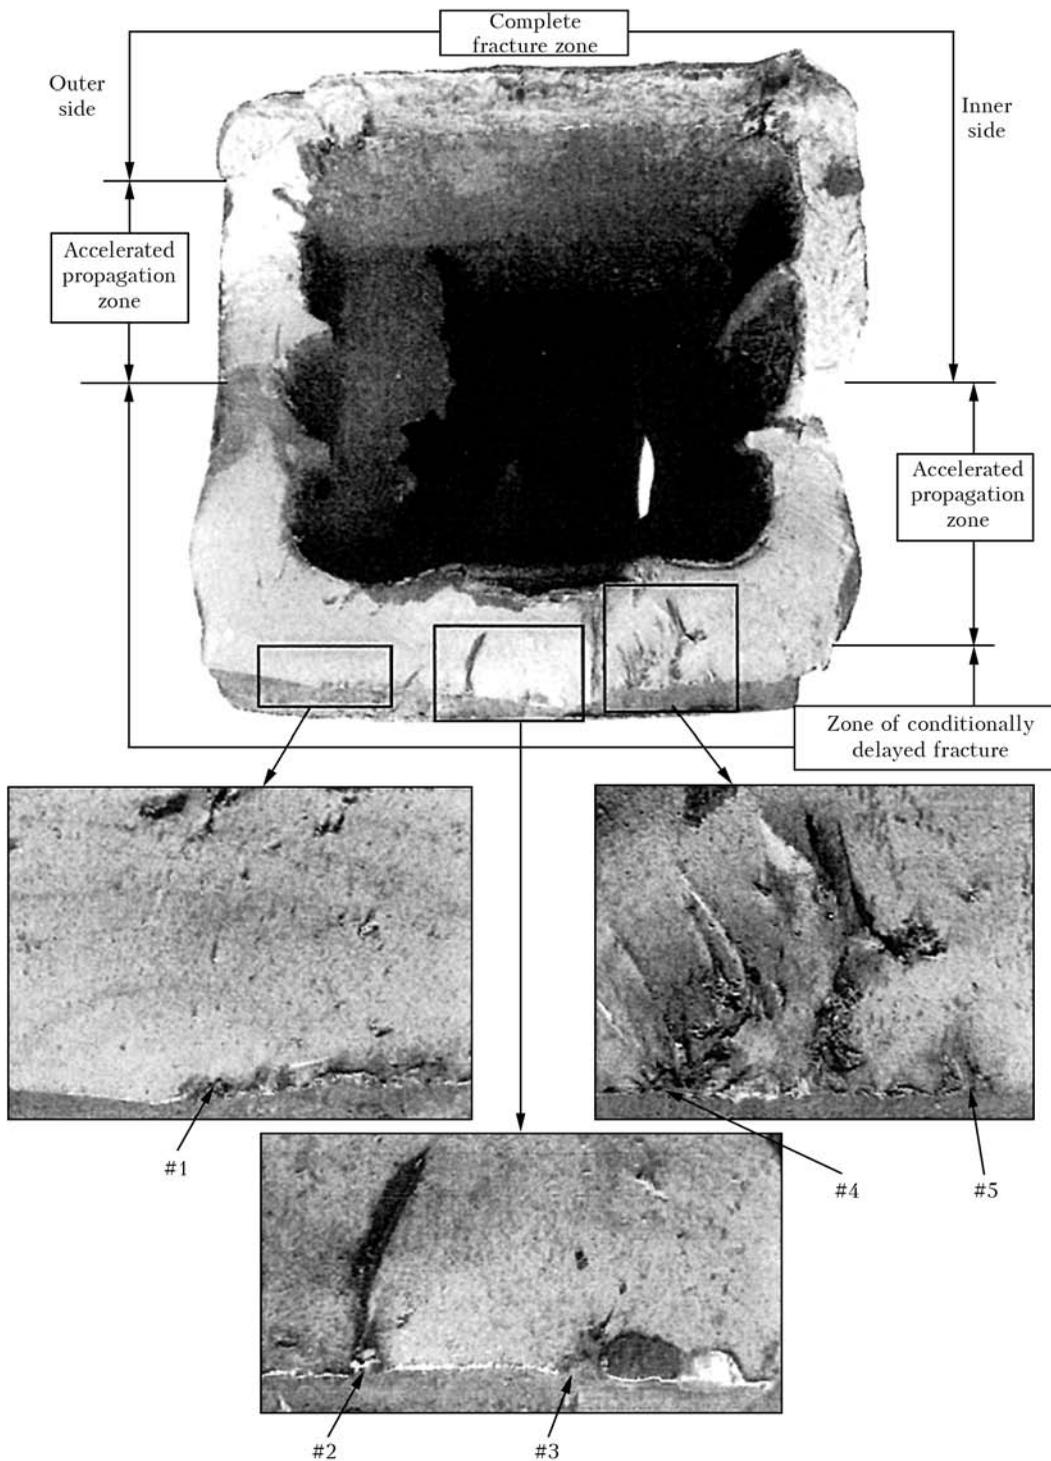
Figure 1 shows fracture of a failed frame, and arrows indicate sites of fatigue fracture initiation [3]. According to this work, the site of initiation of a primary fatigue crack (#1 in Figure 1) was a casting defect — surface blowhole, having the length of 2.6 mm, depth of 1.8 mm in the fracture section and located at 31 mm distance from the surface of the outer vertical wall of the side frame. The defect was not detected by NDT means. Site of initiation of secondary fatigue cracks were casting blowholes located at 66, 104 and 125 mm distance from the surface of outer vertical wall and having the dimensions of 2.0×1.5 mm (#2), 4.3×2.3 mm (#4) and 4.0×1.3 mm (#5) in the fracture section. In addition, there is a

surface defect of 3.0×2.0 mm size (#3 in Figure 1), not specified by the drawing of the technological stiffener, which in [3] is regarded as the site of secondary fatigue cracks formation.

Figure 1. Fracture of side frame of freight car (#1-5 – sites of fatigue crack initiation)

Thus, calculations show that fatigue fracture of the side frame of a train car occurred because of casting defects-blowholes found in the fracture. These defects as to their geometrical dimensions are admissible at design conditions of car service. However, exceeding the design conditions of the car operation, in particular, its movement speed can be the cause for the considered defect transition into the category of inadmissible defects.

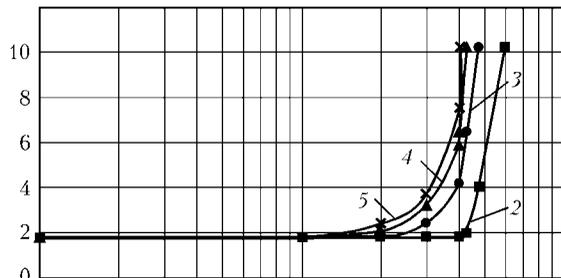
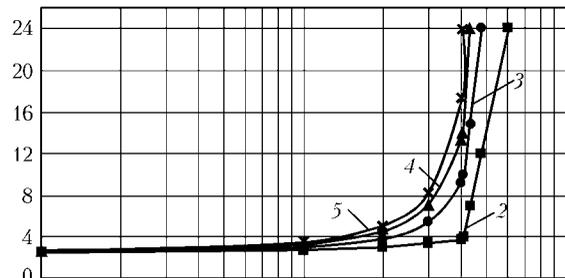
Figure 3. Kinetics of growth of defects #1 (a , b), #3 (c , d) and #4 (e , f) at car movement at a higher speed depending on safety factor γ_m : a , c , e – increase of crack depth a ; b , d , f – $2c$ growth; 1 – $\gamma_m = 1.20$; 2 – 1.25; 3 – 1.30; 4 – 1.35; 5 – 1.40

A similar situation is in place also for defects #2–5, from which secondary cracks are developing, i.e. under design operating conditions of the train the considered defects are admissible, non the less fracture did take place. Let us prove that the cause for the considered fracture can be inclusion into the loading spectrum of a higher speed of train movement. With this purpose a spectrum of speed according to [2] was considered, which corresponds to the design average technical speed of 24.7 m/s. Figure 3 gives the calculated data on the kinetics of variation of dimensions of defects #1, 3 and 4 at increased (compared to design) movement speed, from which it is seen that appearance of $v = 36.25$ m/s, $P = 0.05$ and $v = 38.75$ m/s, $P = 0.02$ in the speed spectrum noticeably changes the kinetics of the change of dimensions a and c of initial defects (cracks). Calculations showed that defects #2 and 5 do not show any growth at these input parameters. Practically, at $N = 5 \cdot 10^6$ cycles the above defects coalesce, forming a continuous crack about 10 mm deep along the base surface, at which the remaining life of the side beam is quite limited. It is characteristic that at $N = 3 \cdot 10^6$ loading cycles (approximately cor-

responds to the moment of setout repair 9.5 months before failure) the defects have grown noticeably and they can be detected by the non-destructive methods. Naturally, the considered variant of operation at increased speed is quite hypothetical. It shows that a quite probable cause for fracture could be the accumulated damage related to car operation in modes not envisaged by design.
