# ASSESSMENT OF THE EFFECTIVENESS OF COMPOSITE BANDS FOR RECONDITIONING OF DEFECTIVE SECTIONS OF PIPELINES

The paper gives the results of testing 720 × 10 and 530 × 8 mm pipes with composite-polymer bands in sections with defects simulating local corrosion damage. Joint work of the band and pipe at static and cyclic loading caused by inner pressure is shown. Effectiveness of reinforcement of defective pipeline sections by composite-polymer bands is established and features of fracture of a banded pipe are noted.

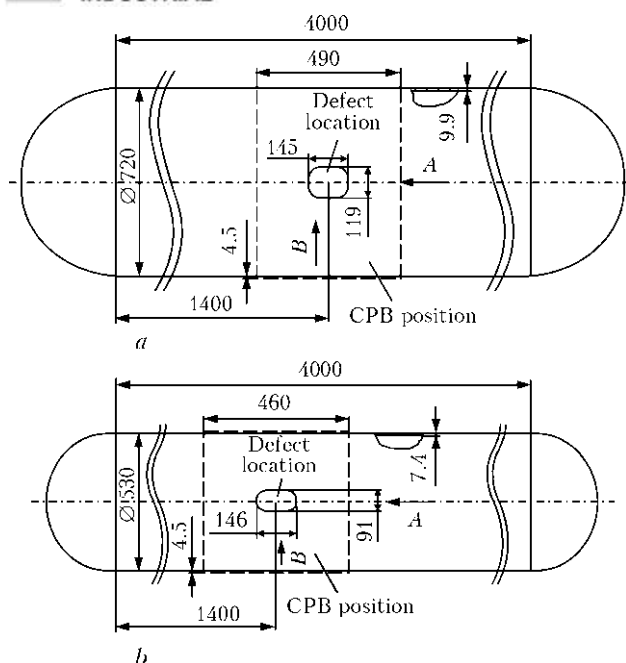
**Figure 1.** Samples-stands Dn 720 (a) and Dn 530 (b) with artificial defects and CPB

Defective sections were reinforced by applying a multilayer band. Technology of CPB application envisages preparation of the pipe surface by sand-blasting, as well as filling the defects and smoothing the roughnesses, in particular, in the presence of reinforcement in the weld, using REM-Steel composite material, the specification of which is given in TU 2257-005-00396558–98. After polymerization of REM-Steel and surface cleaning in keeping with VRD 39-1.10-013–2000 CPB was applied. For both pipes the band consisted of seven layers of glass net, and its thickness was equal to approximately 4 mm. Band width for Dn 720 pipe was equal to 490 mm, and for Dn 530 pipe it was 460 mm. All the operations on band mounting were performed at excess pressure of 4.94 MPa in pipes, that corresponds to 70 % of the working pressure. After complete polymerization of the band pipe testing began.

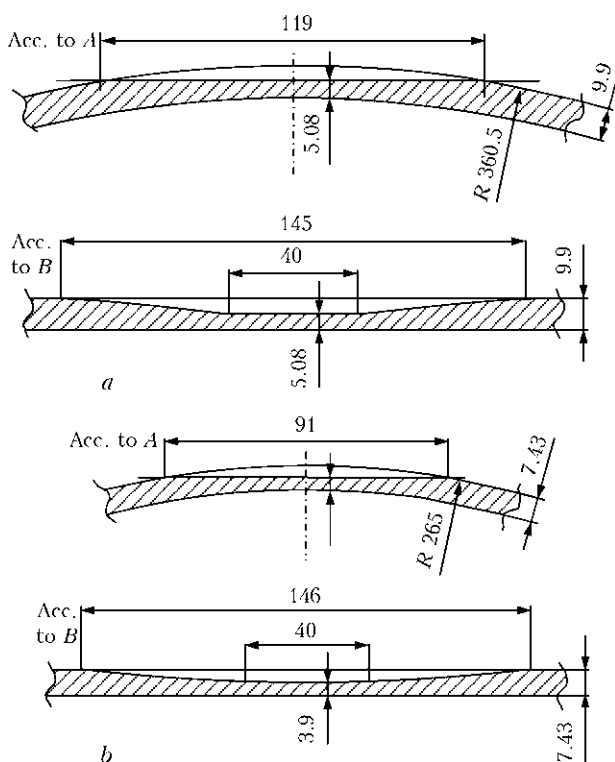
**Figure 2.** Geometrical dimensions of defects on samples-stands: a — Dn 720; b — Dn 530

Coefficients of lowering of the pipe load-carrying capacity were determined, proceeding from the prerequisite, that the defect influence is similar to that of an isolated through-thickness hole at equality of the areas of the defect and hole in the longitudinal direction [4–6]. Proceeding from the actual dimensions of defects, strength coefficients were equal to: for Dn 720 × 10 pipe — 0.72, for Dn 530 × 8 pipe — 0.617.

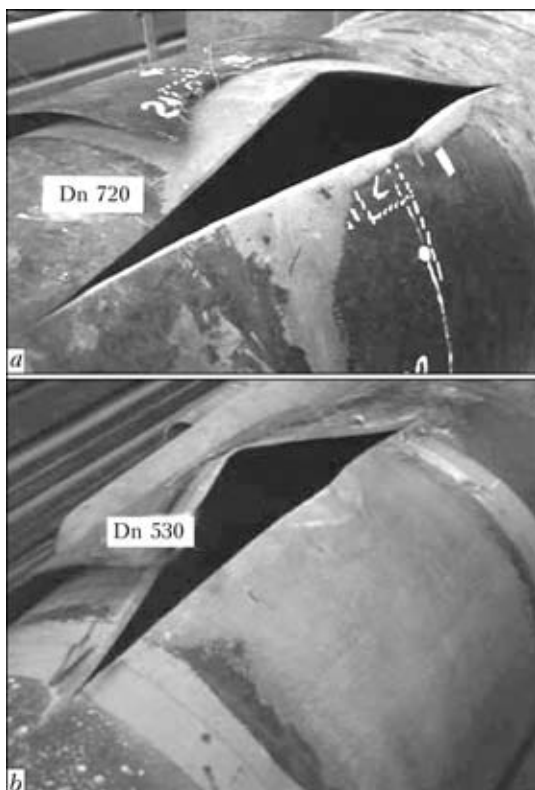
Failure of a pipe reinforced by CPB has its special features. At loads inducing plastic deformation of the pipe, a field of deformation concentration starts forming in the defect location. When deformations have reached critical values for the band, its rupture occurs, which does not cover the entire width of the band, but just one part of it located above the defect. Here no delamination of the band from the pipe is observed. At the moment of band rupture the pressure in the pipe drops somewhat, and then starts rising again, and exceeds the level of initial band rupture. At this stage the angle of inclination of loading diagram decreases somewhat which is indicative of slowing down of load increment, and more intensive strain increase. Failure of sample-stand Dn 720 (Figure 6) is tough,

and it occurred at inner pressure of 14.87 MPa. Here, a longitudinal crack formed, which ran through defect center. Immediately before pipe failure, band delamination occurred in the defect zone accompanied by characteristic crackling.

Testing of sample-stand Dn 530 was conducted by the same schematic as that of Dn 720. At the pressure of 13.5 MPa the first rupture of part of the band occurred (about 30 % of its width). Pipe failure occurred at the pressure of 142.3 MPa (Figure 6, b).

Figure 6. Appearance of failed sample-stands
