OPTIMIZATION OF CONDITIONS OF REDUCTION HEAT TREATMENT OF BLADES OF ALLOY KhN65VMTYu AFTER LONG-TERM SERVICE

Yu.P. TARASENKO, O.B. BERDNIK and I.N. TSARYOVA

A.A. Blagonravov Institute of Engineering Science, RAS, Novgorod, Russian Federation

Condition of the material of gas turbine engine blades after long-term service was studied and their reparability was determined. Parameters were developed for high-temperature heat treatment of alloy KhN65VMTYu (EI893) to extend the service life of product.

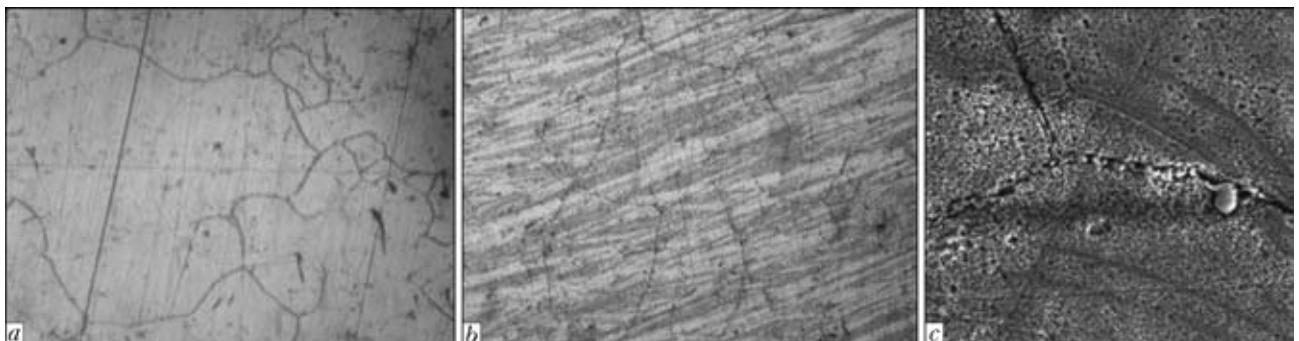
The microstructures of alloy KhN65VMTYu after different operating time are presented in Figures 1–3. It follows from the analysis of structure of metal of all blades that as a result of long-term service at operating temperatures the structure-phase state of material changes considerably and is deteriorated. Trans- and intercrystalline microcracks in the structure were not revealed, but microstructure of alloy is characterized by difference in grains. It is known that at the boundaries of different-grain metal in the process of service the cracks can appear as the volumes of coarse and fine grain deform in different way. Metal in the root part has more homogeneous microstructure. In the metal with lower operating time (53,000 h) the strengthening intermetallic γ' -phase (Ni_3Al , Ti) is almost completely dissolved in the solid solution and its remnants have chaotic distribution in the volume of grains. The grain boundaries are linear, filled with fine-dispersed carbide and intermetallic phases (see Figure 1).

Figure 1. Microstructure of alloy the KhN65VMTYu specimens after service during 53000 h cut from the first (*a*, *b* – $\times 250$) and root part of blade (*c* – $\times 10000$)

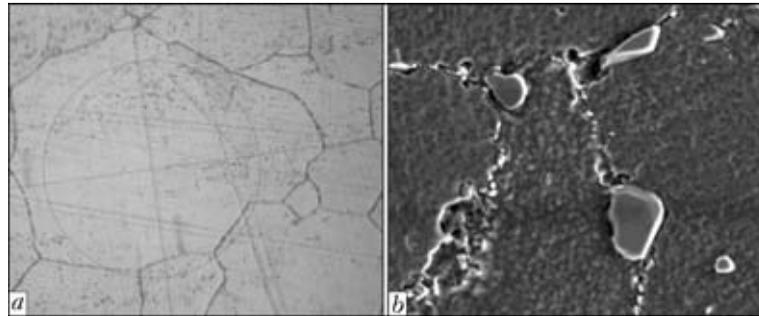
Figure 3. Microstructure of alloy KhN65VMTYu after service during 62,449 h (a – $\times 250$; b – $\times 1000$)

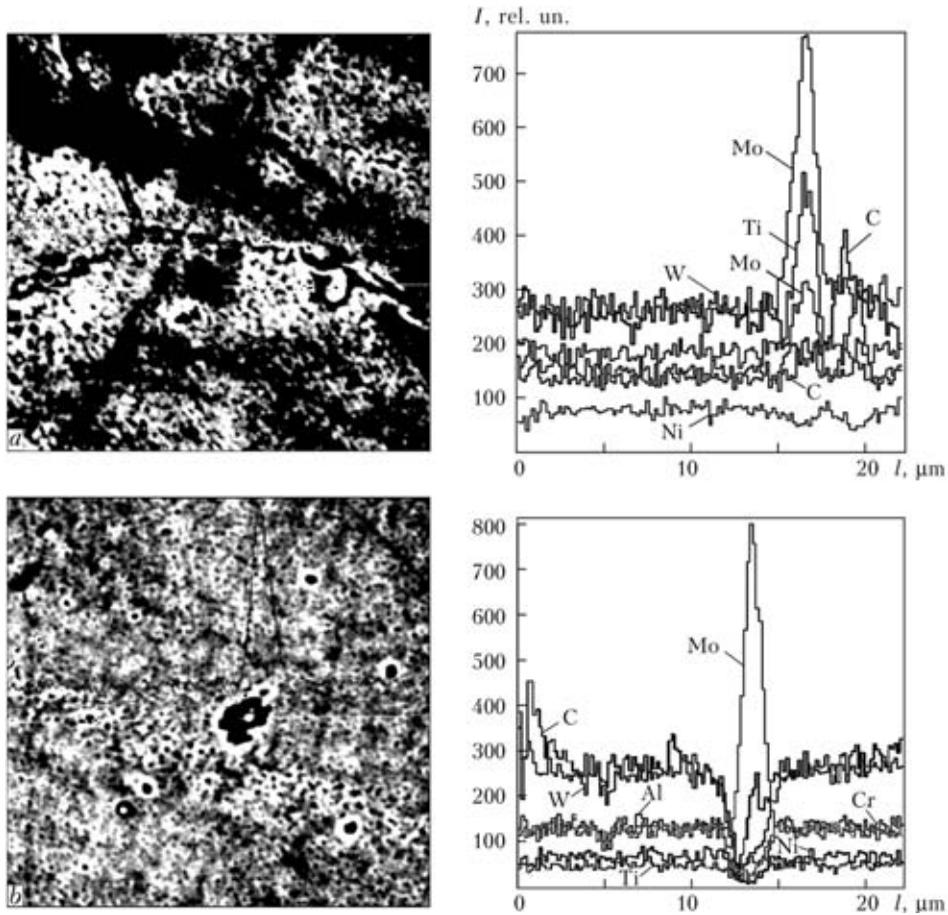
As a result of microspectral analysis of carbide inclusions located at the boundary and inside the grains of metal, the spectrograms were obtained which allow us to state that the investigated carbide inclusion, presented in Figure 4, *a*, was formed on the basis of tungsten, molybdenum and chromium and corresponds to complex carbide of group II of the type (W, Mo, Cr)C, while in Figure 4, *b* – to carbide of molybdenum Mo_2C , which is also carbide of the group II (interstitial phase). Due to a low carbon content in the alloy KhN65VMTYu ($\leq 0.07\%$) the amount of carbide phase in it is negligible and it is located mostly along the boundaries of austenite grains.

Figure 4. Microstructures and spectrograms of carbide inclusions detected at the surface of cross sections: *a* – after service; *b* – after RHT using mode 4 (see Table 1)

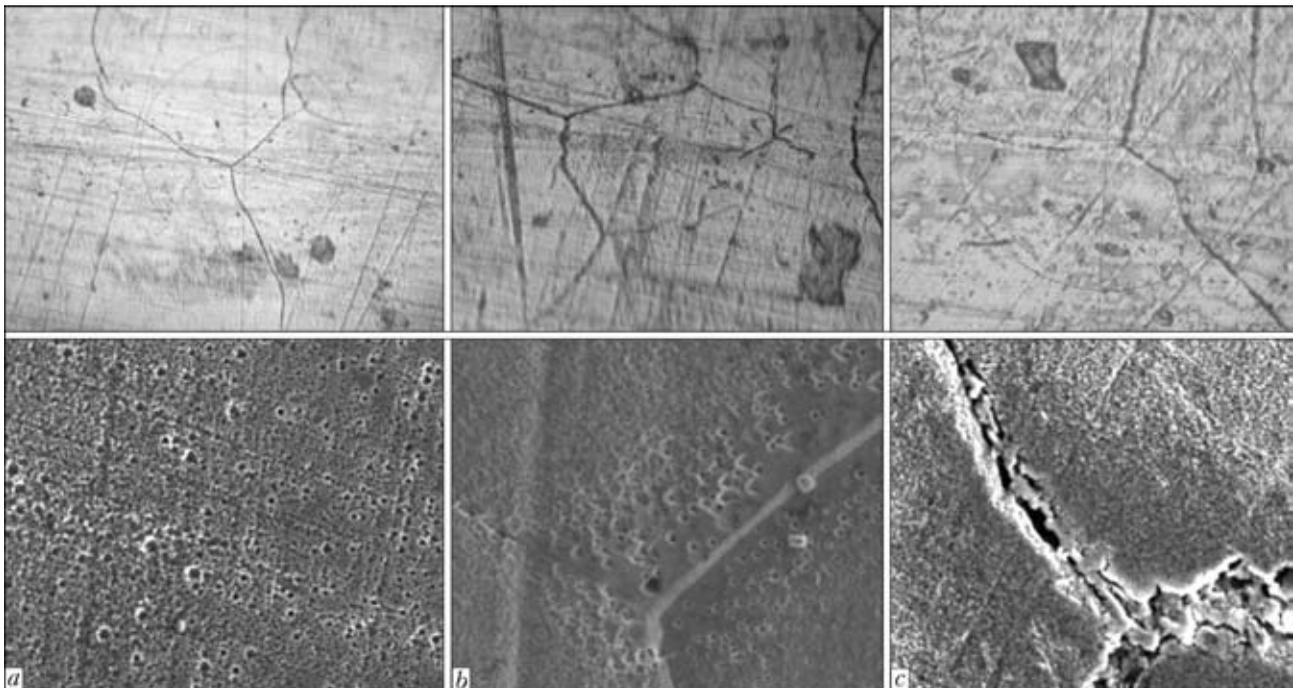
γ' -phase: in use of step conditions of RHT the content of γ' -phase is increased up to 3–4 %, during one-step ageing at 820 or 850 °C the amount of γ' -phase is increased up to 10 %, which is the admissible content for this alloy. In RHT of specimens using the condition 5 during 30 h, the complete regeneration of degrade structure of blade metal occurs. In this case the excessive intermetallic γ' -phase is observed in a form of fine-disperse precipitates. The content of γ' -phase after RHT is increased up to 12 %, however at long-time ageing the precipitation of coarse carbides at the grain boundary occurs which are the concentrators of stresses.

Figure 5. Microstructure of alloy KhN65VMTYu with operating time of 53,000 h after different variants of RHT: *a* – mode 1; *b* – mode 2; *c* – mode 5 (see Table 1)

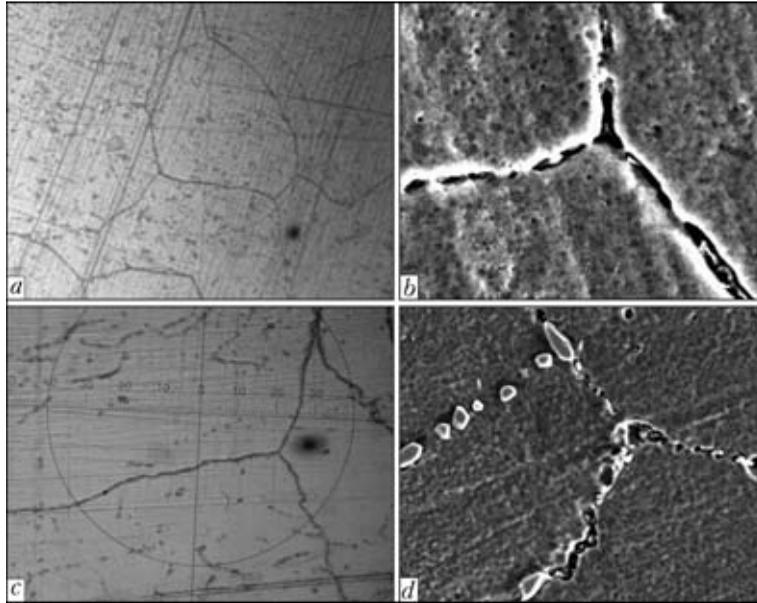
In RHT on the alloys with operating time of 60,142 and 62,449 h (Figure 6) the satisfactory result was obtained: the dissolution and redistribution of intermetallic phase and refining of carbides occurred. The changes in microstructure were positively reflected on mechanical characteristics of material presented in Table 1. RHT resulted in decrease of tensile strength to 990–940 MPa and increase of yield strength up to 555–485 MPa which corresponds to the standardized values of mechanical properties.

Figure 6. Microstructure of alloy KhN65VMTYu after RHT: *a, b* – mode 4 at operating time of 60,142 h; *c, d* – the same at operating time of 62,449 h (*a, c* – $\times 500$; *b, d* – $\times 10000$)

For the alloys with operating time of 60,142 and 62,449 h, the condition 4 of RHT was applied (see Table 1), which showed optimal values of structural
