# DEFECTS OF JOINTS OF HIGH-STRENGTH RAILS PRODUCED USING FLASH-BUTT WELDING

S.I. KUCHUK-YATSENKO, V.I. SHVETS, A.V. DIDKOVSKY, E.V. ANTIPIN and L.M. KAPITANCHUK

E.O. Paton Electric Welding Institute, NASU

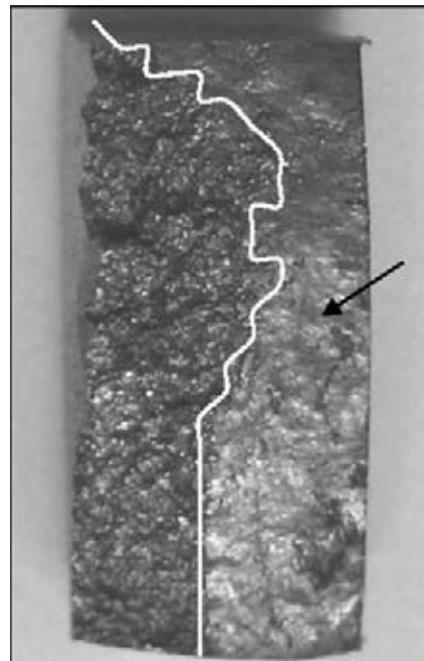
One of such defects is lack of penetration. In FBW the lack of penetration is formed under the conditions when the metal of rail edge is in solid or solid-liquid state before upsetting. At the fracture it has an appearance of a plane bright area (Figure 4). It was established that microstructure of surface of the analyzed lack of penetration represents plane areas of rail metal matrix (Figure 5, spectrum No.1), divided by a structural

**Figure 4.** Lack of penetration on fracture surface of rail welded joint

The presence of defects of this type even of small area (1–2 mm<sup>2</sup>) detected using modern means of ultrasonic testing, is not admissible in welded joints as far as they reduce the values at static and impact tests and provoke fatigue fractures of welded butts.

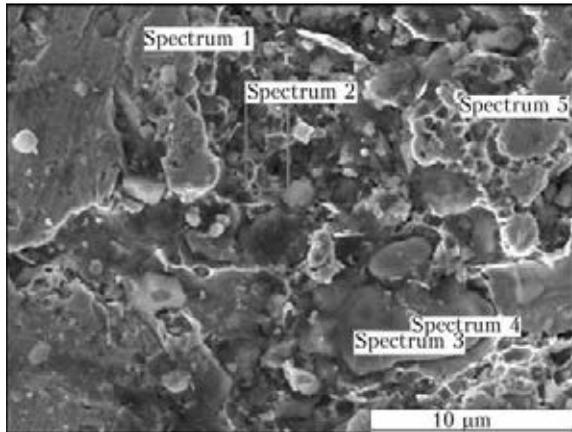
**Figure 5.** Microstructure of fracture surface and chemical heterogeneity on the area of lack of penetration in rail welded joint

component, composed of oxides and silicates (Figure 5, spectra Nos. 2–5). Obviously, this structure component is formed of non-metallic inclusions of base metal and oxidation products of rail metal fused along the boundaries.

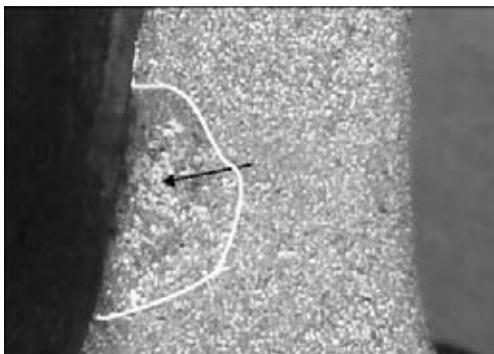
Another type of defects represents spots with a non-developed relief in the range of which the bright and dead spots are combined (Figure 6). The analysis of microstructure of fracture surface showed that bright spots represent a layer of iron-manganese silicates (Figure 7, a). Dead spots, adjacent to a monolithic layer, are the area of clustering the particles of iron-manganese silicates (Figure 7, b). The fracture occurs as a result of delamination along the film at the area of monolithic layer and along the pit mechanism in the places of inclusions clustering.

The iron-manganese silicates are formed in the process of welding at the oxidation of fused metal. It is supposed [3] that formation of oxide structures in the plane of a joint is determined

**Figure 6.** Iron-manganese silicates on the fracture surface of rail welded joint

by the presence of oxygen in the spark gap during the period of fusion, preceding the upsetting. It is shown in work [4] that the main factor influencing the formation of defects in the plane of a joint is the state of melt at the fused ends of parts during the period, preceding the upsetting. If the melt is preserved, then it is squeezed out during deformation from the butt together with oxides, forming at its surface, independently of oxygen content in the spark gap. The duration of existence of melt layer on edges depends on its thickness, gradient of temperature field in the near-contact area of edges and speed of parts fusion [5].

The described defects are observed in the joints of rails welded with deviations from the preset values of welding parameters. They are reliably detected using modern methods of ultrasonic testing even at a small area (1–2 mm<sup>2</sup>). Their presence in welded joints is not admissible as far as they decrease the values of mechanical properties at static and impact tests and provoke fatigue fractures of welded butts.

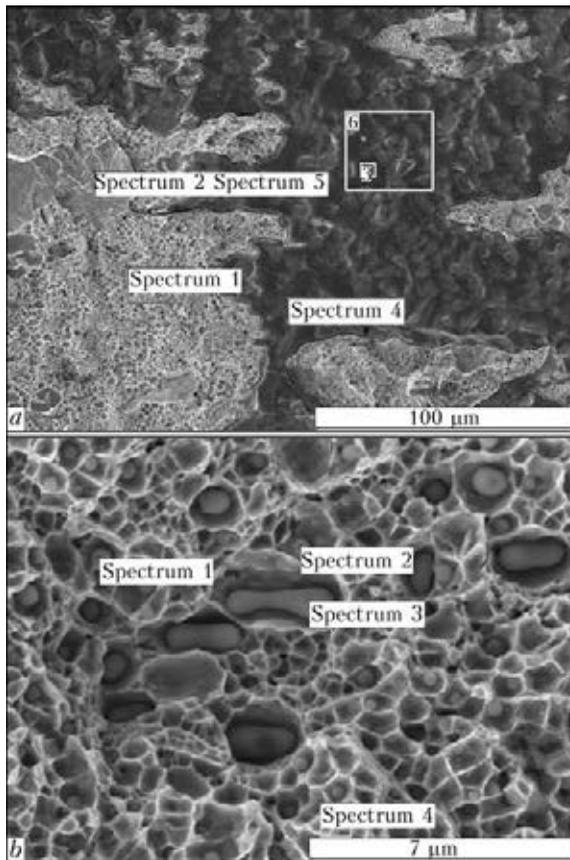
**Figure 7.** Microstructure and results of analysis of chemical composition heterogeneity on the area of fracture with iron-manganese silicates in the form of film (a) and inclusions (b)

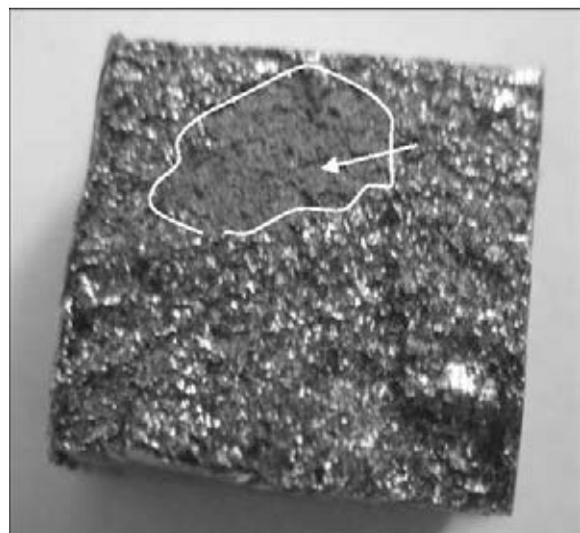
The particular place relates to the defects which are defined in the standard documents as «dead» (DS) or «grey» spots. At the surface of fracture they are observed as the areas of dark color with a non-developed relief (Figure 8). These are the defects which are most often observed during tests of welded joints of different metals produced using FBW.

**Figure 8.** Dead spots in the fracture surface of rail welded joint

examined above, not only by the composition of their structure components but also by their thickness not exceeding 20 μm. Small thickness impedes their detection during ultrasonic testing, from the one hand, and on the other hand the presence of such defects in welds of rails does not have a considerable influence on the values at full-scale tests on static and impact bending. The limited number of DS in the joints of rails is admissible. Their total area is restricted to 15 mm<sup>2</sup> [2] by existing standards which is sufficiently grounded by experimental data.

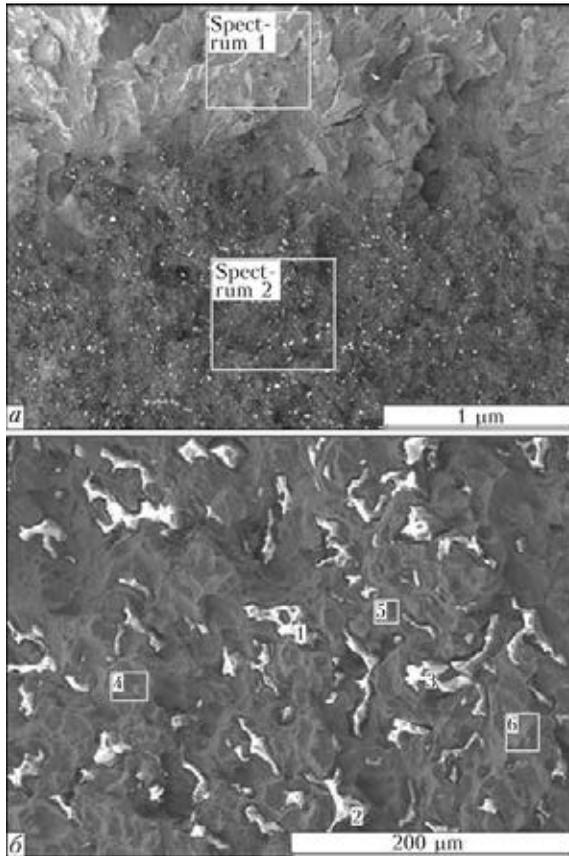
The comparative analysis of chemical composition from the defect area showed that DS are enriched with aluminium, manganese, silicon as compared to the surrounding surface of crystalline structure (Figure 9, a). During the more detailed investigations it was established that DS represents the clusters of particles of manganese aluminium silicates, arranged in the metallic matrix (Figure 9, b). The particles have a fused

The characteristic feature of inclusions of aluminium silicates is a negligible amount of iron in their composition (0.86–0.99 at.%). It evidences of the fact that their formation is not connected with the flashing of edges. They are formed in the layer adjacent to the fused metal on the base of inclusions of base metal (see Table 2). The saturation with manganese occurs during its transition from the matrix into the forming fusible silicate, which is possible due to the high diffusion mobility and surface activity of manganese in iron. The location of aluminium silicates in the layer adjacent to the fused metal impedes their squeezing out into the flash during upsetting.

It is known that fusible aluminium silicates are formed during underoxidation of silicon in presence of aluminium [6]. As the source of silicon the silicocalcium can be, used as deoxidizer

during manufacture of rails, that is indirectly confirmed by presence of calcium in the composition of aluminium silicates. The aluminium gets to the steel from ferroalloys and, possibly, the ladle slag [7].

**Figure 9.** Microstructure and results of analysis of chemical composition of fracture surface of rail joints on the area of a dead spot from area (a) and locally (b)

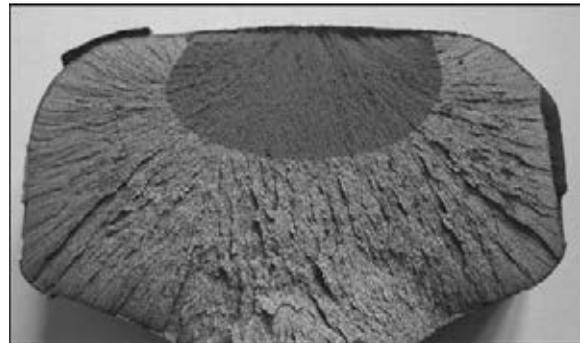
In the last time, on the fractures of rails, fractured not only along the joint but also along the base metal, defective areas was found in the head area of the shape close to oval of dark color and non-developed relief (Figure 10).

The formation of oval spot is obviously occurs on the basis of DS as a result of interaction of aluminium silicates with ferrous oxide, for example, in the case of underoxidation of steel. Here more fusible oxide systems are formed, which are characterized by a high fluidity [8]. Under the thermodeformational conditions of rolling and welding these fusible oxides are penetrated along the structure boundaries and form the oval spots.

Figure 10. Oval spots on fracture of rails

The absence of metallic joint on the larger area results in considerable reduction in strength.

In welding of high-strength rails of modern production, as the results of large amount of test batches of welded rails show, the probability of DS formation increases as compared to the similar data obtained in welding of rails of open-hearth production. It is obviously connected with getting of aluminium into the steel as associated element, for example, during adding of vanadium, titanium, niobium or other technological operations. To eliminate the defects like these it is necessary to carry out works on improvement of processes of steel melting and pouring.

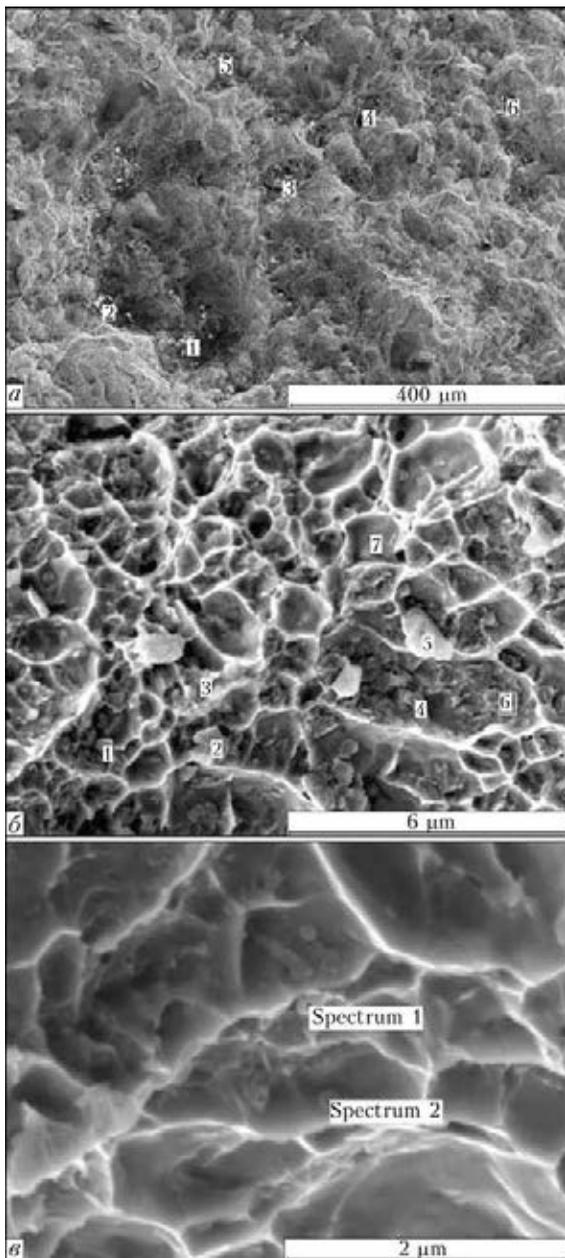
It was established that fracture on the area of oval spot occurs according to the pit mechanism (Figure 11). Within the limits of area the groups of inclusions of 20 mm size were found representing the complex oxides composed of aluminium, silicon, magnesium, calcium (Figure 11, a). The inclusions, which are similar by their chemical composition, but finer in size, are pre-

sent in the pits (Figure 11, *b*). In the pits the inclusion of iron oxides can also be found, the size of which amounts to tenth fractions of micrometer (Figure 11, *c*).

Figure 11. Microstructure and results of analysis of chemical composition of non-metallic inclusions on the area of oval spot of fracture of rail welded joint: *a* – clusters of particles of aluminium, silicon, calcium, magnesium oxides; *b* – particles of oxides located in the pits; *c* – iron oxides
