# EXPERIENCE OF INTRODUCTION OF THE TECHNOLOGY OF RECONDITIONING MICROPLASMA POWDER SURFACING AT REPAIR OF HIGH-PRESSURE TURBINE BLADES IN BATCH PRODUCTION

Company «MOTOR SICH»

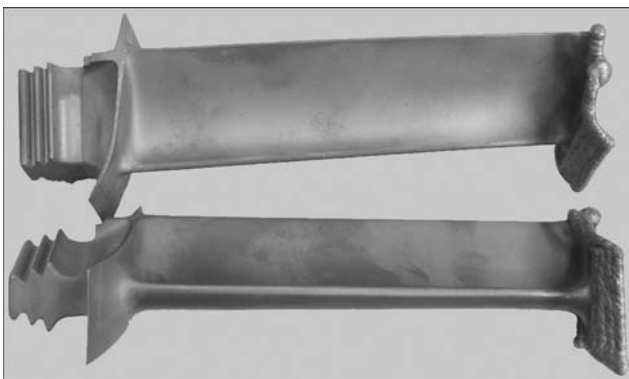
**Figure 2.** Blade after reconditioning of shroud platform (base metal is JS26-VI alloy, surfacing material is JS32 alloy)

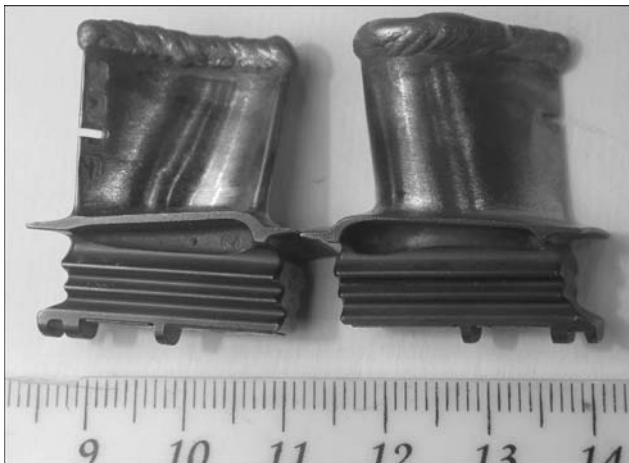
**Figure 3.** Blade after reconditioning of airfoil edge (base and deposited metal is JS32 alloy)

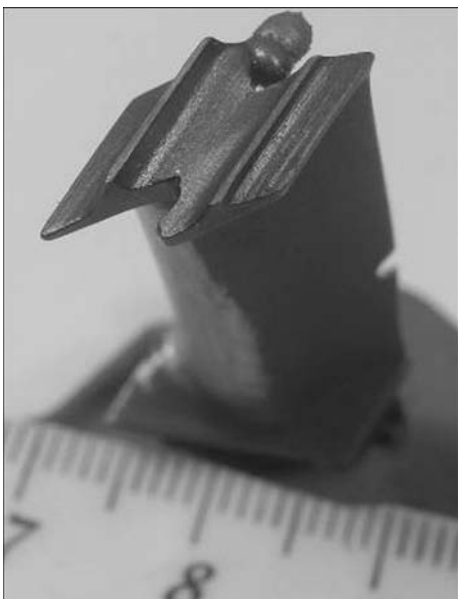
**Figure 4.** Blade after restoration of Z-shaped profile (base and deposited metal is JS6K alloy)

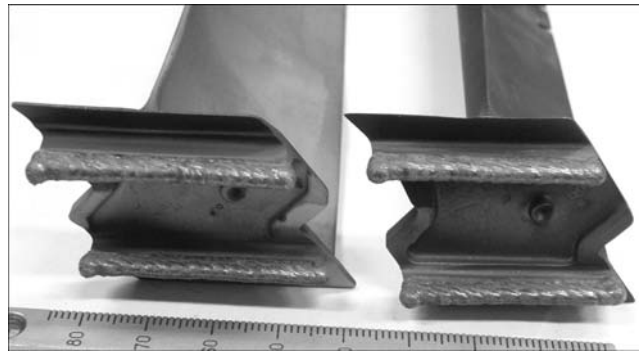
**Figure 5.** Blades after reconditioning labyrinth seal edges (base metal is JS6K alloy, surfacing material is Stellite 12)

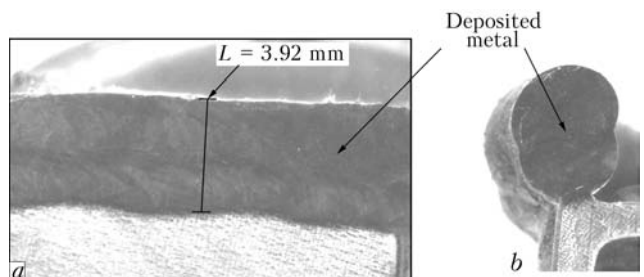
Example of metallographic testing of reconditioned JS32-VI blade is given in Figures 6 and 7. Analysis of longitudinal and transverse sections showed that at 2-layer surfacing of airfoil edge by powder from JS32-VI alloy deposited layer height was equal to about 4 mm, and its thickness was 3.0–3.5 mm (see Figure 6). HAZ was small, structural changes were equal to about 0.1–0.2 mm (see Figure 7). No inadmissible defects of metallurgical nature were found in the deposited metal and HAZ.

**Figure 6.** Appearance of longitudinal (a) and transverse (b) section of reconditioned seal element of the blade

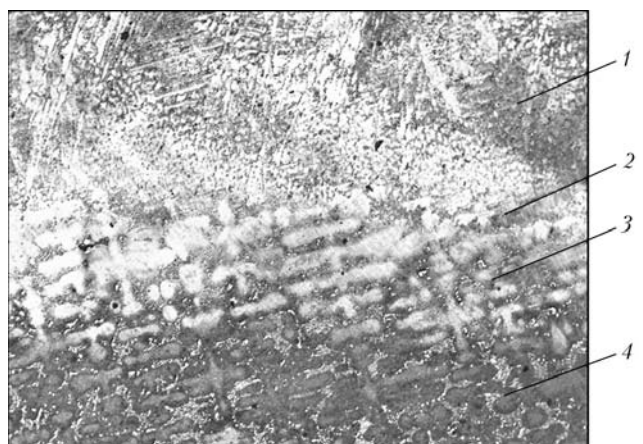
**Figure 7.** Microstructure ( $\times 100$ ) of reconditioned seal element: deposited metal JS32 (1), fusion line (2), HAZ (3) and base metal JS32-VI (4)
