SELECTION OF TECHNOLOGY FOR REPAIR WELDING OF PARTS OF TURBINE UNITS

The peculiarities of disassembly-free repair of steel grade 15Kh1M1FL body of the control valve of the medium pressure cylinder of the turbine PT-200-130 of the heat power plant, in which a crack was formed after a long-term service, are given. The repair without disassembly of the valve is possible due to the use of technology of repair arc welding by pearlite electrodes with preheating and thermal recovery. 12 Ref, 1 Table, 7 Figures.

The aim of this work was the selection of welding technology in disassembly-free repair of cast body of control valve of the medium pressure cylinder (MPC) of a 130 MW power steam turbine (Figure 1) made of steel 15Kh1M1FL.

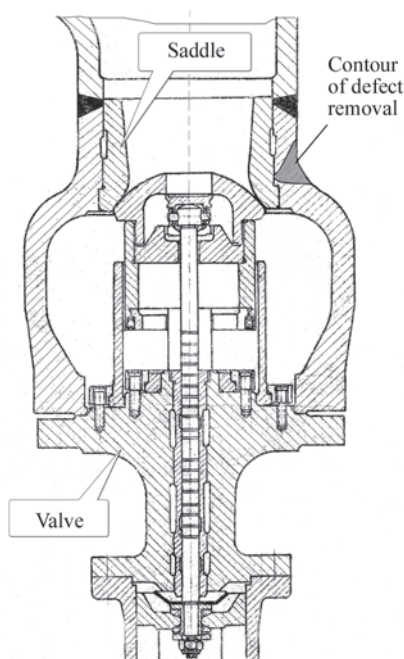
The valve body represents a large-sized casting of a complex configuration (Figure 2), which is welded-on to the case of MPC (Figure 3). The valve worked out about 300 thousand hours at the temperature of 545 °C and at the vapor pressure of 3.0 MPa. The damage in the form of a small (30–40 mm) crack in the fusion zone of austenitic deposit on its outer surface was detected during preparation of the turbine for major repairs. The deposit was located on the area of variable cross-section, in which the wall thickness varied from 60 to 140 mm. This deposit worked out without remarks about 200 thousand hours. It was made by high-nickel electrodes TsT-28 (type 08Kh14N65M15V4G2) during rewelding of removed metal area of 420×155 mm section and 45 mm depth, formed during removal of the delaminated metal deposited by austenitic electrodes of

Figure 3. As-assembled control valve

by coarse grains, embrittlement of grain boundaries, phase and structural transformations which reduce the mechanical properties. As a result, a removed metal area with dimensions in the plan of 590×185 mm and the depth within 30–65 mm was obtained. Moreover, in its middle part a through slot of 10–18 mm width and 120 mm length was formed, in which the surface of the saddle was uncovered (Figures 3 and 5).

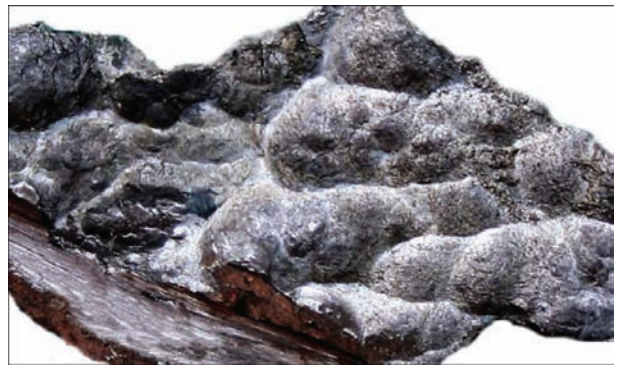
During removal of a defect applying layer-by-layer grinding, the propagation of delamination and separation of austenite metal in small pieces were observed (Figure 4). Moreover, the delamination surface had a relief, typical for deposited metal, and the hardness of its areas had high (HV 480–520) and low (HV 110–150) values. It indicates that the fracture occurred in the fusion zone both in the carburized as well as in the decarburized area. The completeness of removal of austenitic metal was controlled by a magnetic powder method and by metallographic etching of surface with 20 % nitric acid. Except of austenitic metal, a layer of base metal of 8–10 mm thickness was also grinded. This made it possible to remove the HAZ metal having a high degree of defectiveness caused

Figure 4. Fragment of austenitic deposit ($\times 3$). Appearance on the side of delamination surface

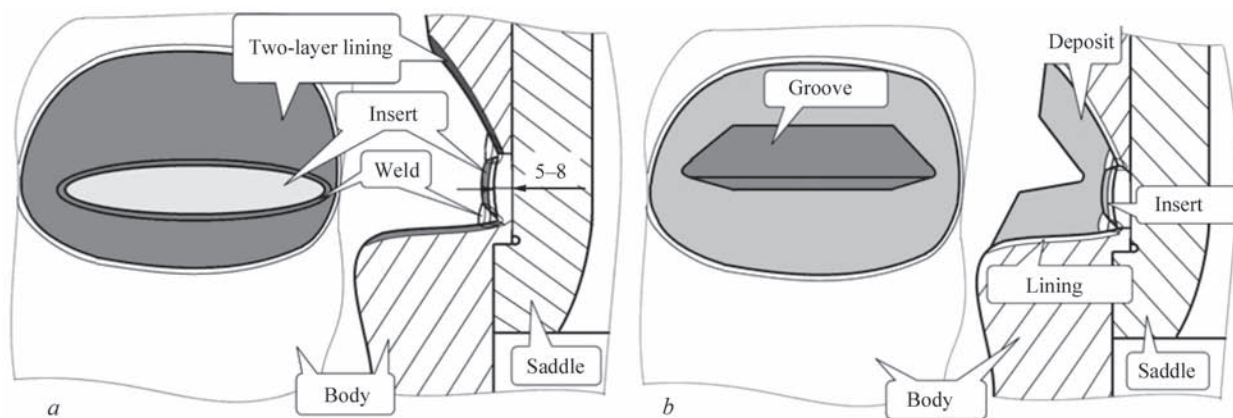
Figure 5. Preparation of a crack in the body of the MCP control valve for welding and the stages of its rewelding

To eliminate the damage of saddle during rewelding of through slot, a special insert was welded-in to it at the distance of 5–8 mm from its surface (Figure 5, *a*). The insert was cut out of the section of pipe (steel 15Kh1M1F) deposited by the electrodes TML-5 (06Kh1M) and subjected to heat treatment: normalization and high-temperature tempering. The profiling of the insert was performed strictly according to the size of slot with the edge bevel for welding at the angle of 45° on the side of deposit. It was located by 1–2 mm higher than the lower edge of the slot with the formation of gap of 1.0–1.5 mm size between the edges to be welded. To prevent a possible welding-on to the saddle, its surface was protected with anti-burning coating. The root layer of the weld of the insert was made by argon-arc welding using W-electrode with the filler wire of grade Sv-08KhGSMFA of 1.6–2.0 mm diameter. The value of welding current was 220–240 A and the presence of a gap provided a complete penetration of edges welded. The subsequent weld layers of the insert were made by electrodes TML-5 (06Kh1M). The surface of welded joint of the insert was dressed up to a metallic glittering and controlled for absence of cracks by a visual method.

electrodes of grade TML-5. The scheme of crack metal removing for welding and stages of its rewelding are shown in Figure 5. The annealing beads during surfacing of the first layer were produced by 3 mm electrodes and a width of not more than 5–8 mm. They were applied with overlapping by 40–50 % of the width of previous bead. The second layer was made by 4 mm electrodes. When the base metal was heated to the temperature exceeding 280 °C, the welding was stopped to reduce and equalize the temperature to the preheating level. After surfacing of the second layer, the surface was subjected to peening by 0.5 kg hammer with a rounded striker. This technological method is an effective way to reduce welding stresses [4]. After dressing the surface of the as-peened metal, its control for absence of defects was carried out. The subsequent filling of the removed metal area was performed in two stages: the first one is a layer-by-layer surfacing on the side and bottom regions of the removed metal area in the direction from edges of the removed area to the centre up to the formation of a longitudinal V-shape groove of 15–20 mm width and the common slot angle of 40–45° in the middle part of the removed area (Figure 6, *b*). The second stage is filling the groove by surfacing using longitudinal

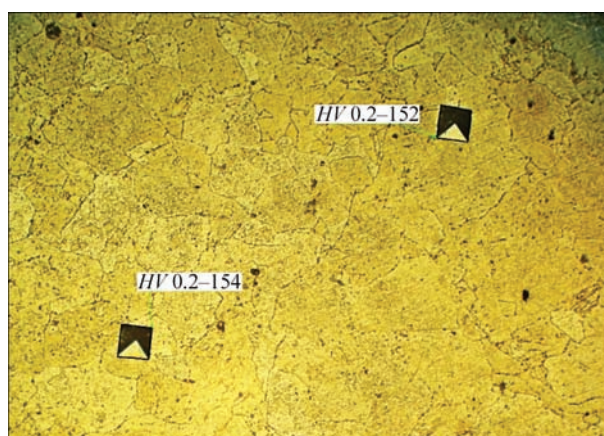
The microstructure of base metal represents a fine grained bainite with carbide particles of up to 12 μm size and single isolated micropores of up to 2 μm size. The ferrite component amounts to not more than 5 %. The microfracture of base metal corresponds to point 2 of the scale of the Appendix Zh OST 34-70-690-96 at the admissible one being not higher than point 4 [1]. The microhardness of structural components is given in Table and the microstructure of base metal is given in Figure 6.

The results of investigations of base metal prove its reparability with application of arc welding and its possible further operation.

Figure 6. Microstructure ($\times 200$) of steel 15Kh1M1F at the area of repair

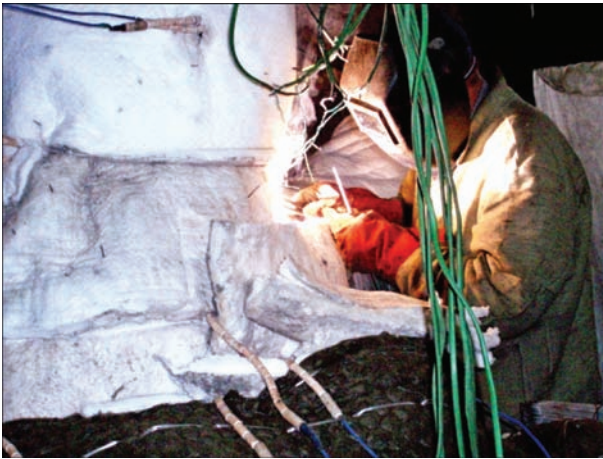
Figure 7. Performing repair welding of a crack in the body of the MCP control valve

beads. The moment of performing repair welding is shown in Figure 7. After end of surfacing, the thermal recovery of metal was carried out by maintaining the temperature of 280 °C during 24 h with the help of the installation «Weldoterm». The cooling of surfacing area was carried out under the layer of thermal insulation at the rate of not more than 25 °C/h to the temperature of 70 °C, and at a lower temperature — in a calm air with the removed thermal insulation. As a result, the hardness of the deposited metal was obtained within the limits of HB 150–175 and of the base metal in the heat-affected-zone HB 140–240.

The quality control of metal was carried out before, during and after surfacing throughout the whole surface of the deposited metal and beyond its 150 mm width by visual-measuring, magnetic-powder and ultrasonic methods. The cracks were not revealed. Based on the results of ultrasonic testing, the metal of repair rewelding met the requirements according to the quality level 2 in accordance with EN 12680-1:2003 and SOU VEA.200.1.1/01-2016.
