REPAIR OF LARGE-SIZED BLADES OF THE FAN OF GAS-TURBINE ENGINE*

I.B. MARKOV, I.A. PETRIK, A.G. SELIVERSTOV and Yu.A. MARCHENKO

JSC «Motor Sich»

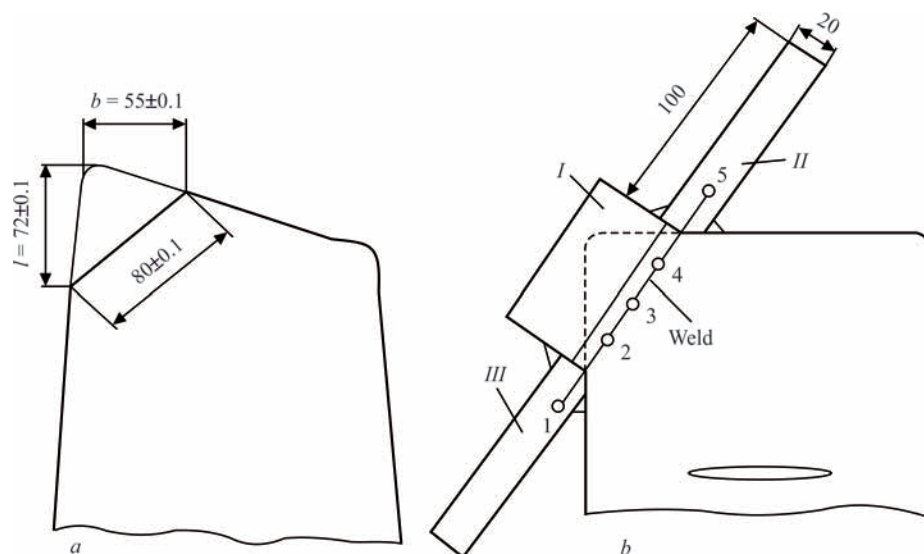
Figure 1. Schematic of calculated zones of repair (a) and location of the weld (b): I — welded fragment; II, III — run-off tabs; 1–5 — base points of weld division into sections

Welding of the blade with tack-welded fragment (Figure 3, b) was performed by EBW from two sides. The weld was divided into sections by five base points (Figure 1, b), with correction of welding modes, depending on the change of the thickness of blade airfoil profile section from 1.2 up to 2.4 mm. Programming of welding mode parameters allowed ensuring sound formation of the weld, and avoiding appearance of defects in the form of burns-through (Table 1).

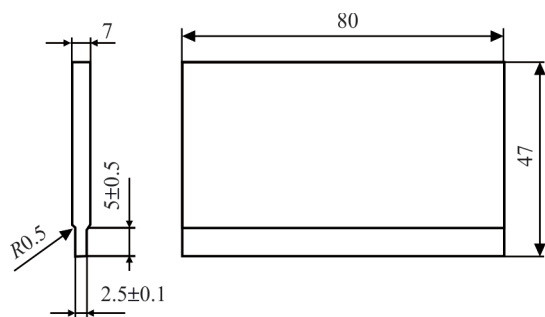
Optimum configuration of the fragment was developed (Figure 2) and dimensions of run-off tabs (Figure 1, *b*) were determined, taking into account the fact that undercuts can form at EBW on the edges of a blade, which has final dimensions. Fragment material corresponds to the part base material.

Figure 2. Configuration of the fragment in the welding area

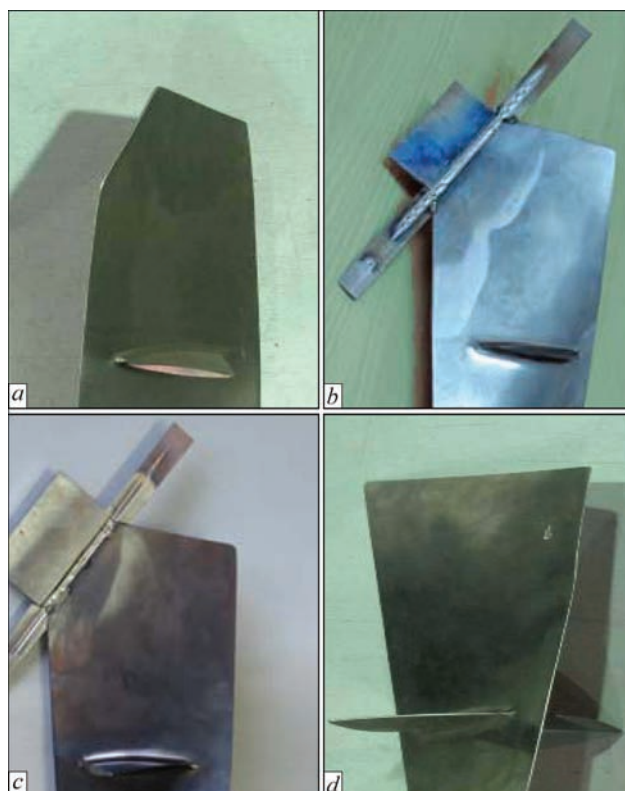
After blade welding, two-step HT (Figure 3, c) was conducted by the following mode: HT first step was performed by EBA in specialized unit Lara-52 at $T = 910\text{ }^{\circ}\text{C}$ with 10 min soaking. EBA modes were selected by analogy with other GTE parts from two-phase titanium alloys, and considerably reduced distortion [4]. Second step — furnace annealing — was performed in a shielding atmosphere at $T = 650\text{ }^{\circ}\text{C}$ for 3.0–3.5 h.

Furtheron, machining of welded fragment was performed up to achieving the required profile configuration with preservation of initial dimensions (Figure 3, d). Finished blades were subjected to control of the repaired locations by LYuM1-OV method and to X-ray testing. No defects were found by control results.

Figure 3. Steps of blade repair performance: a — cutting; b — EBW; c — HT; d — machining

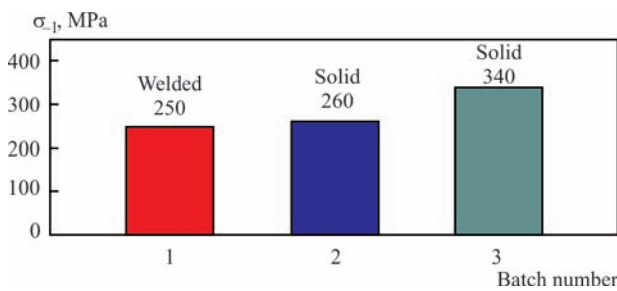
Figure 5. Fatigue limit for three batches of blades

1. Results of fatigue tests revealed lowering of σ_{-1} of solid blades, after certain operation time that corresponds to the level of σ_{-1} of welded blades.

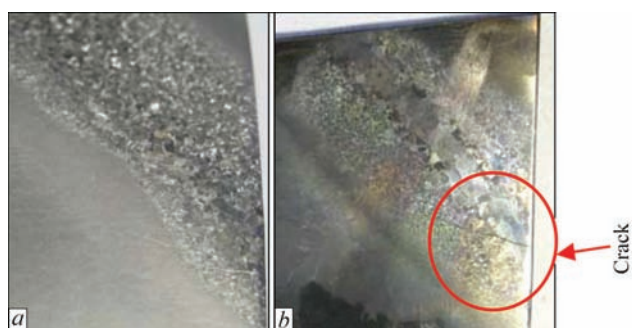
Results of metallographic examination of blades with welded fragment revealed that impact of the thermal cycle of welding and heat treatment lead to grain coarsening (Figure 6).

Fracture sites are located on blades at average distance of 4–5 mm from weld axis that coincides with the data obtained in the work on determination of welded sample fracture sites [8].

Figure 6. Structural changes after welding: *a* — coarse-grain section; *b* — welded joint fracture

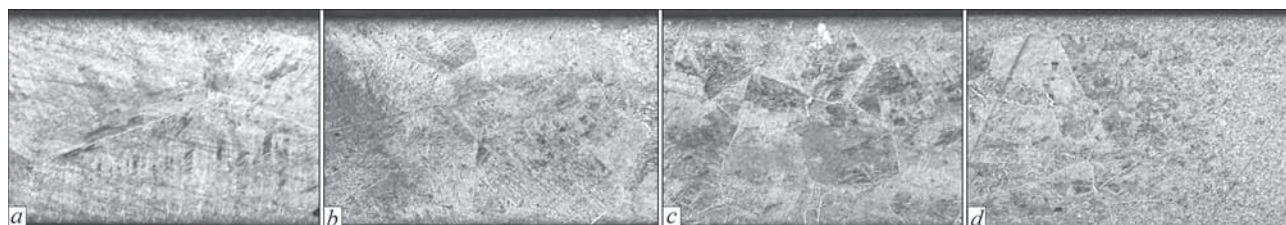
Weld material has an acicular structure with coarse grains of primary β -phase (Figures 7, *a*; 8, *a*). In HAZ metal the microstructure is also represented by coarse grains of β -phase, with intragranular lamellar structure with their transition to globular-lamellar form ($\alpha + \beta$)-phase of base material (Figures 7, *b-d*; 8, *b-d*). Base metal microstructure corresponds to the second type of microstructure scale No.1 OST 1 90002–86.

Figure 7. Macrostructure ($\times 50$) of blade weld zone: *a* — weld; *b* — weld + HAZ; *c* — HAZ; *d* — HAZ + base metal

the distance of about 70–72 mm from the blade upper end face in the zone of EBW weld with subsequent frontal development from the back to the trough of the blade (Figure 7). Having analyzed the fracture structure, we can see that crack propagation in blades with ind. Nos 1502F and 1439F ran through the weld to the length of 7 and 9 mm, respectively. It is indicated by coarse-grained structure, with subsequent propagation through the base metal with fine-grained structure. In blade No.815Ya crack propagation occurred on the length of 20 mm through the welding zone without reaching the base material, which is indicated by coarse-grained structure of the fracture. It should be added that presence of welding defects of the type of inner cavities and micropores was revealed in the fracture of blades (ind. No.815Ya, ind. No.1502F) on leading edge face, the size of which is admissible for standard welded joints (Figure 9).

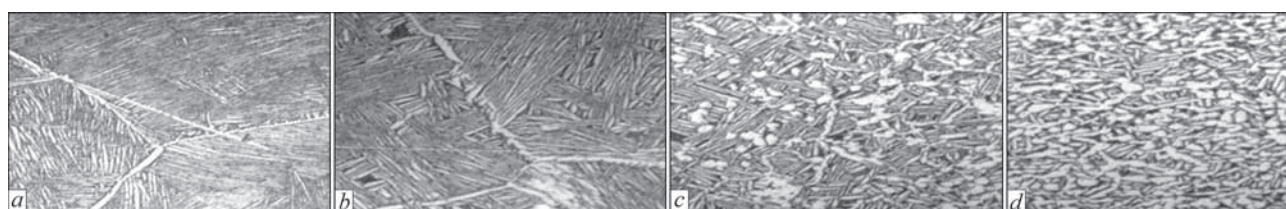
Figure 8. Microstructure ($\times 500$) of blade weld zone: *a* — weld; *b* — weld + HAZ; *c* — HAZ; *d* — base metal

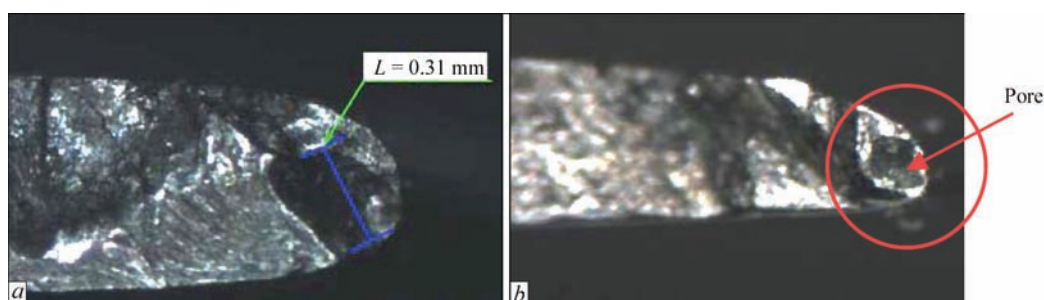
Metallographic examination of the sites of blade fracture after testing was performed. Fracture is of fatigue nature with sites located on the leading edge in the area of the welded joint. Cracks propagated through the weld with transition into the blade base material. Welding defects of the type of inner cavities and micropores were revealed in blade fracture on the face of the leading edge, the size of which does not exceed the admissible requirements for standard welded joints.

Figure 9. Welding defects of the type of inner cavities and micropores: *a* — ind. No.815Ya ($\times 50$); *b* — ind. No.1502F ($\times 32$)

- elimination of weld microdefects, revealed at metallographic examination;
- testing a selective method of hardening with metallic spheres in a magnetic field.
