DEVELOPMENT OF THE TECHNOLOGY OF RECONDITIONING THE SEALING ELEMENT OF NOZZLE BLADE SECTOR FROM DIFFICULT-TO-WELD HIGH-TEMPERATURE NICKEL ALLOY OF ZhS6 TYPE BY MICROPLASMA POWDER SURFACING

E.O. Paton Electric Welding Institute of the NAS of Ukraine

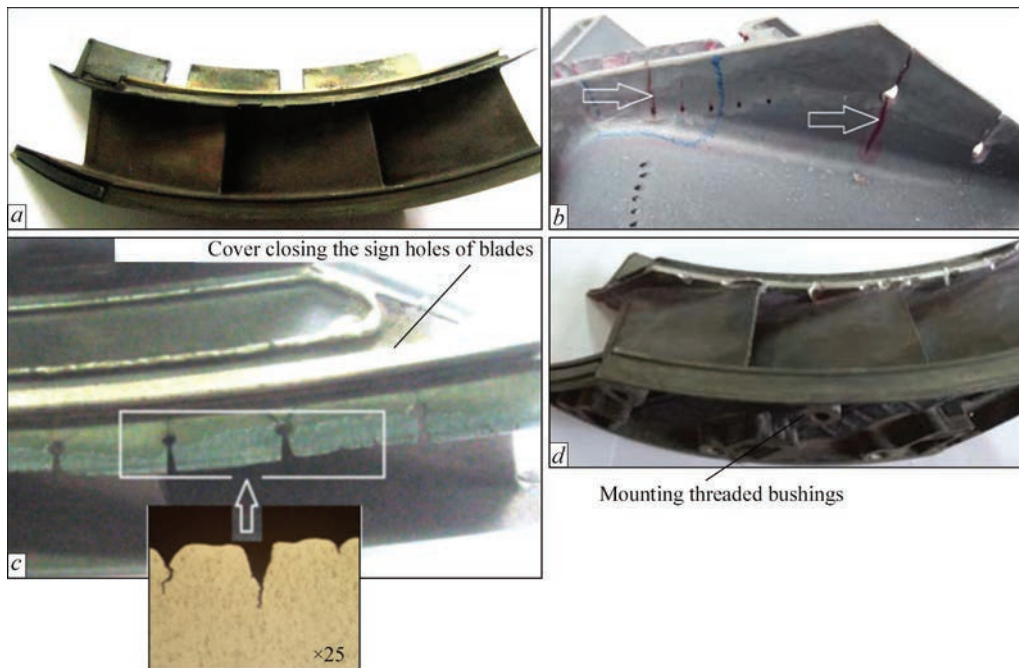
It is known [1] that after operation for more than 700 h the relative quantity of damaged parts rises significantly in one of the modern bypass gas turbine engines with an afterburner. A typical representative of such parts is the sector of nozzle blades (SNB) of a high-pressure turbine (HPT) from high-temperature nickel alloy (HTNA) ZhS6K (Figure 1, *a* and Table 1), which belongs to the group of stator parts. One of the main types of operational damage of this SNB are thermal fatigue cracks, making it impossible to apply the currently available reconditioning technologies using methods based on fusion welding and brazing, (Figure 1, *b*) and loss or damage of the design shape of a large number of sections of the side sealing element, as a result of corrosion-erosion damage at high temperatures (Figure 1, *c*). Cutting out such defects requires practically complete removal of the material of HPT SNB side sealing element (Figure 1, *d*).

Figure 1. Appearance of HPT SNB from ZhS6K alloy (a), its operating damage (b, c) and cutting out of defects on the side sealing element (d)

Design-technological analysis of a typical repair cutting out of HPT SNB side sealing element (Figure 2, *a, b*) showed the need for deposition of large volumes of HTNA — $v_d = 7\text{--}13\text{ cm}^3$, depending on the number of its damaged sections. Use of IN625 type alloys without dispersion strengthening by γ' -phase as the deposited metal for the side sealing element (see Table 1) for this SNB was considered unpractical, because of the risk of losing the spatial stability of the reconditioned structural element as a result of a reduced high-temperature strength and increased ductility of such a material in operation at $T \geq 1000\text{ °C}$. It should be noted that the authors of this work are unaware of any previous examples of application of repair technologies of aviation GTE parts with such an increase of the volume of deposition of HTNA with a high content of strengthening γ' -phase. Analysis of publications in the post-Soviet space showed

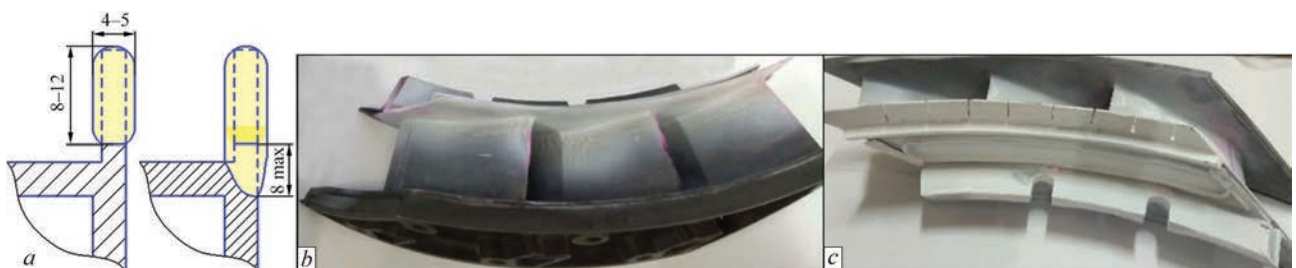
Figure 2. Characteristics of the required cross-section of the deposited bead at restoration of HPT SNB side sealing element from ZhS6K alloy (a) and appearance of its surface restored by multilayer MPPS after liquid-penetrant testing (b, c)

A priority task at development of the technology for restoration of the side sealing element of the above HPT SNB was evaluation of cracking susceptibility for a typical structure of ZhS6K alloy deposited by MPPS method (Figure 3) at successive increase of its volume in the direction of the respective increase of height H and length L of the deposited bead, in order to ensure the technological strength of such a welded joint (see Figure 2, b) in as-deposited condition.

Proceeding from the materials of the conducted investigations, repair of a test batch of the above HPT SNB from ZhS6K alloy was conducted for Lutsk Repair Plant «Motor» by the technology developed at PWI (see Figure 2, c) and respective technological instructions were developed.

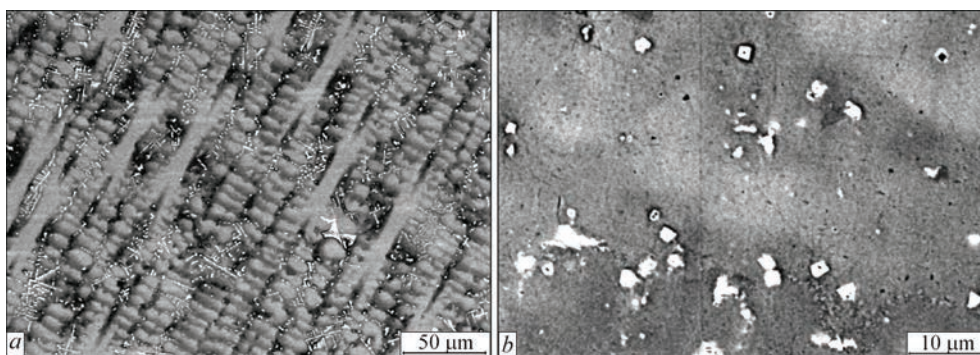
Figure 3. Microstructural features of ZhS6K deposited metal in as-deposited condition, scanning electron microscopy

element by multilayer MPPS, because of low deformability of the alloy during surfacing.

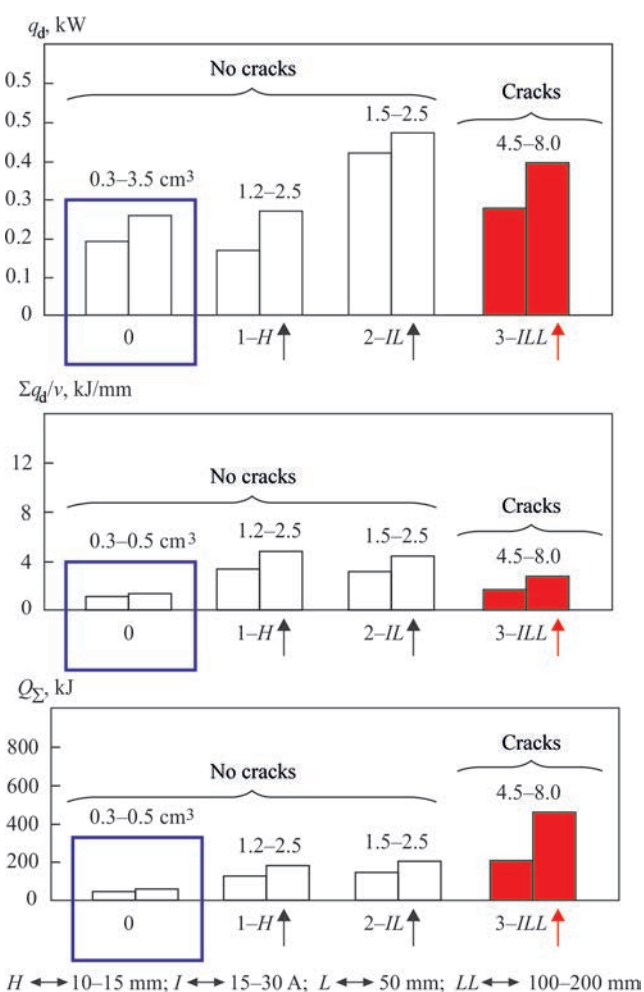
Similar to previous work [6], devoted to assessment of cracking susceptibility of ZhS32 alloy at MPPS, respective evaluations in terms of determination of the main indices of total heat input into the product were conducted also for the deposited ZhS6K metal (Figure 4). It was established that no cracks form in the «base metal–deposited metal» welded joint of ZhS6 type alloy under the conditions of typical MPPS applications for restoration of blade shroud platforms ($L \approx 35\text{--}40$ mm; $H \leq 5$ mm; $v_d \leq 2.0$ cm³). However, already at increase of bead length above $L = 100$ mm during multilayer deposition of more than 5–7 mm height ($v_d > 4\text{--}6$ cm³), the susceptibility to reheat cracking begins to be manifested in the deposited metal of ZhS6K alloy in most cases. Their appearance is due to the cumulative action of two factors: formation of residual longitudinal stresses [7] and established low deformability of the formed deposited ZhS6K metal (Table 2). Thus, the impossibility of ensuring the technological strength at application of ZhS6K alloy as deposited metal is established for the conditions of restoration of HPT SNB side sealing

Figure 4. Analysis of the regularities of ensuring the technological strength in ZhS6K deposited metal, depending on a number of indices of the amount of heat input into the product (q_d — efficiency of microplasma arc; $\Sigma q_d/v$ — sum of heat inputs of all the deposition layers; Q_Σ — total heat input into the product) and its volume. Technological variant «0» corresponds to the conditions of MPPS of shroud platforms of HPT blades, described in the text: H — 10–15 mm; I — 15–30 A; L — 50 mm; LL — 100–200 mm

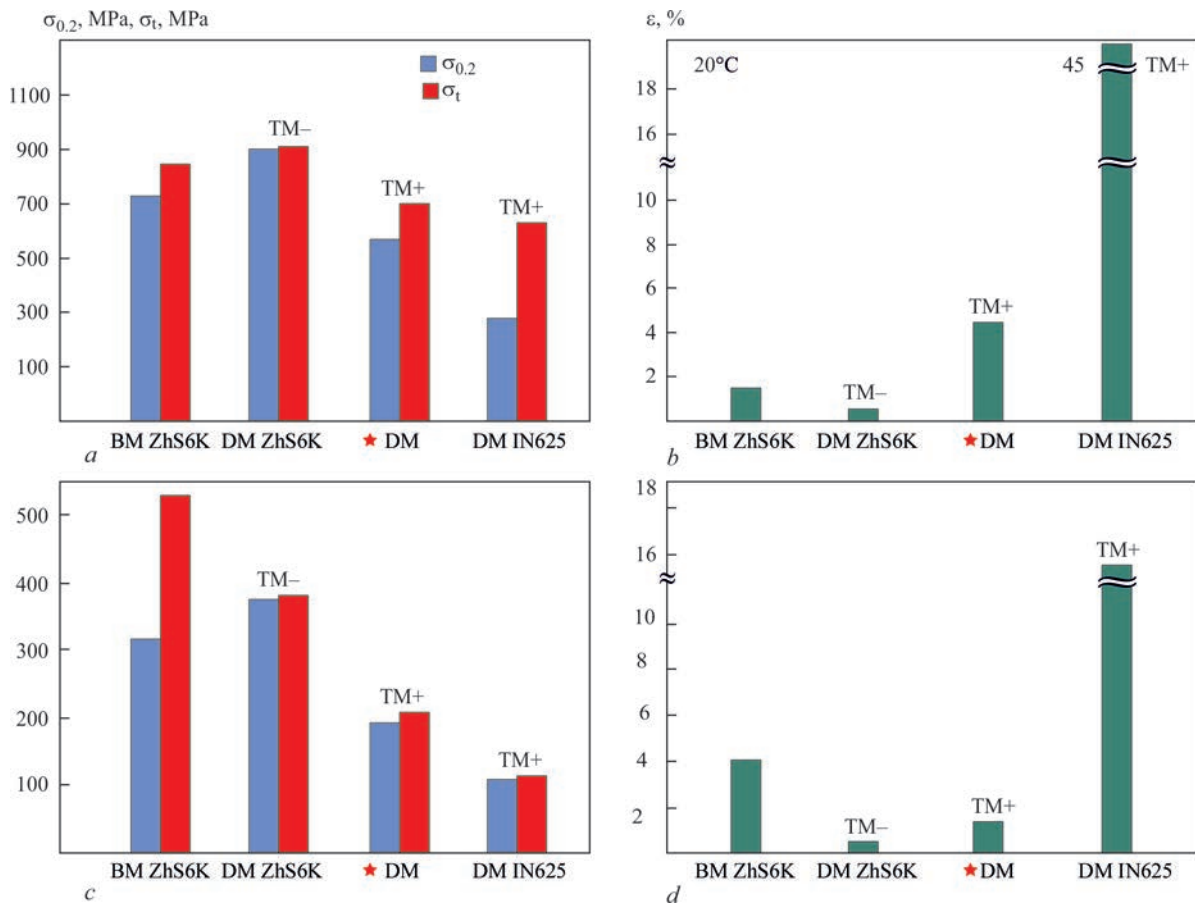
In view of impossibility of ensuring the technological strength at restoration of the side sealing element of HPT SNB at application of deposited metal of ZhS6K alloy, a decision was taken to apply deposited metal of reduced high-temperature strength. Static tensile testing of witness-samples of such deposited metal (Figure 5), conducted in servohydraulic machine MTS-810 by the procedure of [9], showed that the following level of short-term strength values is achieved compared to ZhS6K deposited metal: 0.7–0.8 at 20 °C and 0.5–0.55 at 1000 °C.

Figure 5. Analysis of short-time mechanical properties of different variants of deposited metal and regularities of ensuring its technological strength at restoration of HPT SNB side sealing element (BM — base metal; DM — deposited metal; \star DM — selected system of deposited metal; TS+ and TM- — technological strength is or is not achieved, respectively). Short-time mechanical properties of ZhS6K base metal are given by the data of [10]: a, b — 20; c, d — 1000 °C; (d — $\times 25$)
