PECULIARITIES OF EMERGENCY FAILURE OF A PROCESS PIPELINE

M.D. Rabkina, V.A. Kostin and T.G. Solomiichuk

E.O. Paton Electric Welding Institute of the NAS of Ukraine

Analysis of failure of process pipeline, including a study of the properties, chemical composition and structure of the metal of welded joints, as well as the center of fracture and nature of crack propagation, made it possible to establish the most probable causes that led to its premature failure. It is assumed that such reasons are: a defect in a longitudinal weld; residual stresses in the pipe resulting from local heat treatment of the assembly circular weld; and probable longitudinal stresses arising from pipeline sagging between the supports. Ref. 9, 4 Tables, 7 Figures.

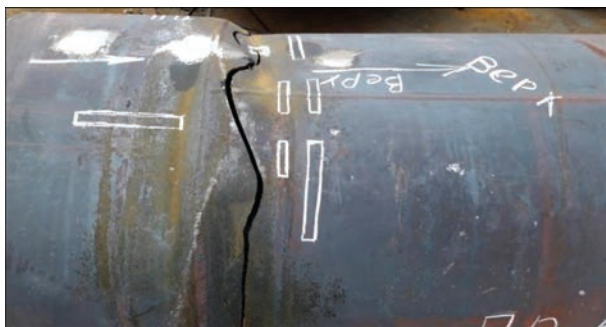
Previous visual analysis of the destruction mode showed that fracture propagated both in base metal and in the HAZ, as well as in the circumferential site weld (Figure 1). Here, the failure center was not determined. Pipes were supplied for mounting in the form of sections from several shells after welding in the manufacturing plant. Then these sections were welded by site circumferential welds.

Figure 1. Fragment of the dismantled pipe with fracture region and marks for cutting out templates for investigations and mechanical testing

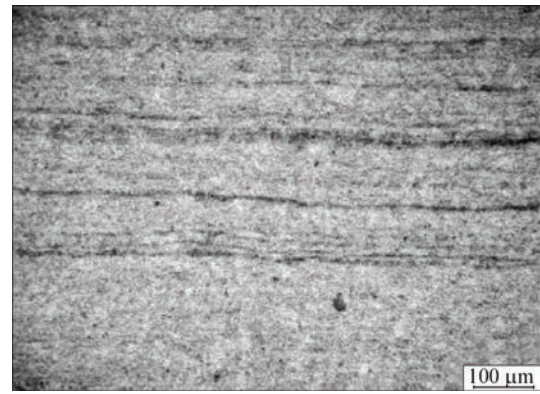
Metallographic analysis of the pipe base metal showed that its structure consists of ferrite matrix, alloyed by chromium and molybdenum, and dispersed carbides. Traces of general corrosion in the form of rust islands are observed both from the side of the pipe outer and inner surface. At intensive etching the carbide phase becomes more noticeable. In addition, in the middle sections along the sheet thickness, particularly in the longitudinal direction, the structural inhomogeneity of metal is clearly revealed in the form of alternating narrow dark and wider light bands, which is probably related to different content of carbon (Figure 2).

Figure 2. Base metal microstructure

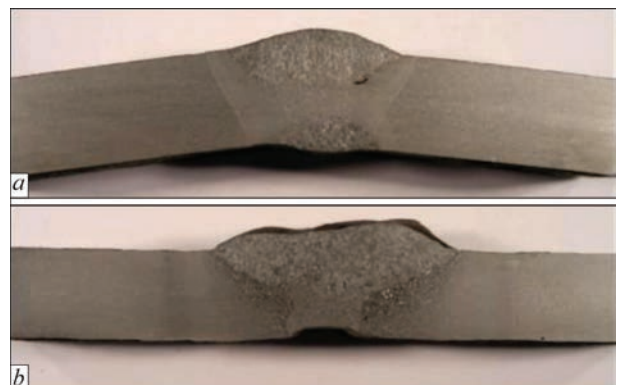
Macrostructure of welded joints is shown in Figure 3. The shape of the longitudinal weld looks like a cone. It is quite probable that prebending of the edges was not performed during pipe forming from a sheet. Considering that the longitudinal welds, having such a shape, are spaced around the ring at sequential joining

of the shells by a site weld, additional welding stresses are known to develop because of violation of conjugation of the surfaces being welded. Circumferential site welds (Figure 3, *b*) also have certain defects. First, the height of the reinforcement bead, which should not be more than 2.5–4.0 mm, exceeds these values in a number of cases, similar to the longitudinal welded joint. Moreover, a lot of lacks-of-penetration and considerable contraction of the root layer are found.

Figure 3. Macrostructure of welded joints: longitudinal (*a*) and circumferential (site) (*b*)

similar defects are absent in the site welded joint in the part of the pipe, preserved after failure (Figure 3, *b*).

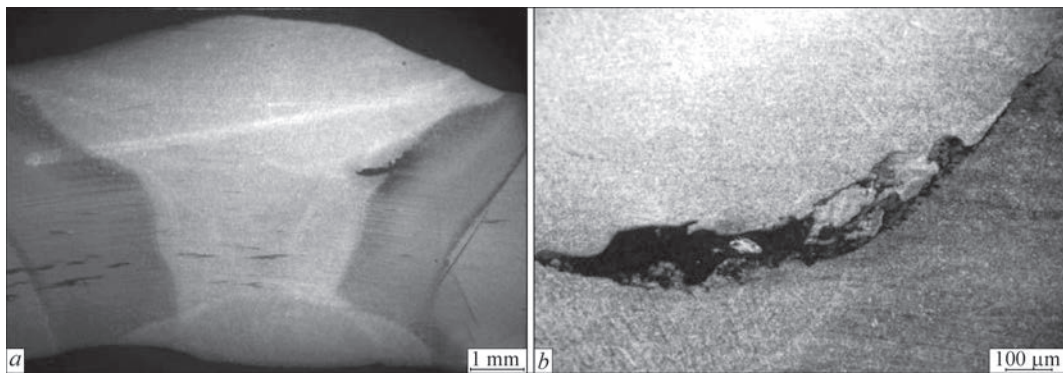
It should be noted that at comparison of longitudinal welded joints made at the manufacturing plant and circumferential welded joints, made in site, rather high-quality performance of plant joints, compared with site butt joints, is found. However, analysis of welded joint microstructure allowed revealing the zones of lack-of-fusion also in the longitudinal weld. So, a defect was detected in the transverse microsection of the longitudinal welded joint, which is located on the boundary of the filling layer and by its shape repeats the contour of the bead in the weld pool (Figure 4). The defect area (in the plane, shown in the photo) reaches the size of 0.3×2 mm.

Despite the fact that the main problems in welding of high-strength steels are related to the fact that the welded joints are susceptible to cold cracking [4], this defect of the welded joint belongs to the category of defects of interbead lack-of-fusion. At the same time,

Figure 4. General view of the cross-section of the longitudinal welded joint (*a*) and interbead lack-of-fusion (*b*)

Thus, considering the possibility of appearance of underbead defects in the longitudinal welded joint (Figure 3, *a*; Figure 4), it is possible that such lacks-of-fusion or solidification microcracks could provoke initiation of brittle cracks at the initial stage of destruction. Their further propagation was, probably, promoted by a number of other reasons, for instance, presence of residual welding stresses due to violation of postweld heat treatment; failure to follow the pressing mode; poor design of pipeline fitting, etc. Here, the macrocrack propagated from the destruction center to both sides around the pipe ring which indicates that the axial stresses in the pipe under the impact of internal pressure are much higher than the hoop stresses. This assumption requires further study.

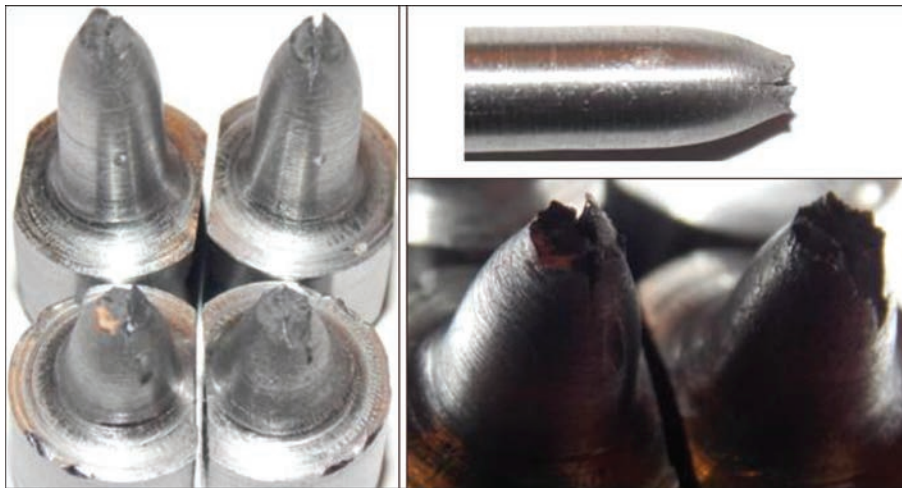
Figure 5. Delamination in the fracture of samples at tensile testing of longitudinal welded joints

Analysis of the results of mechanical testing showed that the metal of the studied pipe fragments has high strength characteristics at a sufficient level of ductility (Table 2). Here, the metal is practically isotropic in the sheet plane. However, as will be shown below, at tensile testing of welded joints no delamination was found in the sample neck (Figure 5) that is, most probably, due to anisotropy in Z-direction [5–7].

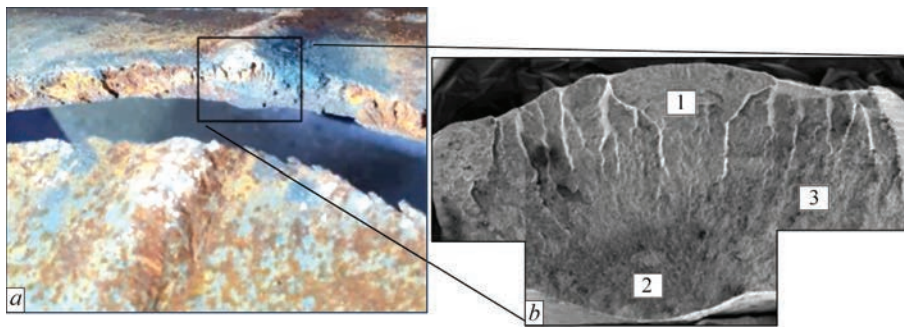
Figure 6. Appearance of a sample with the area of the start of pipe fracture in the longitudinal weld (*a*) and of the crack initiation region (*b*); *b* — $\times 10$

Investigations of fracture surface. Visual-optical analysis of a fragment of broken pipe showed that the area of maximum opening of the crack is located in the region of the longitudinal weld crossing the HAZ of the circumferential weld (Figure 6). Here, it was found that the macroscopic features of the crack passing, namely the chevron pattern, change from one direction to the opposite one exactly in this region that was classified as the point of the start of pipe destruction.

Comparison of macro- and microstructure of the longitudinal welded joint (Figure 3, *a*; Figure 4) and morphology of fracture surface (Figure 6, *b*) allowed distinguishing three main areas in the destruction center: 1 — facing layer with filling layers; 2 — root layer; 3 — near-weed zone.

The facing layer is characterized by the dendritic structure in the fracture (Figure 6, *b*) that formed during liquid metal solidification in welding. Along-

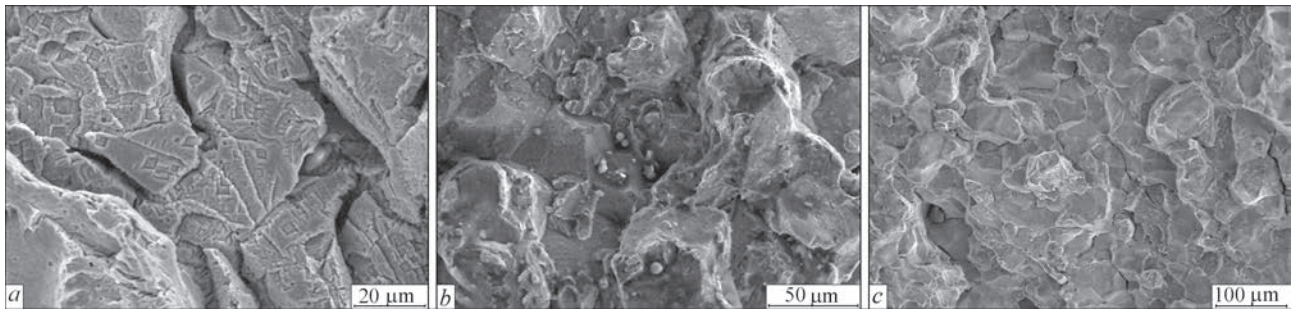
Figure 7. Fracture mode: *a* — facing weld; *b* — root weld; *c* — near-weld zone

side fracture in the primary dendritic structure, also cleavage facets and twins, characteristic of the secondary structure, are observed in the fracture [9]. In both the cases, formation of secondary cracks is in place (Figure 7, *a*, *b*), which cross the fracture surface. Presence of a viscous component in the fracture in the form of river pattern should be also noted. Appearance of secondary cracks, combined with tough regions against the background of overall brittleness is indicative of instability of crack propagation.

Analysis of fracture in the root layer showed that fracture occurred on the boundaries of secondary grains and has a stone-like nature (Figure 7, *b*). This region turned out to be strongly oxidized. Appearance of corrosion products is obviously related to the results of diffusion penetration of active elements (oxygen, hydrogen, carbon) into the root weld from the inner surface of the pipe in operation.

The fracture surface in the near-weld zone (Figure 7, *c*) is also characterized by stone-like fracture with enrichment by sulphur and phosphorus between the grains.
