INVESTIGATION OF THE CAUSES FOR APPEARANCE OF DEFECTS IN WELDED BUTT JOINTS OF TRAM RAILS MADE BY THERMIT WELDING

E. Turyk¹, I.O. Ryabtsev², M. Lomozik¹, K. Krasnovskyi¹

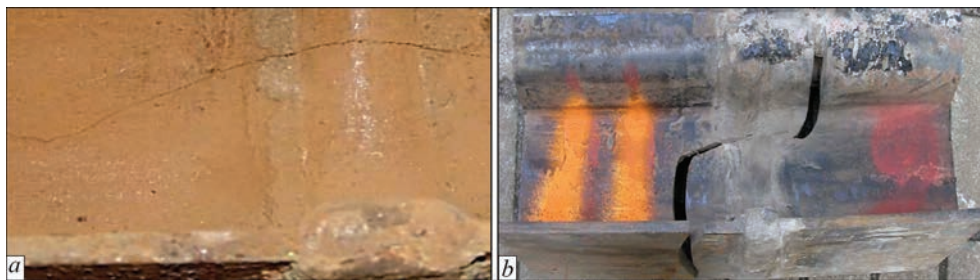
Cracks that led to fracture of the rails, initially propagated across the welded butt joint approximately at a half of the height of the rail web (Figure 1, *a*). The length of the cracks reached 20 cm. Then the cracks changed the direction by 90° towards the head and the flange of the rail and a complete fracture of the butt joint occurred (Figure 1, *b*).

Figure 1. Initial crack (*a*) and nature of fracture of tram rails in the zone of welded butt joint (*b*)

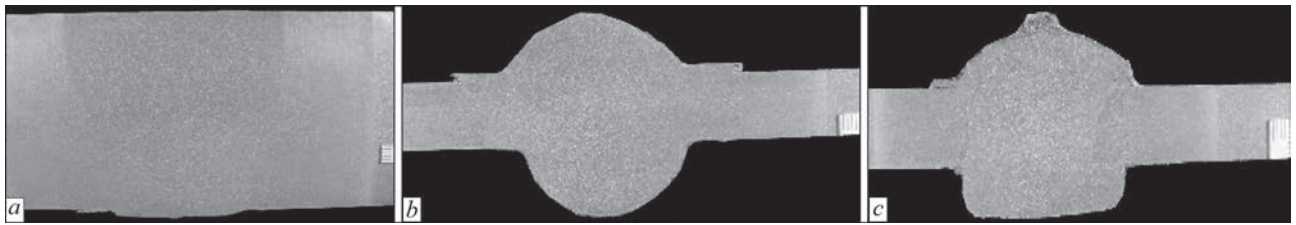
Figure 2. Macrostructure of welded butt joint in the zone of head (a), web (b) and flange (c) of rails

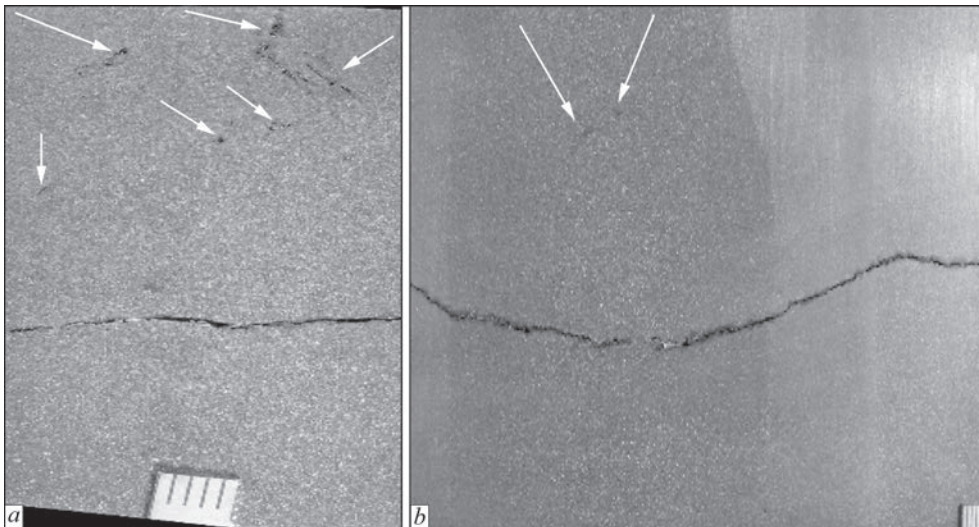
Figure 3. Macrostructure of welded butt joints C1 (a) and C2 (b) in the crack zone (arrows mark accumulation of gas pores)

However, in the welded butt joints C1 and C2 in the fracture zone, the accumulation of tiny pores were detected (Figure 3).

1. In the metal of the welded butt joints of the rails C1 and C2 of the route “A”, welding defects in the form of accumulations of gas pores were revealed, which are formed as a result of quite rapid cooling of weld metal. Porosity was also detected in the welded joints I and II of the route “B”.

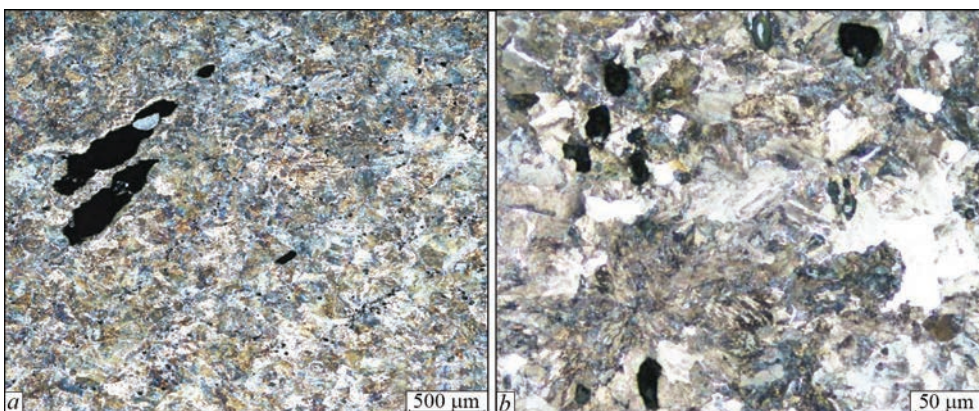
Figure 4. Microstructure of welded butt joints C1 (a) and C2 (b) in the crack zone. Pores in welds.

Porosity of the welds was confirmed by microscopic examinations (Figure 4). The cause for pore formation is reduction in the solubility of gases at a decrease in temperature. Too fast cooling of the welded butt joint increases the probability, that bubbles of gases may not have time to come to the surface and pores will be formed.

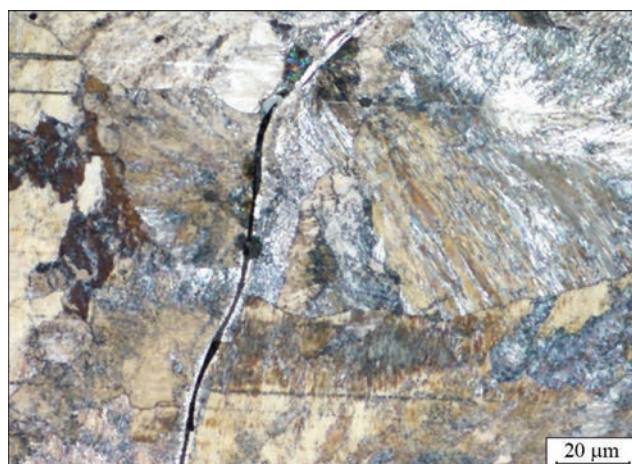
Figure 5. Microstructure of welded butt joint C1 in the crack zone 991.6 MPa and relative elongation $\delta_5 = 13.0\text{--}16.3\%$ of the material of the rails Nos 1–4 also meet the requirements of the standard for steel R260: $\sigma_t \geq 880$ MPa, $\delta_5 \geq 10\%$. Analysis of the chemical composition of welded butt joints C1 and C2, performed using thermit method, showed that the content of alloying elements in the welds also meets the requirements of the standard PN-EN 14730-1:2017-06 [2]. Examination of macrostructure of the welded butt joints in the area of the head, web and flange of the rails did not reveal defects of welding in the form of lacks of fusion, lacks of penetration and slag inclusions (Figure 2, *a–c*).

In the weld of the butt joint C1 in the area of the rail web, single microcracks were detected throughout the grain boundaries, that occur at a considerable distance from the main crack (Figure 5).

Microcracks, apparently, are the result of the exposure to tensile stresses that cause plastic deformation of the weld metal. Microcracking is caused by the appearance of liquid films of easy-melting eutectic on grain boundaries, which have a solidification temperature much lower than the solidification temperature of iron.

2. In the welded butt joint C1 of the route “A” on the area of the rail web, inadmissible welding defects in the form of single microcracks throughout the grain boundaries were revealed.

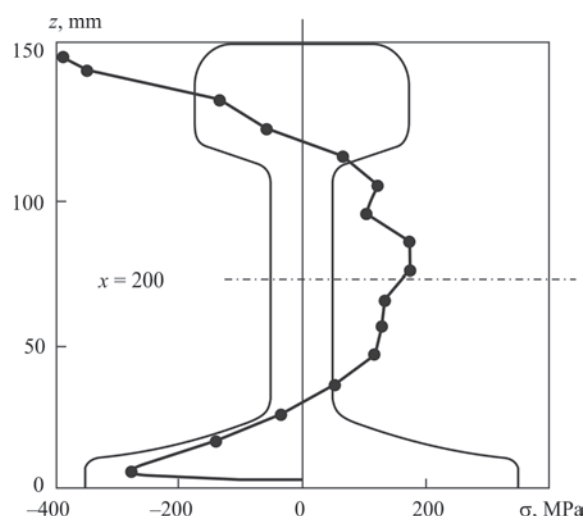
Figure 6. Distribution of residual stresses in the butt joint of rails made by thermit welding [5]

Gas pores and microcracks in the welded butt joints C1 and C2 of the tram route “A” contribute to arising of fatigue cracks that were formed in the web of the rails in the zone of the highest residual tensile stresses (Figure 6).

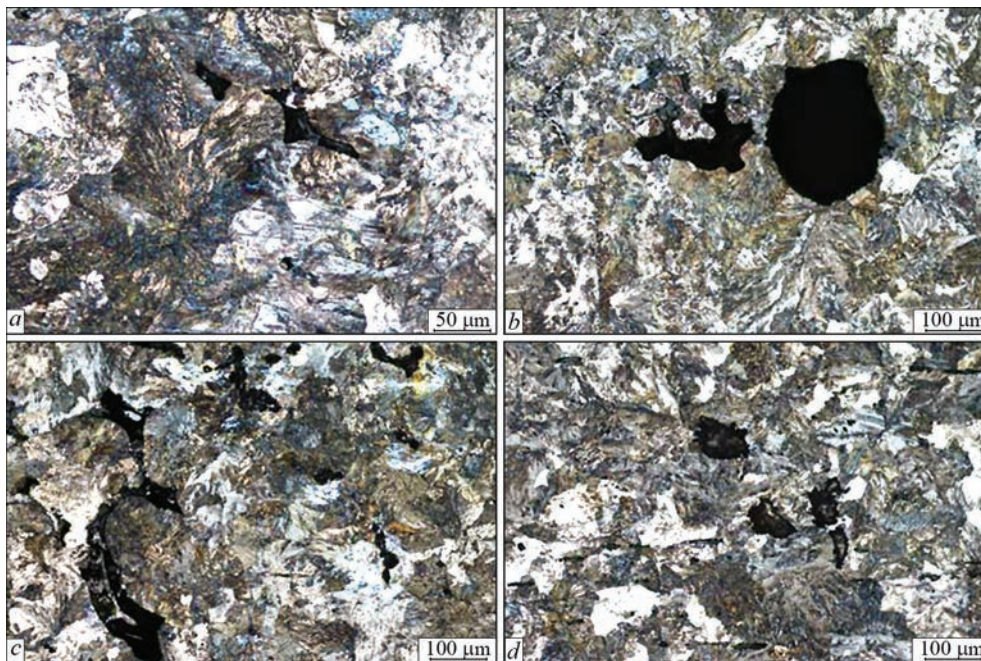
Metallographic examinations revealed accumulation of pores in the welds of the butt joints I and II in the area of head and flange of the rails (Figure 7).

Figure 7. Gas pores in the head (*a, c*) and in the flange (*b, d*) of rails of welded butt joints I and II, respectively
