PECULIARITIES OF FRACTURE OF WELDED JOINTS OF RAILWAY RAILS OF OXYGEN-CONVERTER K76F STEEL

V.I. Shvets, I.V. Ziakhor, L.M. Kapitanchuk, O.V. Didkovskiy, E.V. Antipin

E.O. Paton Electric Welding Institute of the NASU

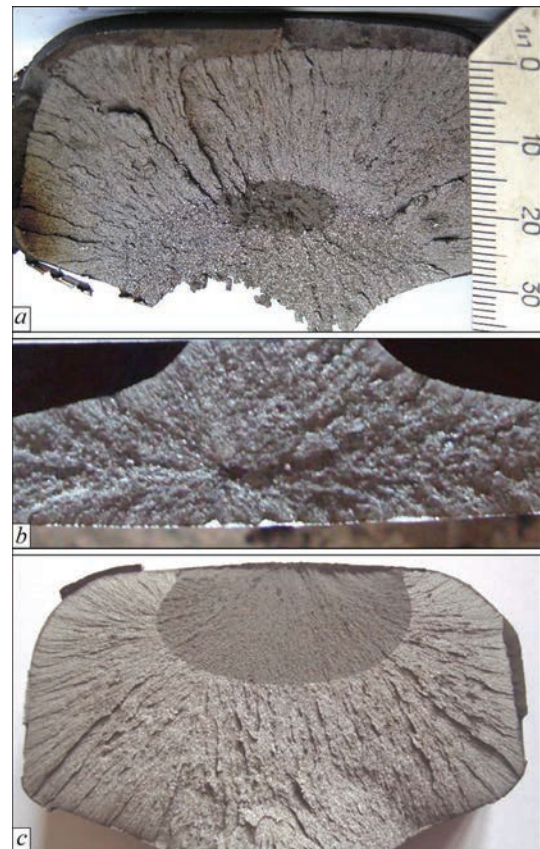
During mechanical static bending tests, fracturing of rail joints usually occurs on the butt joint. The rail joints of individual batches were fractured on the base metal or HAZ. During visual inspection, regions of the oval shape were detected on the fracture surface, which were of dark colour due to peculiar features of the relief. In the work, these regions are defined as “oval spots” (OS) (Figure 1). OS, which were nuclei of butt joint fracture, were located mainly in the rail head (Figure 1, *a*), rarely — in the foot (Figure 1, *b*).

Figure 1. Oval spots on the fracture surface of rails: *a* — in the head area; *b* — in the foot area; in the head area at a distance of 7 mm from the joint line

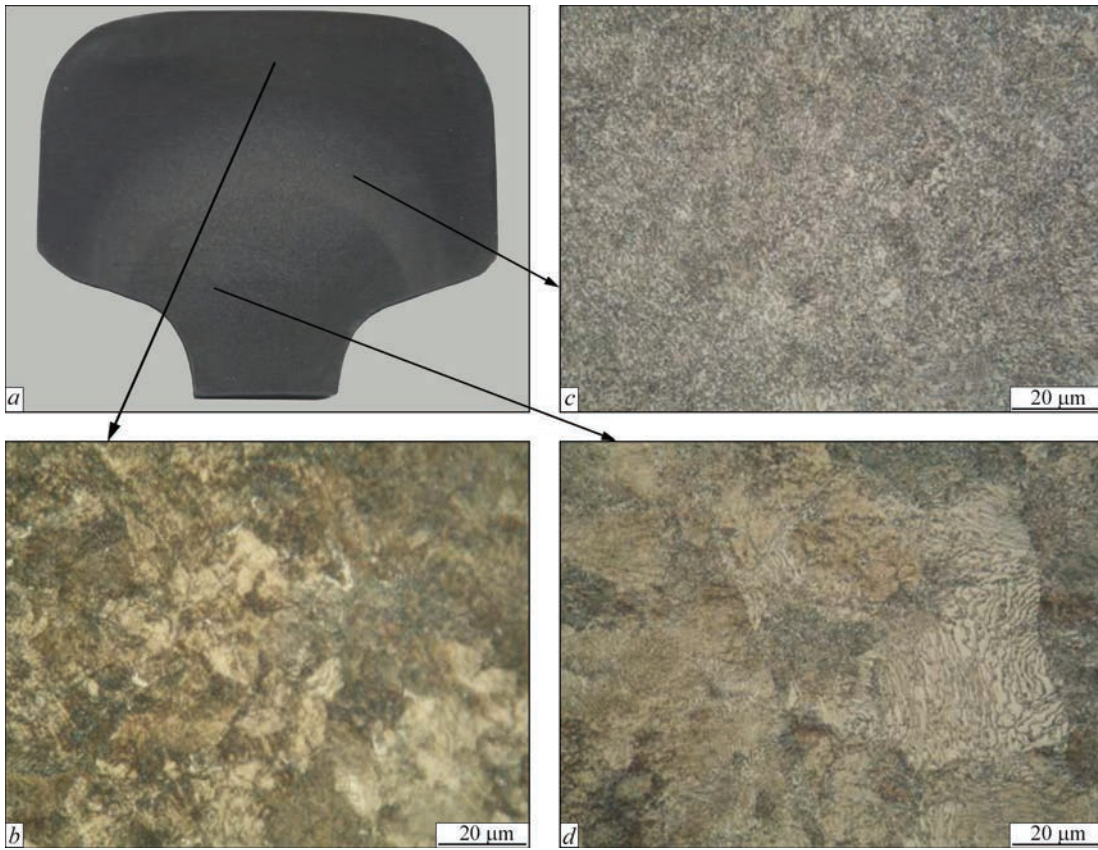
Figure 2. *a* — rail macrostructure in the head area, $\times 1000$; *b* — near-surface layer; *c* — tempering regions; *d* — base metal

According to the results of spectral analysis, the chemical composition of the metal in the investigated rails corresponds to the grade one (Table 1). The rail macrostructure does not reveal disorders of metal continuity. In the head area, the regions of HAZ are clearly revealed, typical for the rails after surface heat treatment (Figure 2, *a*). Near the rolling surface, a heat-hardened layer of dark colour of up to 15 mm width is observed. This layer is adjacent to a layer of gray colour (tempering area), which is distinguished by a reduced hardness compared to the near-surface layer and base metal: *HV* 2430–2680 MPa, *HV* 3590–3800 MPa and *HV* 2700–3040 MPa, respectively. Microstructure of the near-surface layer of a dark colour is sorbite (Figure 2, *b*), and that of a gray layer and the base metal is sorbite-pearlite (Figure 2, *c, d*).

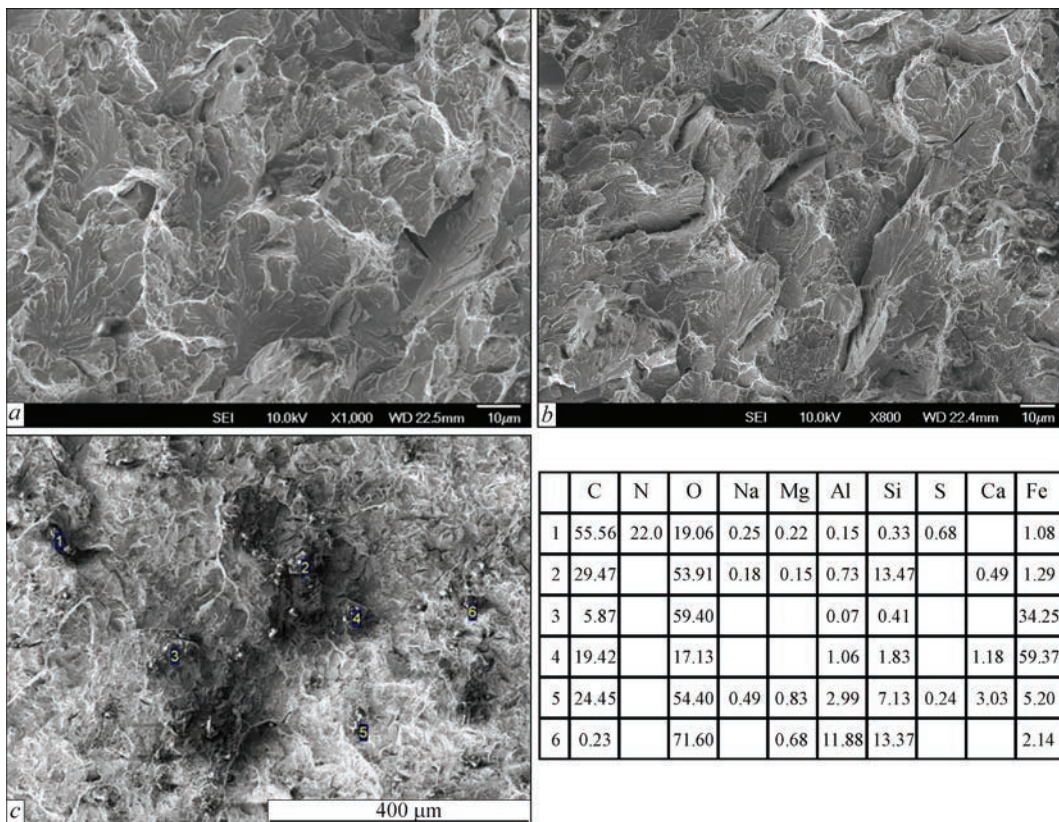
Figure 3. Fracture surface in the region of heat-hardened layer (*a*, *b*), nonmetallic inclusions (*c*) and results of X-ray microanalysis of chemical composition (at.%)

Fractographic examinations of the fracture surface during fracturing on the base metal showed that within the heat-hardened layer, the fracture is transcrystalline. The fracture surface consists of facets of intragranular spalling with elements of plastic deformation: stream-like pattern, tongues, tear crests (Figure 3, *a*). In some places, secondary cracks are encountered (Figure 3, *b*). Nonmetallic inclusions on the fracture surface are represented by complex oxides of aluminium, calcium and silicon (Figure 3, *c*; Table 1).

The formation of oxide clusters is a cause for the formation of a developed relief in this region.

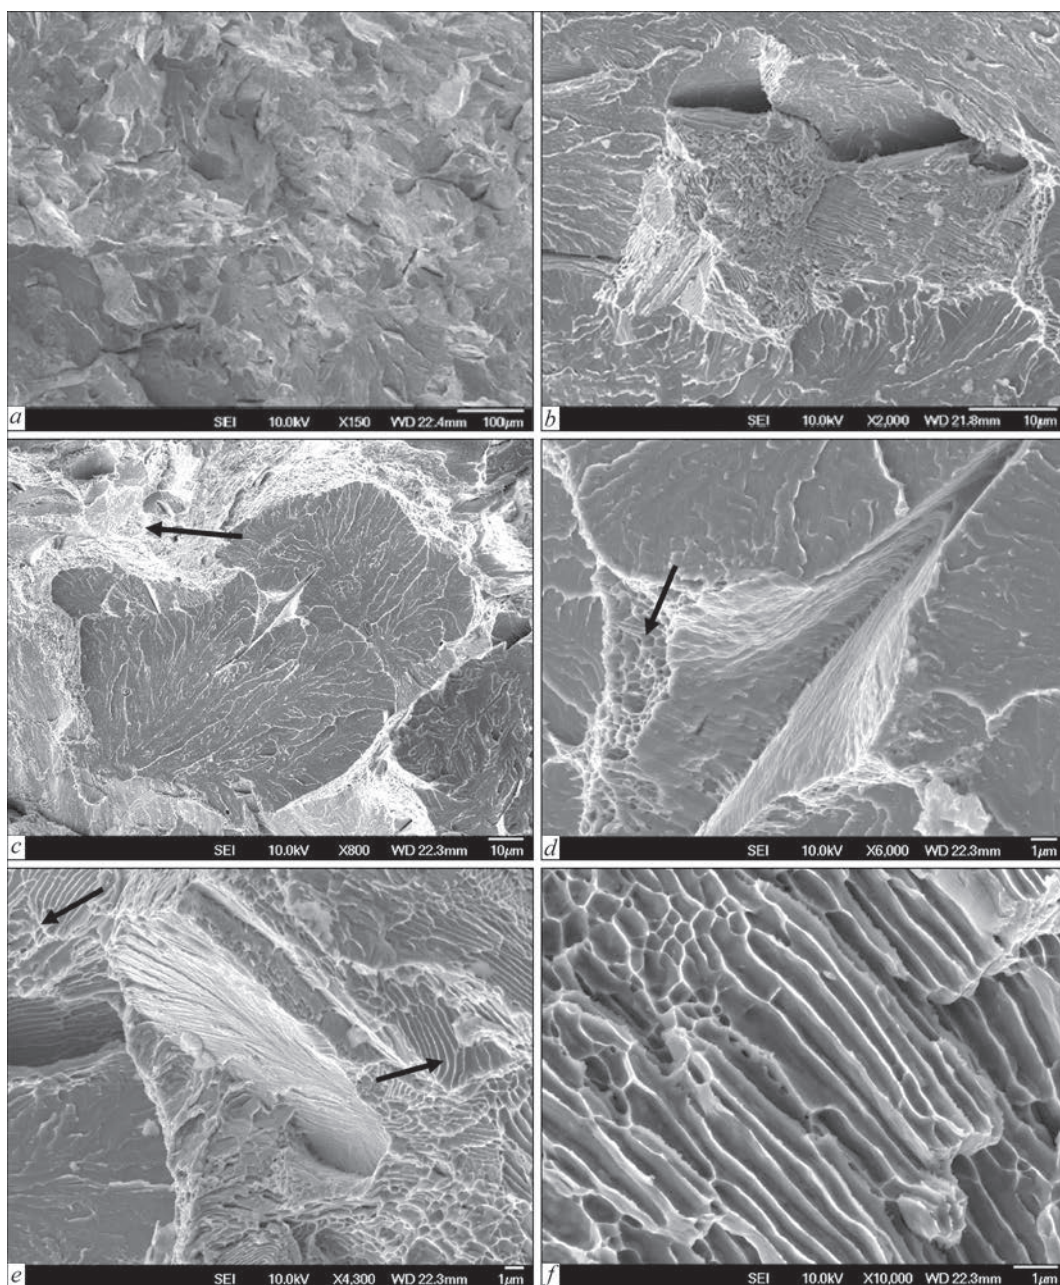
Figure 4. Fracture surface in the tempering region (*a, b*); opening of metal on the film of iron oxide (*c, d*); opening of metal on the pearlite colonies (*e, f*)

In the tempering region, the fracture is mostly transcrystalline. However, fracturing is accompanied by the formation of spalling facets (Figure 4, *a*). Numerous secondary cracks (Figure 4, *b*) are present near spalling facets in the microstructure, places of metal opening on the film structural component (Figure 4, *c, d*) and pearlite colonies (Figure 4, *d, e*) are observed.

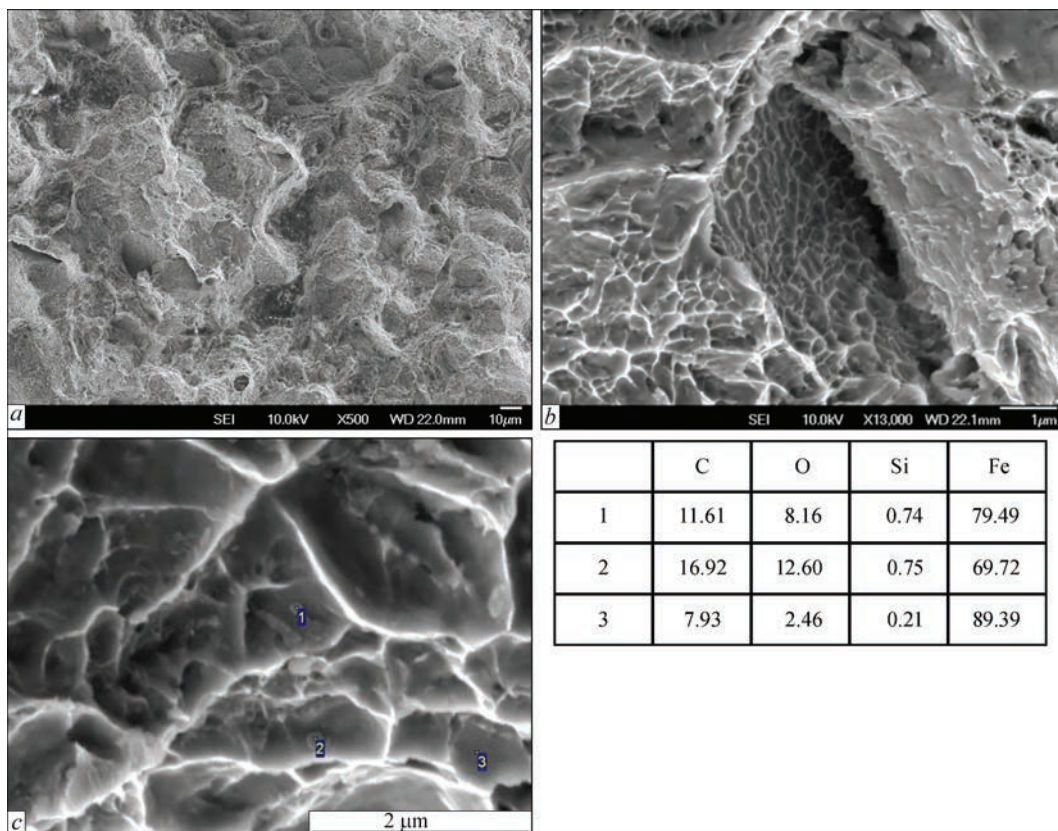
In the OS region, unlike in the tempering regions and a heat-hardened layer, the fracture is intercrystalline (Figure 5, *a*). The fracturing surface is dimple (Figure 5, *b*). According to the chemical composition, the particles, which are located in the dimples and determine the nature of fracture, are iron oxide (Figure 5, *c*, Table 1). The size of the particles is the tenth fractions of a micron.

Figure 5. Fracture surface in the OS region (*a, b*), particles on facets of intragranular fracturing (*c*) and results of X-ray microanalysis of chemical composition (at.%)

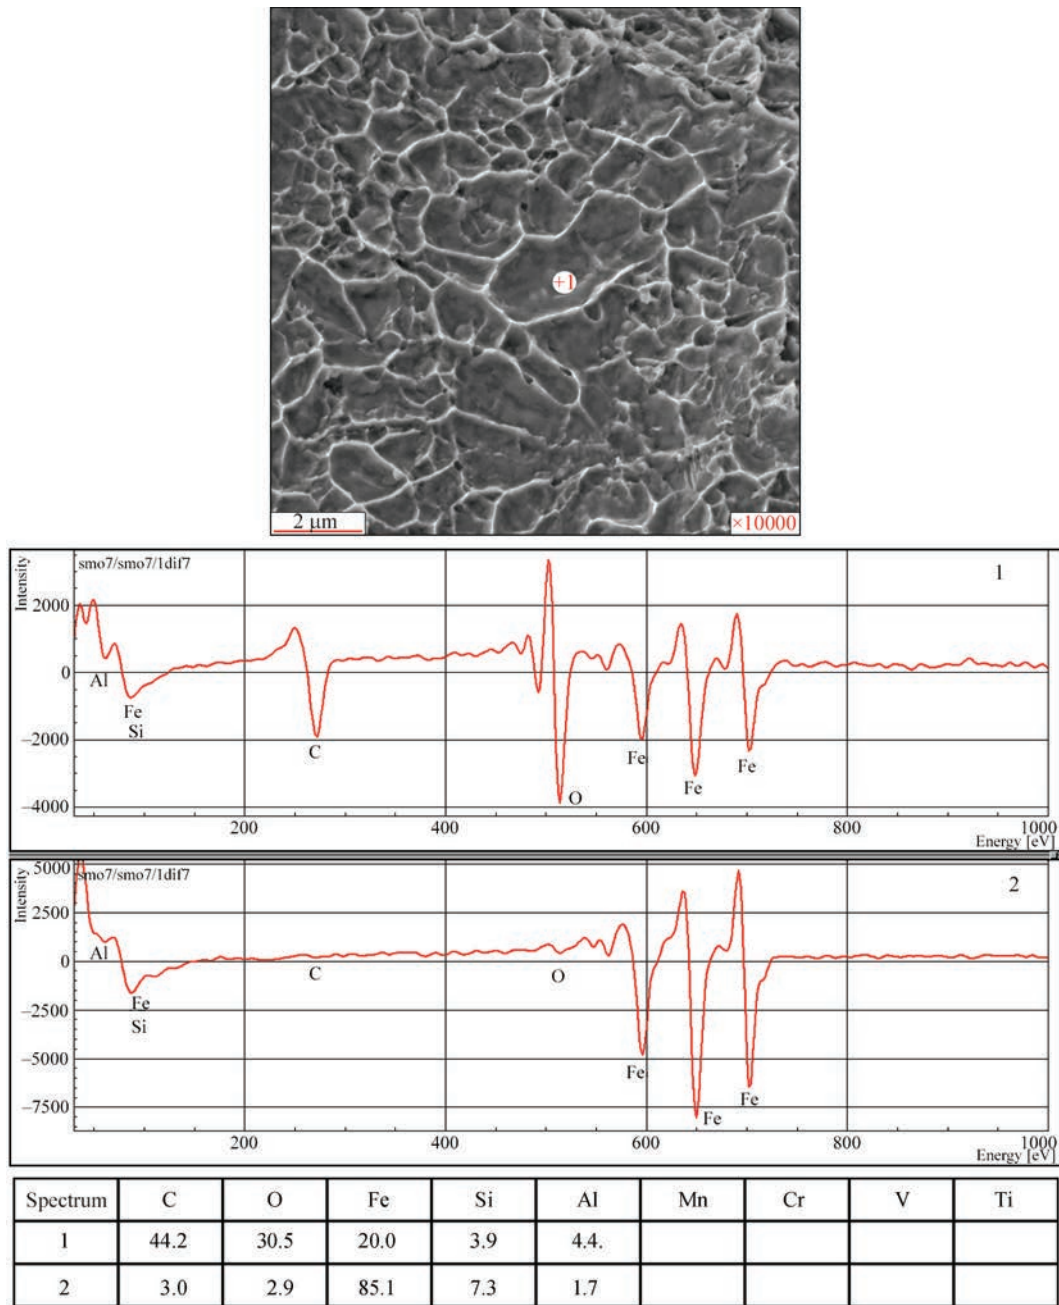
Using the method of Auger-electronic spectroscopy, the elemental composition and its changes during layer-by-layer ion etching of the dimple surface were analyzed. Figure 6 shows the place of shooting, spectra before and after ion etching, as well as a table with the content of elements calculated by spectra. As is seen, the surface layer contains iron, oxygen and a small amount of aluminium. According to the profile of the element distribution in depth, the width of the layer with the elemental composition different from the base metal was about 50 Å (Figure 7). The results

Figure 6. Results of Auger-spectral analysis of dimples surface in the OS region (at.%): 1 — before ion etching; 2 — after ion etching

of the examination suggest that opening of metal in the OS region occurs on the oxide film, which is located on the grain boundaries. Apparently, the film is a complex, mainly, iron oxide, with some amount of aluminium oxide.

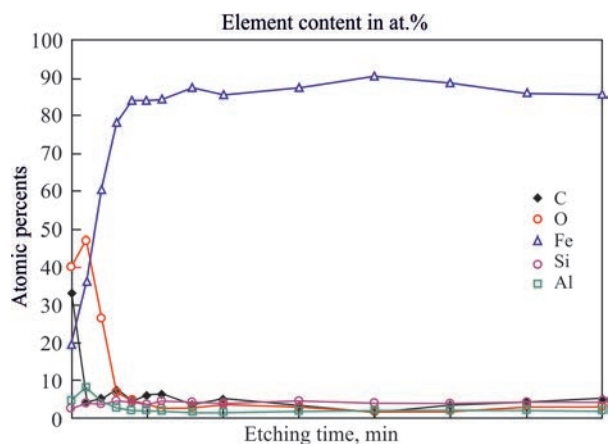
Figure 7. Distribution of elements in depth from the dimple surface in the OS region at an etching rate of 20 nm/min

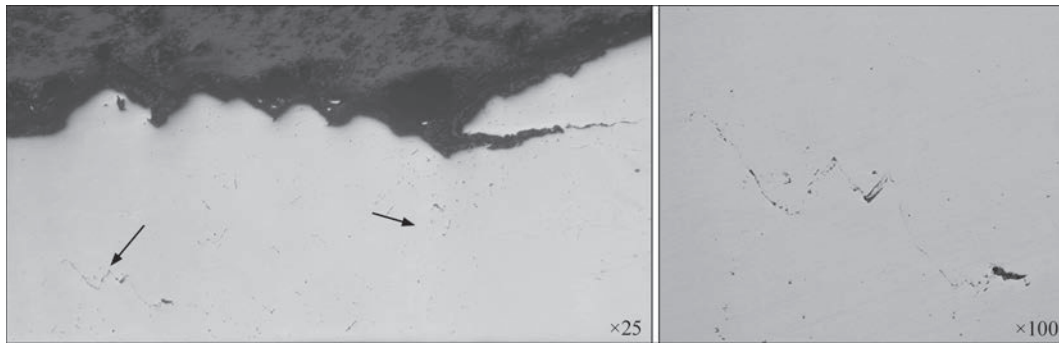
Figure 8. Nonmetallic inclusions in the rail metal adjacent to OS

In order to find the origin of oxide films, metallographic examinations of rail metal in the region adjacent to the OS were carried out. Numerous nonmetallic inclusions were found on the polished surface of the cross-section (Figure 8). According to the data of micro X-ray spectral analysis, in the metal, numerous iron oxides (Figure 9) are observed along with the inclusions of complex aluminium, silicon, calcium oxides typical to the converter rail steel. Iron oxides are located mainly on the grain boundaries. Obviously, the presence of a large number of iron oxides is associated with insufficient degree of rail steel deoxidation.

The nonuniform distribution and formation of clusters of iron oxides are caused by the features of ingot crystallization [5]. The impurities partially soluble in iron, including oxygen, are pushed into residual melt. In the places of residual melt crystallization at the structural boundaries, iron oxides are precipitated.

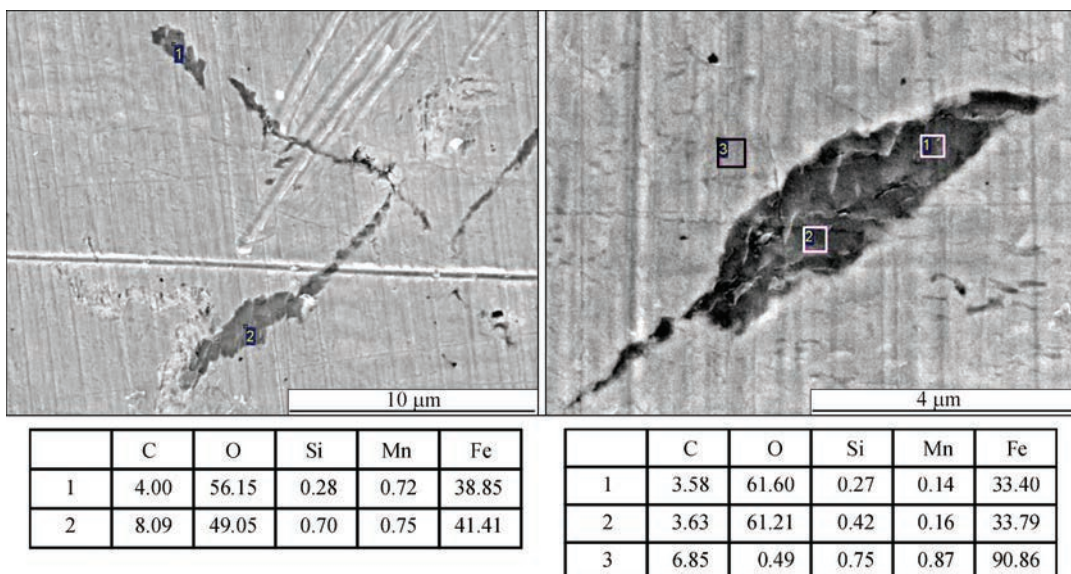
Figure 9. Results of micro X-ray spectral analysis of nonmetallic inclusions (at.%) in the rail metal adjacent to OS

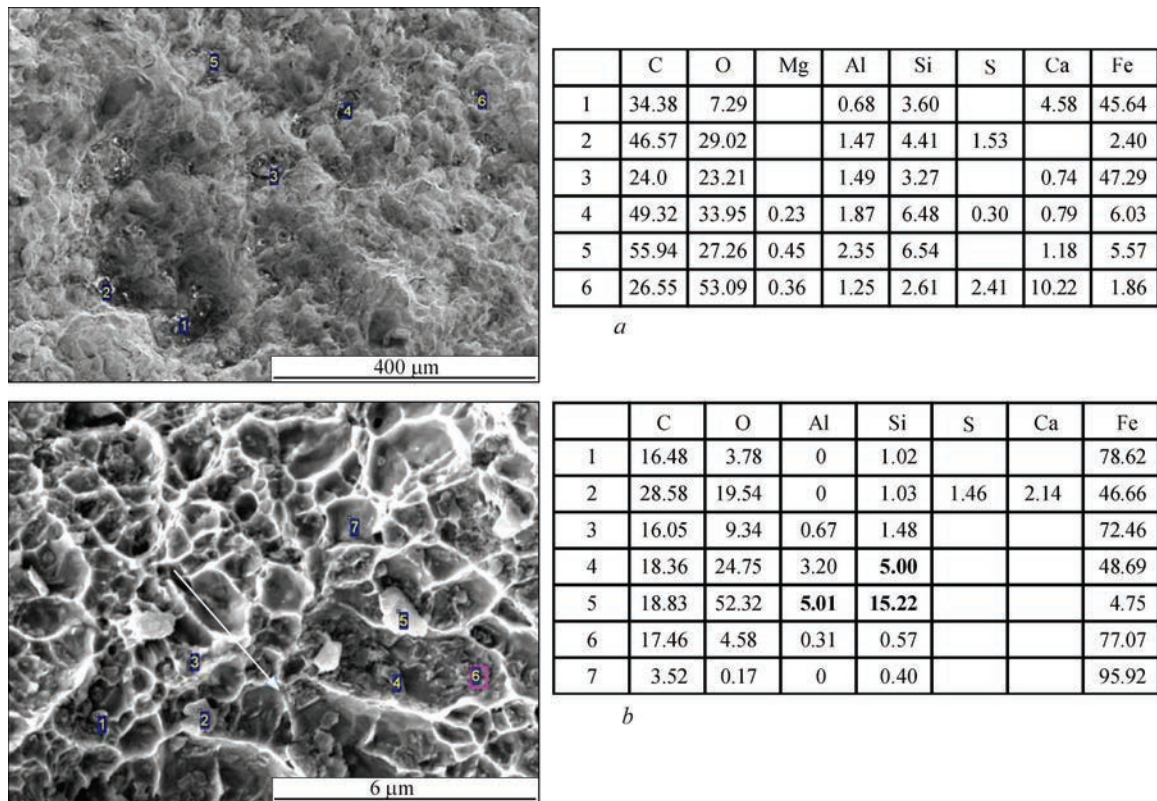
Figure 10. Fracture surface and X-ray microanalysis (at.%) of chemical heterogeneity in the OS region during fracturing of a butt joint at a distance of 7 mm from the joint line

confirms the participation of these oxides in the formation of oxide film.
