STUDY OF INTERGRANULAR CORROSION CRACKING IN WELDED JOINTS OF CHORNOBYL NPP PIPELINES. MATERIALS SCIENCE ASPECT

MATERIALS SCIENCE ASPECTS OF THE CONDITION OF Du300 PIPELINES OF ChNPP UNIT No. 3

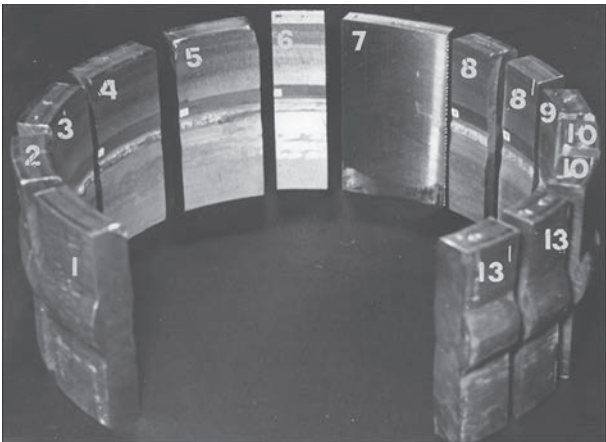
Figure 2. General appearance of a ring with a weld, cut into templates

Figure 2 shows a ring cut into templates containing a weld (in this case, weld No. 8 of the pressure pipeline). The templates are arranged in the same order as in the uncut ring, and the numbers indicated on the templates allow localizing subsequent investigations by referring to the corresponding template number.

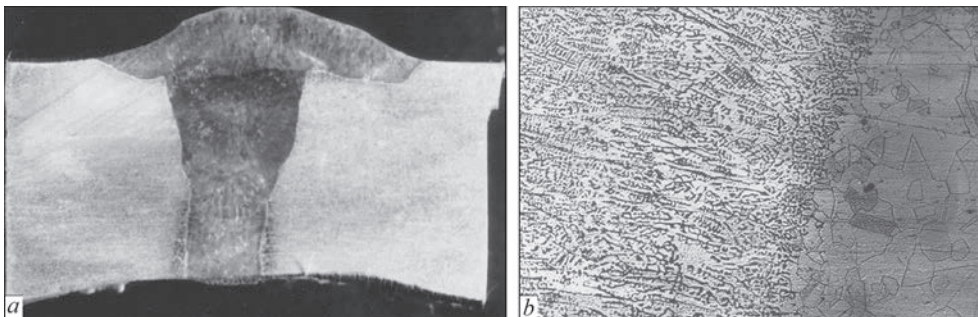
**Figure 4.** Structure of the pipeline material (325×16, 08Kh18N10T steel) at Unit 3 of the ChNPP after 100 thou h of operation: *a* — macrostructure, ×3; *b* — microstructure, ×100

Macrosections were made on the cutting surfaces (see Figure 2), followed by etching in 1 part HNO_3 + 2 parts HCl reagent, which allowed revealing the contours and structure of the weld (Figure 4), as well as cracks, if any were present (Figure 5).

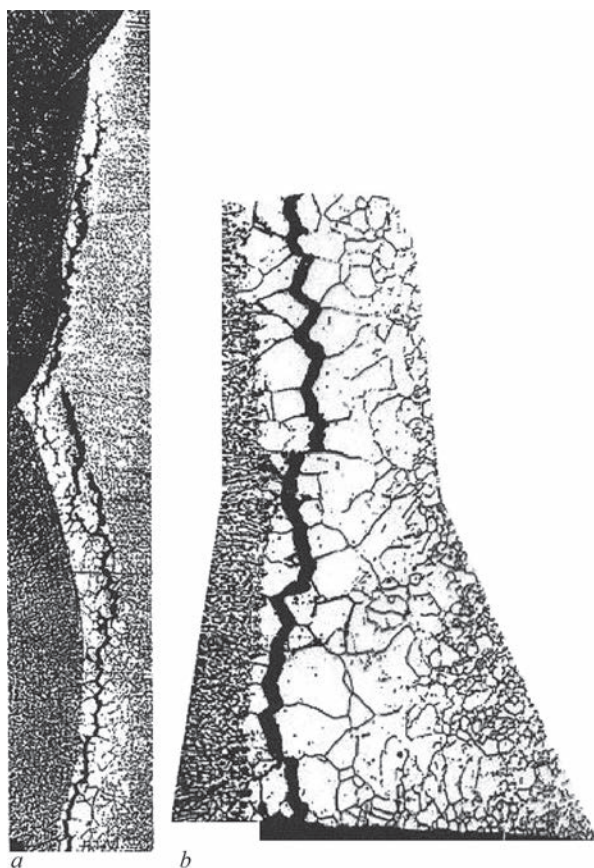
Figure 5. Appearance of a crack in the near-weld zone of welded joint: *a* — $\times 30$; *b* — $\times 80$

Metallographic examinations made it possible to reveal cracks of circumferential orientation on the inner surface of the pipe (both in the weld and in the near-weld zone). The cracks observed in the near-weld zone were in the form of cracks with branches (Figure 5).

Branching cracks usually propagate deep into the base metal of the pipe intergranularly, along a narrow zone of the fusion line of austenitic grains that had grown during welding.

Crack initiation on the inner surface of the pipe had a multi-embryonic nature, and the propagation of main circumferential cracks occurred by merging of multilevel embryonic cracks. Cases of cracks location were observed on both sides of the weld.

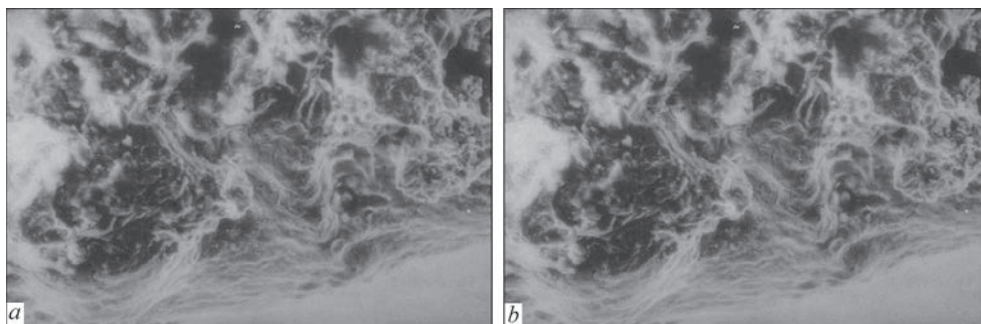
Fractographic and metallographic examinations of the crack surface cleaned of corrosion deposits showed that the main mechanism was intergranular fracture with crack branching typical of corrosion. On

Figure 6. Microfractograms of a corrosion crack surface: *a* — before cleaning; *b* — after cleaning (average fatigue groove pitch $\Delta \approx 1.0 \mu\text{m}$)

the surface of the fracture, free of corrosion products, signs of fatigue fracture in the form of grooves were found, which can be detected even directly near the source of crack initiation (Figure 6, *b*). Distinct fatigue grooves are observed, which are an imprint of the crack front on each loading cycle, with a pitch of 0.4 μm . As a crack progressed, the pitch of the grooves increased to 1.0 μm .

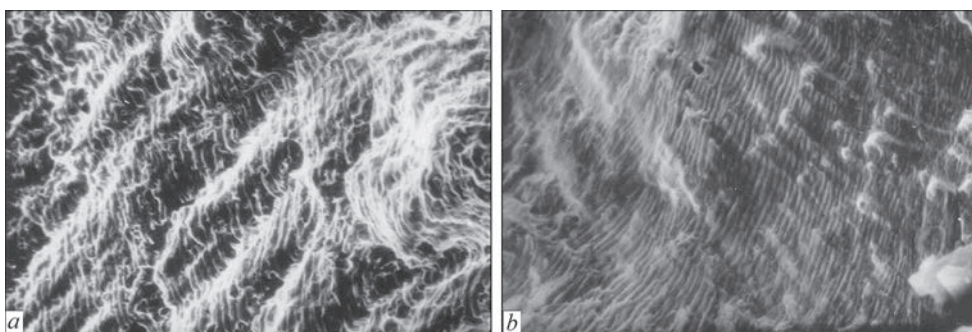
Figure 7. Fracture surface of the 08Kh18N10T steel specimen tested for cyclic crack resistance: *a* — at 20 °C, average fatigue groove pitch $\Delta \approx 1.5 \mu\text{m}$; *b* — at 50 °C, average fatigue groove pitch $\Delta \approx 2.0 \mu\text{m}$

Fractographic studies of the fracture surfaces of the cyclically loaded specimens revealed fatigue grooves that were clearly observed with a constant pitch corresponding to each degree of cyclic loading (Figure 7). This constant nature of the groove pitch was predetermined by the test conditions — the constant load amplitude at each loading stage. The measured groove pitch was related to the middle section of the fatigue fracture kinetic diagram, and in the entire load range, where fatigue grooves were observed, their pitch corresponded to the average crack rate measured directly on the specimen during the experiment.

The less regular fatigue grooves observed on the surface of the intergranular corrosion cracks in the welds of the pipes showed a measured groove pitch of 0.4 to 1.0 μm (see Figure 7, *b*), which falls within the above-mentioned groove pitch interval measured on the specimens. This correspondence can be seen as evidence that the cyclic stress component in the pipe affects the growth of a corrosion crack, i.e., the superposition of stress corrosion cracking and fatigue crack growth processes. In other words, we observe the propagation of cracks by the corrosion fatigue mechanism.

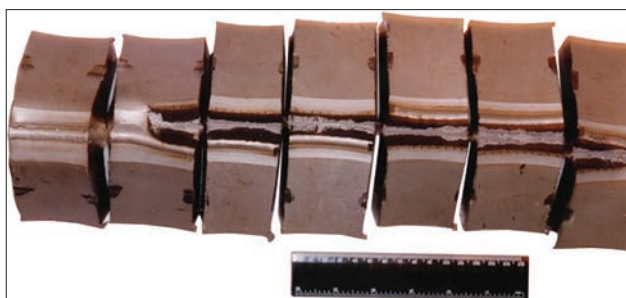
Each opposite half of the template contains the response surface of the same corrosion crack (of dark colour, facing outward in the image) and the surface of the final crack (of light colour, facing inward), resulting from the mechanical fracture of the templates during their bending.

Figure 8. Appearance of a surface crack on the fractured templates

The surfaces of corrosion cracks are covered with a thick layer of corrosion deposits that are dark brown in colour and have significant radioactivity. When studying the growth characteristics of corrosion cracks, it was observed that the choice of the growth trajectory by a crack is largely determined by the place of its initiation, which, in turn, depends on the efficiency (i.e., the sharpness) of the local stress concentrator. Therefore, at the damaged welded joints cut out from pipes, both cracks propagating along the HAZ near the fusion line and (less frequently) cracks growing along the weld metal were observed. To take these features into account, it is necessary, firstly, to determine the strength of the weld metal, and secondly, to determine the limit fracture load of the weld section that remained unaffected by a crack.
