FATIGUE RESISTANCE OF WELDED ELEMENTS OF FREIGHT CARS OF A NEW DESIGN MADE FROM STEELS OF S345 AND S390 STRENGTH GRADE

The paper presents the results of experimental-calculation studies of fatigue resistance of full-scale samples of the bolster assembly and side wall rack sealing assembly of a gondola car of 12-4106-01 model. It is found that their operating life is determined by fatigue resistance of welded joints of structural elements of the assemblies. Their fatigue strength is equal from 12.1 MPa (side wall rack sealing assembly) up to 33.6 MPa (bolster assembly). Sections of fatigue cracks initiation, regularities of their propagation and fatigue limit of the structure were established. As shown by calculation of the car body stressed state, the fatigue limit values ensure operation for 34.1 and 57.0 years for the bolster assembly and side wall rack sealing assembly, respectively, before appearance of the fatigue crack. 9 Ref., 2 Tables, 8 Figures.

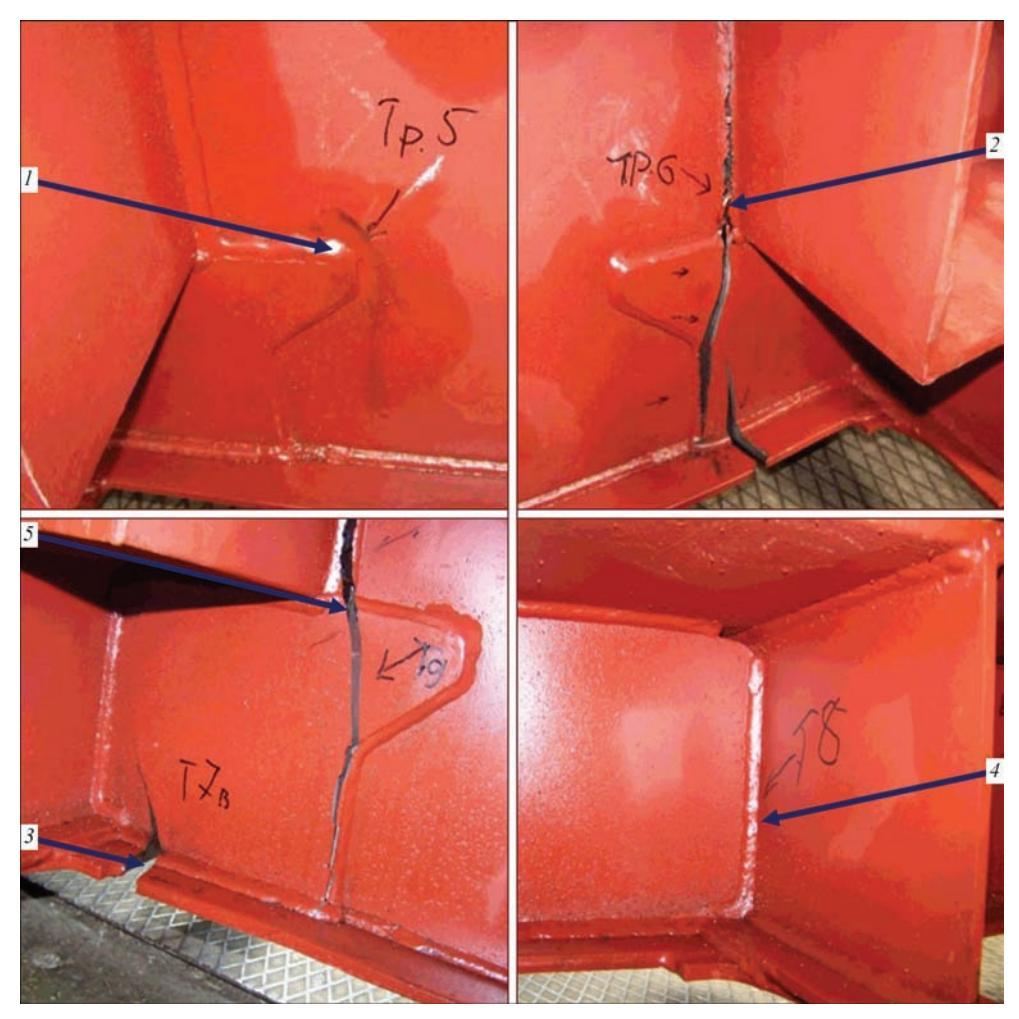
As the process of fatigue crack initiation and propagation in all the three samples of the bolster assembly was identical, the kinetics of fatigue fracture of just bolster assembly No.4 is given below as an example. Sample of bolster assembly No.4 was tested at cyclic loading ($P_{\min} = 98.1$ kN and $P_{\max} = 883$ kN) with the frequency of 5.5 Hz. The distance between the supports was 1400 mm. The following was found at 797 thou cycles: crack at the top of the coverplate on the vertical plate near the center sill (crack T5) 20 mm long and crack between the vertical plate of the body bolster and web of Z-shaped center sill (crack T6) 25 mm long (Figure 4). After 1029 thou cycles a crack was found in the lower horizontal plate of the body bolster at the center sill I-beam (crack T7) 35 mm long. After operating for 1126 thou cycles of stress alternation, the length of crack T5 of 20 mm remained unchanged, crack T6 propagated up to 35 mm, and

Figure 4. Cracks in bolster assembly (sample No.4): *1* — crack T5; 2 — T6; 3 — T7; 4 — T8; 5 — T9 from crack T6 on the other side from center sill

T7 started propagating both in the vertical (along the bolster assembly side wall) up to 10 mm, and in the horizontal direction (along the lower chord) — up to 55 mm. At 1282 thou cycles T7 crack along the vertical propagated up to 40 mm, and along the horizontal — up to 90 mm. A new crack was also revealed between the center sill I-beam (crack T8) 55 mm long. After 1458 thou cycles, the length of crack T5 of 20 mm remained unchanged, T6 propagated in the base material of the vertical plate of body bolster up to 45 mm, T7 grew in the vertical direction up to 80 mm, and up to 130 mm in the horizontal direction, crack T8 grew up to 180 mm. After testing for 2346 thou cycles, a crack was found between the vertical plate of body bolster and web of Z-shaped center sill (crack T9) 50 mm long (from the opposite side of T6). After testing for 2815 thou cycles, the length of crack T5 was equal to 22 mm, T6 - 150 mm; T7 reached the length of 150 mm, both along the vertical and the horizontal, T8 — 180 mm, T9 — 120 mm. The process of active fracture of the bolster assembly started after 2971 thou loading cycles: crack T6 grew up to 250 mm, and crack T9 — up to 180 mm. At 2995 thou

cycles crack T6 reached the length of 320 mm, and T9 was 300 mm), and at 3031 thou cycles the sample failed.

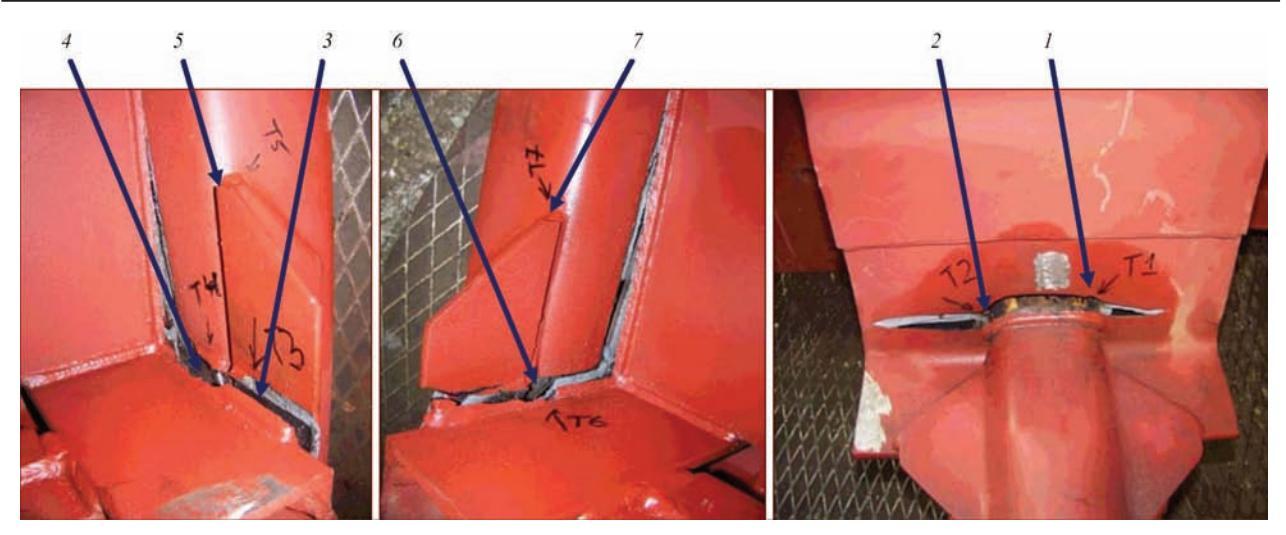
As the process of fatigue crack initiation and propagation was identical in all the three samples of side wall rack sealing, kinetics of fatigue fracture of just sealing of the rack of side wall No.4 is given below as an example. Sample of sealing of the rack of side wall No.4 was tested at cyclic loading ($P_{\min} = 41.2$ kN and $P_{\text{max}} = 68.7 \text{ kN}$) with the frequency of 7.0 Hz. At 325 thou loading cycles fatigue cracks T1 and T2 were found in the joint of the cross-beam (coverplate over the upper flange) with the lower chord 18 mm and 15 mm long, respectively, as well as crack T3 in the joint of the reinforcing angle bar and lower chord 10 mm long (Figure 5). Furtheron, at 931 thou loading cycles crack T1 grew up to 25 mm, T2 up to 50 mm, and length of crack T3 did not change. At 1550 thou loading cycles, coalescence of cracks T1 and T2 occurred, their total length being 110 mm, crack T3 grew up to 22 mm, and new fatigue cracks were found: T4 and T6 in the joint of the rack of side wall and lower chord (from two sides), of 10 and 38 mm length, re-

Figure 5. Cracks in the side wall rack sealing assembly (sample No.4): 1, 2 — in the joint of the cross-beam (coverplate over the upper flange) and the lower chord (cracks T1 and T2, respectively); 3 — in the joint of reinforcing angle bar of side wall rack and the lower chord (crack T3); 4, 6 — in the joint of side wall rack and lower chord (cracks T4 and T6, respectively); 5, 7 — on top of the reinforcing angle bar of side wall rack (cracks T5 and T7, respectively)

spectively; cracks T5 and T7 on top of the reinforcing angle bar of side wall rack of 7 and 10 mm length, respectively. After 2227 thou loading cycles, the length of crack T1 + T2 still was 110 mm, T3 crack grew up to 25 mm, T4 — up to 14 mm, T5 — up to 10 mm, T6 — up to 70 mm and T7 — up to 10 mm. At 2414 thou loading cycles, T1 + T2 crack propagated up to 120 mm, T3 crack merged with crack T4 (total length of 52 mm), T5 crack propagated up to 10 mm, T6 — up to 85 mm and T7 — up to 12 mm. After 2793 thou loading cycles, length of crack T1 + T2 still

was 120 mm, crack T3 + T4 propagated up to 55 mm, T5 — up to 10 mm, T6 — up to 115 mm, and T7 — up to 15 mm. At 3351 thou loading cycles, crack T1 + T2 grew up to 125 mm, crack T3 + T4 — up to 66 mm, crack T5 — up to 10 mm, T6 — up to 130 mm and T7 — up to 15 mm. At 3872 thou loading cycles the sample failed.

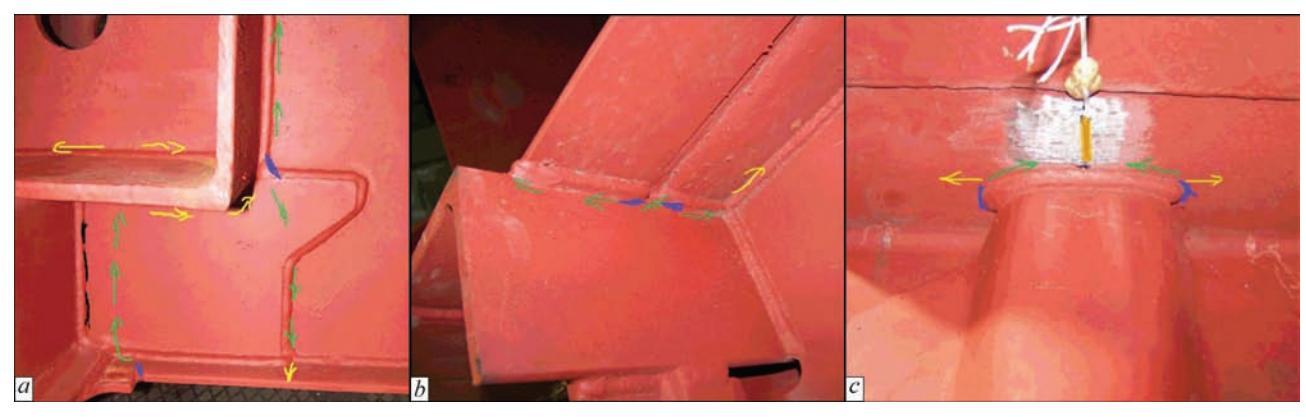
Figure 6. Crack propagation: a — in bolster assembly; b, c — in side wall rack sealing assembly

The generalized pattern of crack propagation and fracture is shown in Figure 6. Crack initiation sites are designated by blue marks. The cracks first propagate along the weld (green arrows). Having reached its boundary, they move over to the adjacent weld or to the base metal (yellows arrows). Black color in Figure 6, *a* shows a crack, which initiates at the initial testing stage, breaks the weld between the small I-beam of the center sill and bolster beam, and after that its propagation stops. It does not lead to loss of the sample load-carrying capacity. Further analysis was conducted for points of crack initiation (lower and upper blue marks in Figure 6). Table 1 gives the test results (cycle number to crack initiation and to sample fracture).

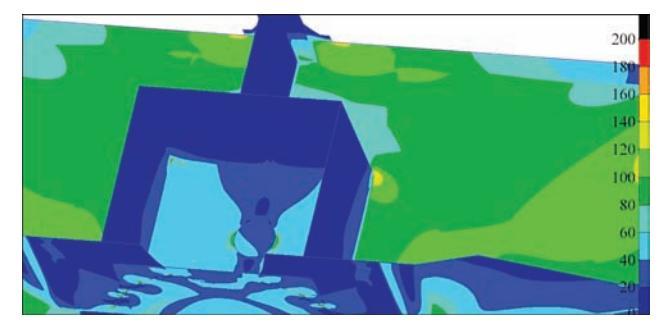
Figure 7. Stresses in bolster assembly from applied working load P = 883 kN, MPa

Fatigue limit (by stresses) $\sigma_{a,N}$ are the stresses due to the action of force $P_{a',N}$. Finite element models of the studied assemblies have been developed for their determination. Distribution of stresses from applied working loads in the samples is given in Figures 7, 8. Performed calculation confirms that stresses are maximum in the points, where cracks initiate (Figure 6, blue marks).

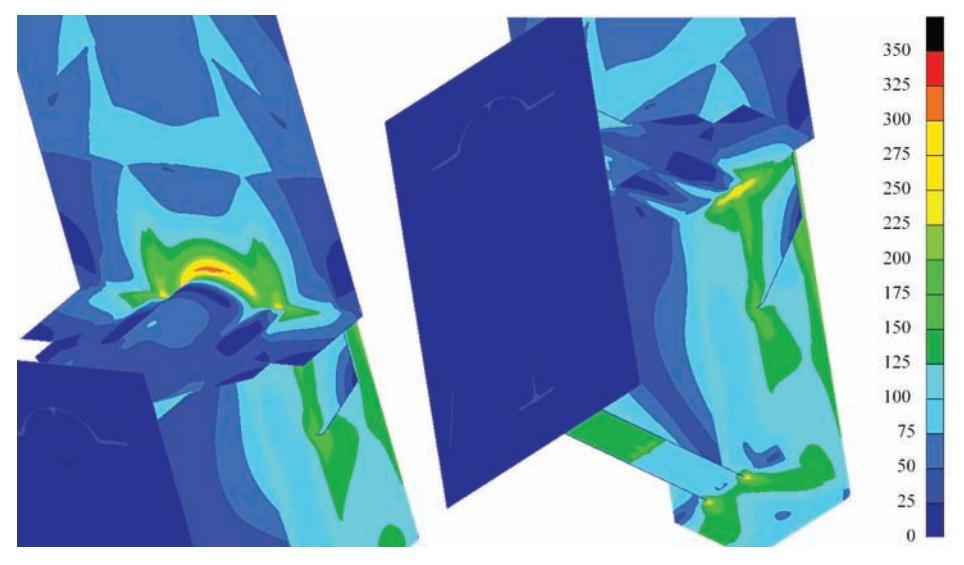
Figure 8. Stresses in side wall rack sealing assembly from applied working load P = 68.73 kN, MPa
