# INFLUENCE OF DESIGN FEATURES OF RELOADER WELDED ASSEMBLIES ON ITS PERFORMANCE

**P.A. GAVRISH and V.P. SHEPOTKO**

Improvement of reliability and safety of structures of machines and mechanisms in long-term operation under cyclic loading is becoming ever more urgent. Welded assemblies of a reloader were taken as an example for analysis of design solutions for the above assemblies allowing for their load level. Special attention is given to questions of decreasing structural stress raisers of weldments. An improved design of reloader diaphragm assembly, as well as geometry of electrotrrolley edge preparation were proposed, ensuring the high quality of welded joints and, therefore, the required fatigue life. 8 Ref., 1 Table, 8 Figures.

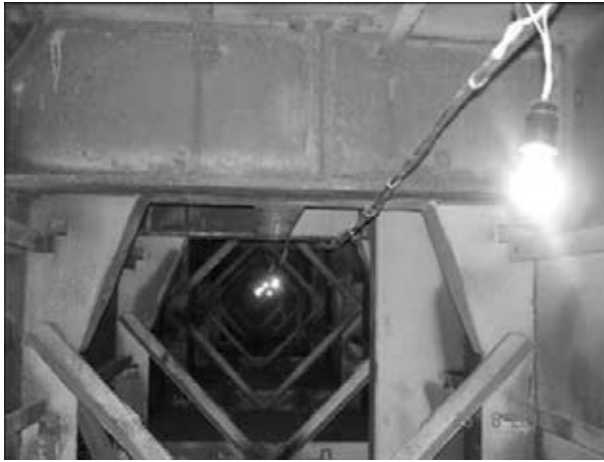
**Figure 1.** Stiffeners in reloader inner compartments

Mounting longitudinal stiffeners in the reloader inner compartments increases the section moment of inertia and reduces the cyclic load range (Figure 1). Such a design of reloader main beams, however, can lead to negative consequences in lifting construction service, as welding of the lower longitudinal stiffener near the diaphragm creates a structural stress raiser [2].

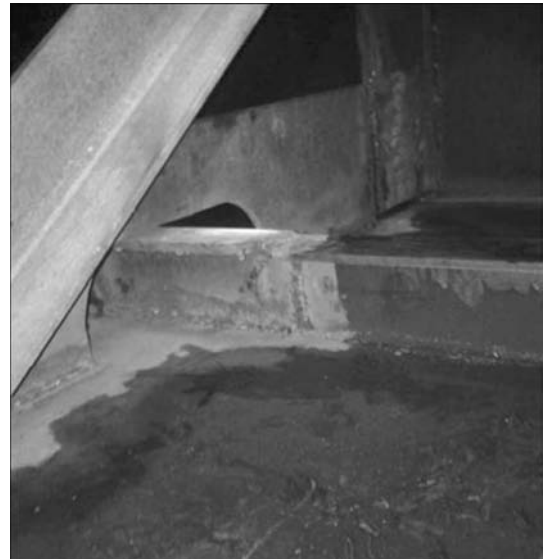
Figure 6. Welded assembly of modified design

bly embodiment with angle stiffener continuation through holes in the diaphragm was selected (Figure 6).

After the welded assembly design has been modified, no cracks developed in the fusion zone of weld diaphragm.
