# CAPABILITIES OF LASER RADIATION FOR IMPROVEMENT OF ELECTRODE WIRE QUALITY

S.B. SHEVCHENKO<sup>1</sup>, I.V. KRIVTSUN<sup>1</sup>, L.F. GOLOVKO<sup>1</sup>, A.N. LUTAJ<sup>1</sup> and V.P. SLOBODYANYUK<sup>2</sup>

Analysis of the processes of manufacturing wire electrodes for semi-automatic welding was performed, structure, quantitative chemical and phase composition of the wire surface layer before and after copper coating deposition were studied, and geometrical dimensions, location depth and relative quantity of nonmetallic inclusions in the coating were determined. Possibilities of removal of such nonmetallic inclusions by laser radiation with 10.6  $\mu\text{m}$  wave length were studied at different treatment parameters. Technology of laser cleaning of welding wire surface was proposed, which is performed before copper coating deposition. An experimental laser process complex was developed to verify development results under conditions close to those in production. 10 Ref., 15 Figures.

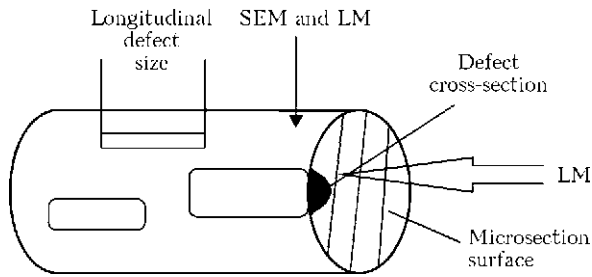
Figure 1. Schematic of object filming

Figure 1 shows the schematic of taking micrographs at examination by light microscopy (LM) and SEM methods.

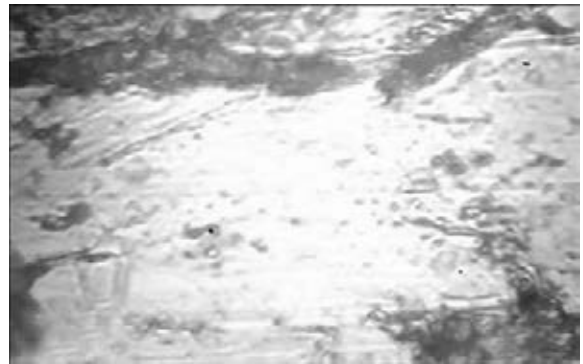
Figure 2. Micrograph (x2000) of copper coating surface (LM)

Figure 2 gives micrographs of copper coating surface, taken by LM method. The coating is non-uniform – regions, not having the colour characteristic for copper, are observed.

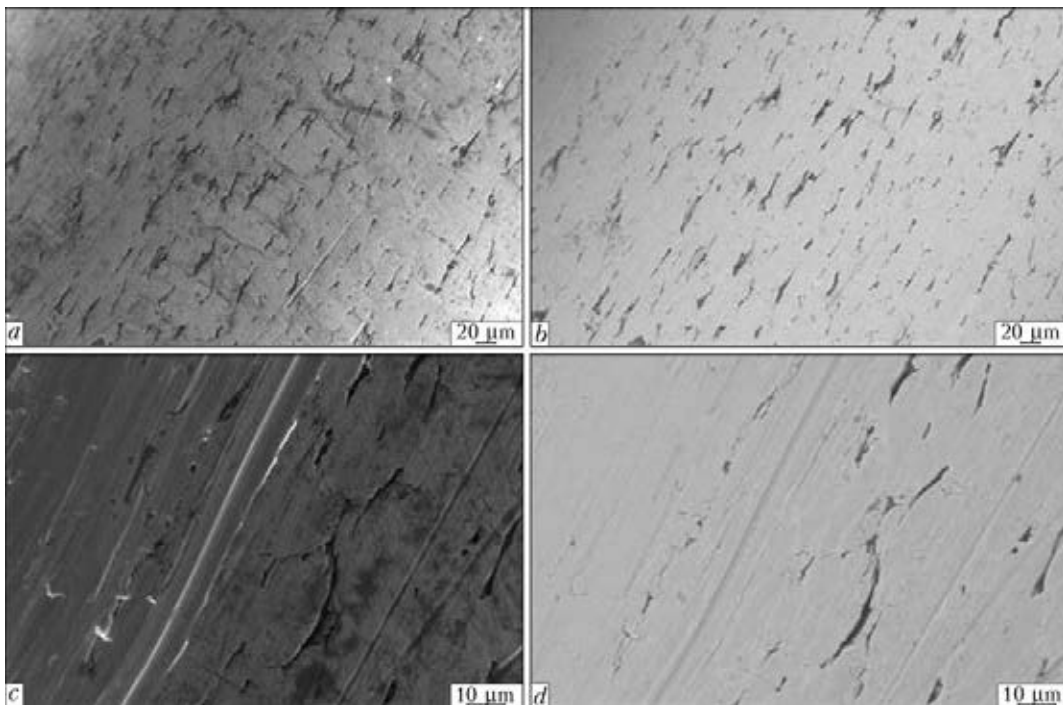
Figure 3. Electron micrographs of different sections of the copper coating: *a, c* – in secondary; *b, d* – in reflected electrons (*a, b* – x500; *c, d* – x2000)

The low depth of resolution of light microscope does not allow a more detailed description of the observed layer defects. Electron micrographs of different coating regions (Figure 3) show a large quantity of surface defects of an elongated shape with the long axis coinciding with the direction of

wire drawing through the die. An essential difference in the contrast of micrographs taken in the secondary (Figure 3, *a, c*) and reflected electrons (Figure 3, *b, d*) is attributable to the following features of the above procedures. At filming in reflected electrons a method of electron recording, minimizing the contrast topographic component, was realized. Thus, the composition (phase) contrast prevails in the above micrographs: micrograph brightest regions correspond to sample regions enriched in heavier elements (with greater atomic mass).

Therefore, the extensive light regions in Figure 3, *b, d* are the copper zones or steel surface. It is impossible to determine which regions correspond to copper or to iron, based on just the difference in contrast, because of the closeness of atomic masses of the above elements. Spots and grey film on the micrographs in Figure 3, *a, b* are the remains of process lubricant used in

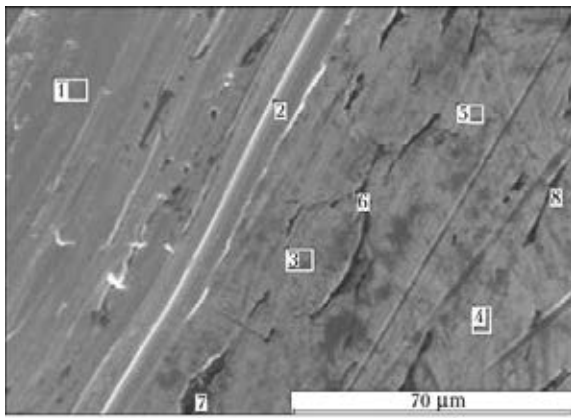
Spectrum	C	O	Si	Mn	Fe	Cu
1	1.75		0.77	2.12	95.36	
2	1.31		0.88	2.14	95.67	
3	2.63		0.67	1.11	58.65	36.93
4	3.93		0.66	1.15	63.91	30.35
5	2.44		0.58	0.96	53.56	42.45
6	21.29	13.24	0.68	0.74	38.51	25.54
7	35.09	16.26	0.37	0.61	34.98	12.69
8	33.32	4.23	0.31	0.67	33.05	28.42
Max	35.09	16.26	0.88	2.14	95.67	42.45
Min	1.31	4.28	0.31	0.61	33.05	12.69

**Figure 4.** Results of X-ray spectral microprobe analysis of the composition of sections marked in the micrograph

drawing. RSPMA results of the composition of various regions of the sample (Figure 4) allow stating that a large part of volume defects are iron oxides, coated by a thin copper layer. Figure 5 gives a more visual representation of RSPMA results, from which it follows that the sample surface consists of two zones: region without coating traces taking 38 % of the entire surface area, and coating region with coarse inclusions of iron oxides. Coating absence over a substantial surface area, in our opinion, is related to poor quality of wire surface treatment before coating deposition (incomplete removal of the lubricant, insufficient degreasing, etc.).

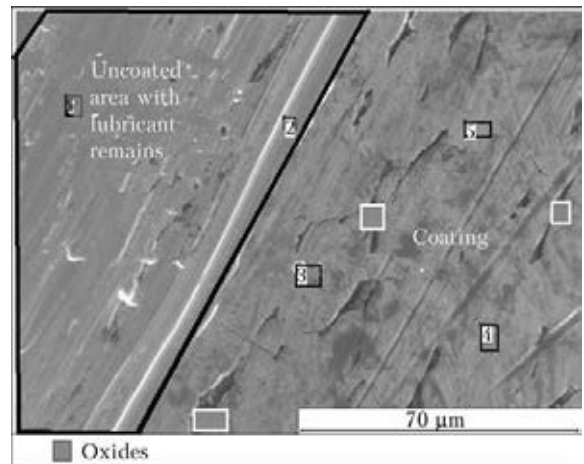
**Figure 5.** Electron micrograph of copper coating

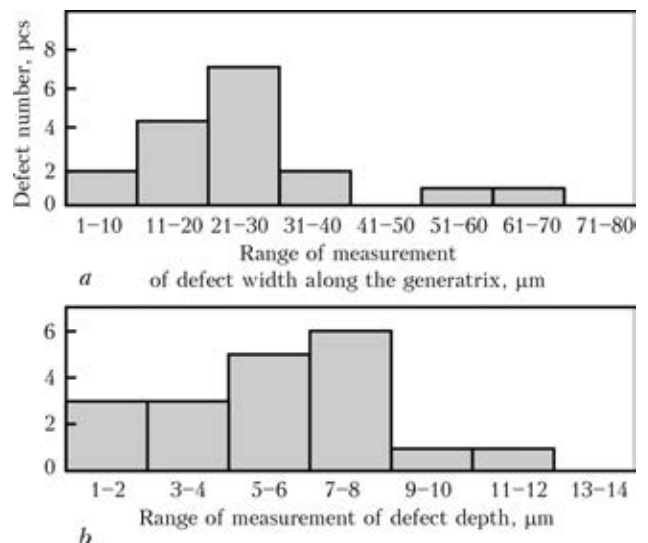
**Figure 6.** Histogram of linear defect dimensions: *a* – width; *b* – depth of surface defects

Metallographic examination of transverse microsections confirmed that defects have considerable dimensions. Data in Figure 6 give an idea of defect depth and width.

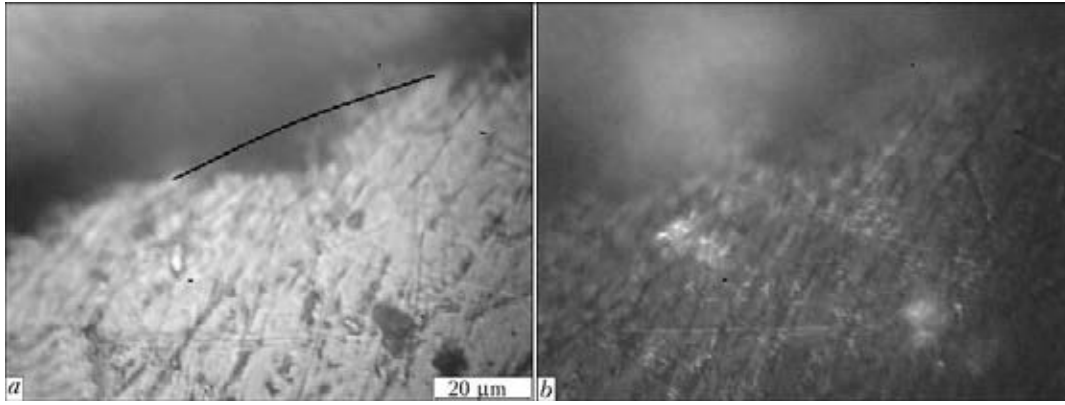
Figure 7. Micrographs of end surface of 3 mm wire in white (a) and polarized (b) light

It is clear that oxides of such dimensions could not have formed by the above mechanism. As shown by metallographic analysis of transverse microsections of 3 mm wire (Figure 7), oxides of the above dimensions are present in the steel inner volumes. Therefore, the initial billet contains iron oxides, located at different distance from the surface.

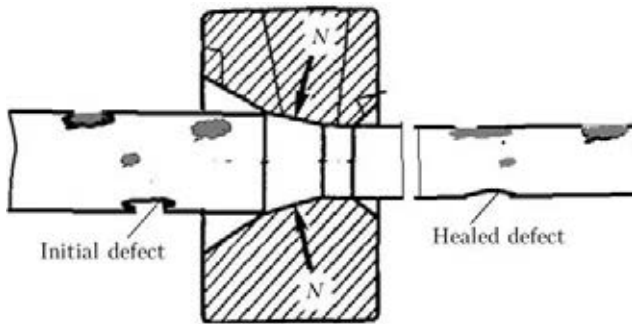
Figure 8. Schematic of defect formation on wire surface at drawing

At passing through each die, oxides located near the billet surface become exposed (Figure 8), thus increasing their surface concentration. The suggested defect formation mechanism is confirmed by absence of plastic deformation traces, characteristic for steel drawing, on defect surface. Therefore, the die was in direct contact with the oxide.

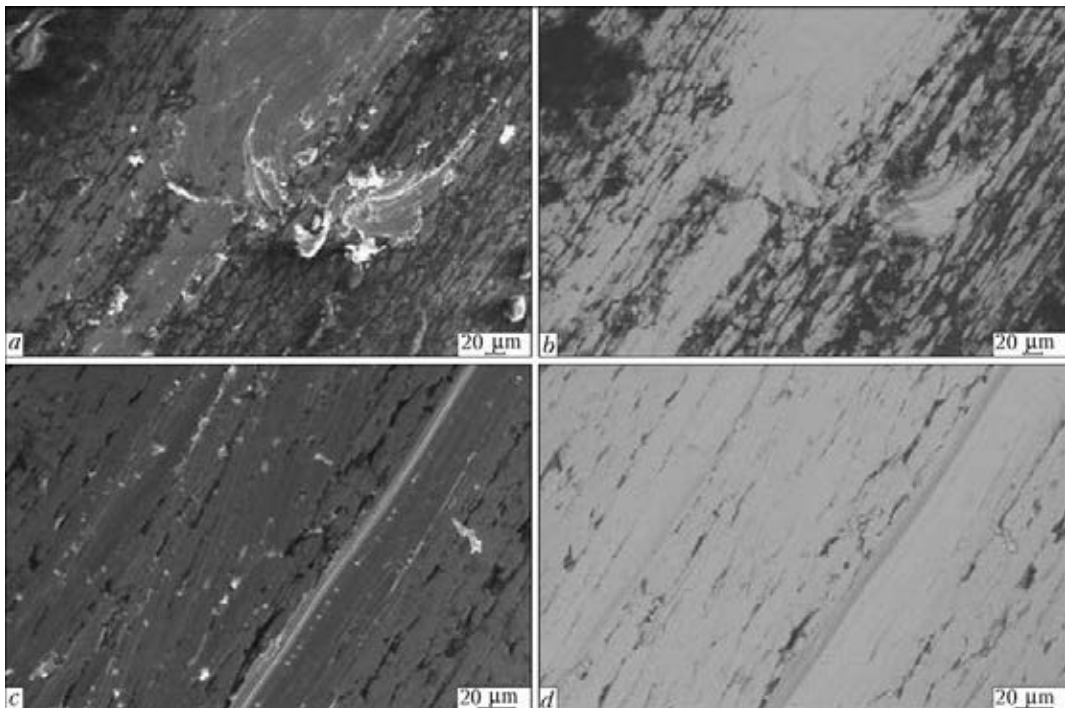
Figure 9. Electron micrographs of 1 mm wire surface after leaving the die (a, b) and after subsequent polishing (c, d)

Let us note in conclusion that polishing of final diameter wire, while essentially reducing the surface roughness (Figure 9), did not in any way

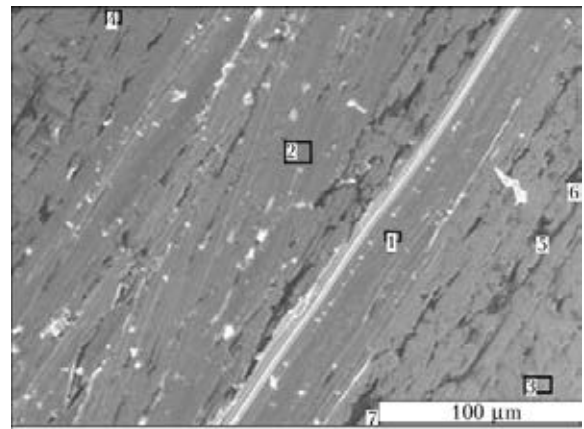
Spectrum	C	O	Na	Si	Ca	Mn	Fe
1	1.40			0.80		2.29	95.52
2				1.15		1.99	96.86
3	4.93			1.19		1.80	92.08
4	1.66			0.76		1.85	95.73
5	51.89	9.75	0.51	0.47	1.86	0.75	34.77
6	48.07	8.43	0.36	0.47	1.33	0.72	40.62
7	37.59	5.41	0.43	0.27	0.78	0.99	54.52
Max	51.89	9.75	0.51	1.19	1.86	2.29	96.86
Min	1.40	5.41	0.36	0.27	0.78	0.72	34.77

Figure 10. RSPMA results for 1 mm wire after polishing

affect the surface oxide concentration (Figure 10).

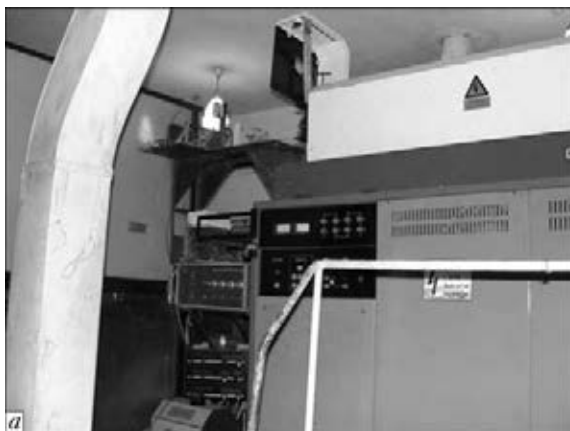
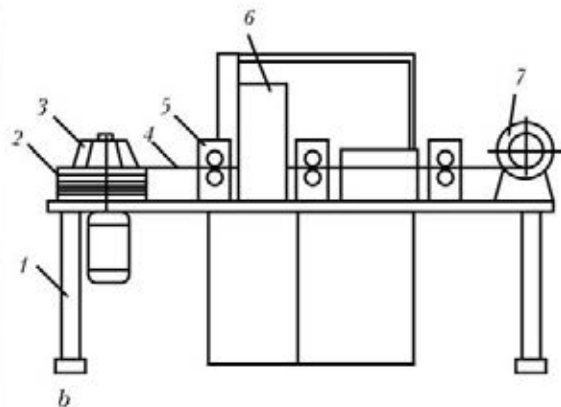
Figure 11. «Kometa-2» laser system (*a*), and diagram of the device for welding wire guiding and rewinding relative to the laser beam (*b*) (for designations see the text)

and readily absorbed by dielectrics (oxides). Therefore, for selective removal of oxide inclusions, the welding wire surface was treated by continuous radiation of CO<sub>2</sub>-laser system «Kometa-2» of 1200 W output power (Figure 11, *a*). Laser radiation with multimode distribution of intensity TEM<sub>20</sub> was focused on the moving wire surface by a plane-spherical lens from KCl with 300 mm focal distance. Here, the diameter of the laser beam in the treatment plane was equal to 1 mm. Shielding gas (argon) was fed into the zone of laser beam impact. A special device was developed for welding wire orientation and displacement relative to the laser beam, the schematic of which is given in Figure 11, *b*. The device consists of a metal case on four supports 1, on which electric motor with reduction gear and receiving cassette 2 and mechanism for fixation of the cassette with wire displacement speed sensor 3 are mounted. Wire 4 is forcedly reeled off initial cassette 7 at preset speed, is directed by guide rollers and is fed into the inductor, where its heating up to tempering temperature is performed in inert gas atmosphere to relieve residual stresses. In the next stage, at wire passing through the next two roller pairs 5, which orient it relative to the axis of the focused laser beam 6, its irradiation is performed. As a result of selective absorption, oxide inclusions are removed from the wire surface through evaporation. To perform this operation, a system of laser radiation focusing based on torroidal mirror, should be built into the wire drawing machine.

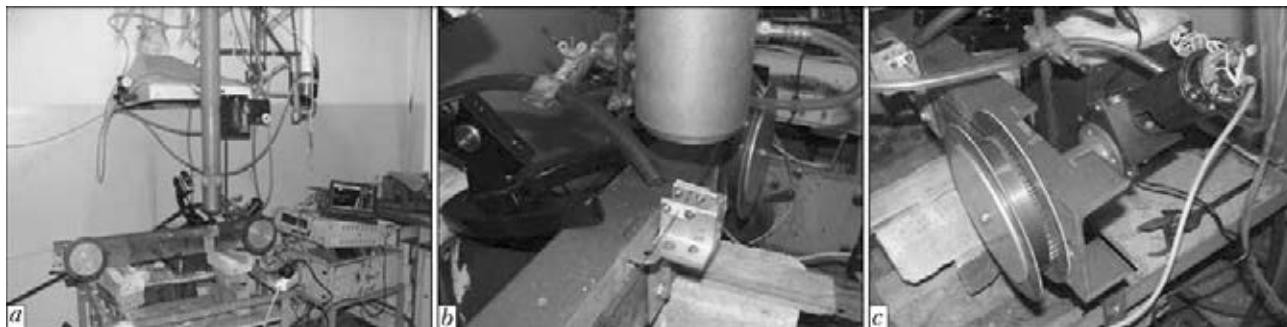
**Figure 12.** General view of the system (a) and its individual devices designed for guiding (b) and rewinding (c) of welding wire at its surface treatment by CO<sub>2</sub>-laser radiation

Experimental studies were conducted in a somewhat simplified test facility, the general view of which and of welding wire guiding and rewinding device is shown in Figure 12.

Special brass dies were used for precise basing of wire surface relative to laser beam axis. To prevent oxidation of irradiated surface, shielding gas (argon) was fed into the laser beam impact zone. Special microscope with WEB-camera con-

nected to a computer, providing from 25- to 100-fold magnification, was used for observation of laser treatment process. Laser radiation power was adjusted within 700 to 1200 W. During laser treatment, the wire was rewound from passive spool onto drive spool. Speed of wire displacement relative to laser beam was varied in the range of 1.5 to 3.5 m/min.

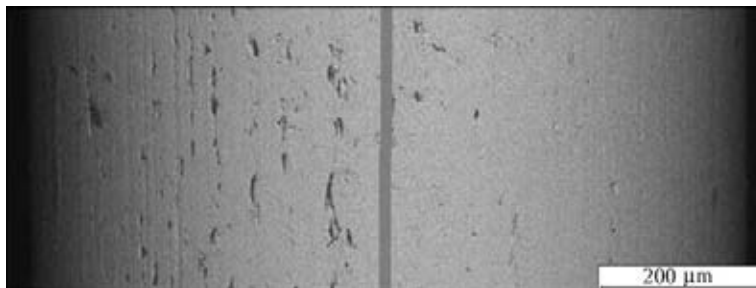
**Figure 13.** Electron micrograph of copper coating surface on the wire treated (right side) and untreated (left) by laser radiation

**Results of examination of the quality of copper coating on welding wire pretreated by laser.** Figure 13 gives the electron micrograph of coating surface, including the zone treated by laser radiation, and zone not subjected to laser treatment. It is seen that laser pre-treatment of wire surface leads to formation of coating with much

smaller number of defects. Their presence near the boundary line (see gray band in Figure 13, and zone 2 in Figure 14) on the treated side is attributable to non-uniform distribution of radiation power density over the wire cylindrical surface. The central part of its irradiated zone 1 (Figure 14) has practically no such inclusions. Such non-uniformity of inclusion distribution is readily removed by application of a laser beam with toroidal distribution of intensity.

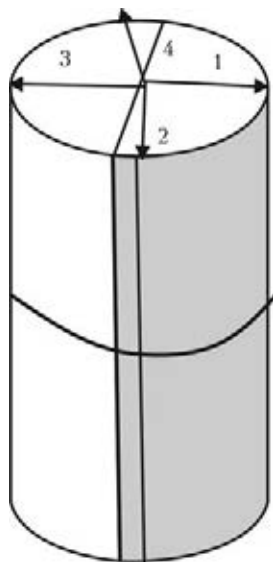
**Figure 14.** Schematic of defect location relative to the center of treated (1, gray) and untreated (3, white) surface (for designations see the text)

RSPMA of defects was performed to provide replies to the above questions. The object was revolving about the wire axis and after rotation through an angle of ~90°, defect micrograph was taken and its composition was determined. Schematic of defect location on the wire is given in Figure 14, and their electron micrographs and element content are given in Figure 15. Results obtained in zone 4 are equivalent to zone 3.

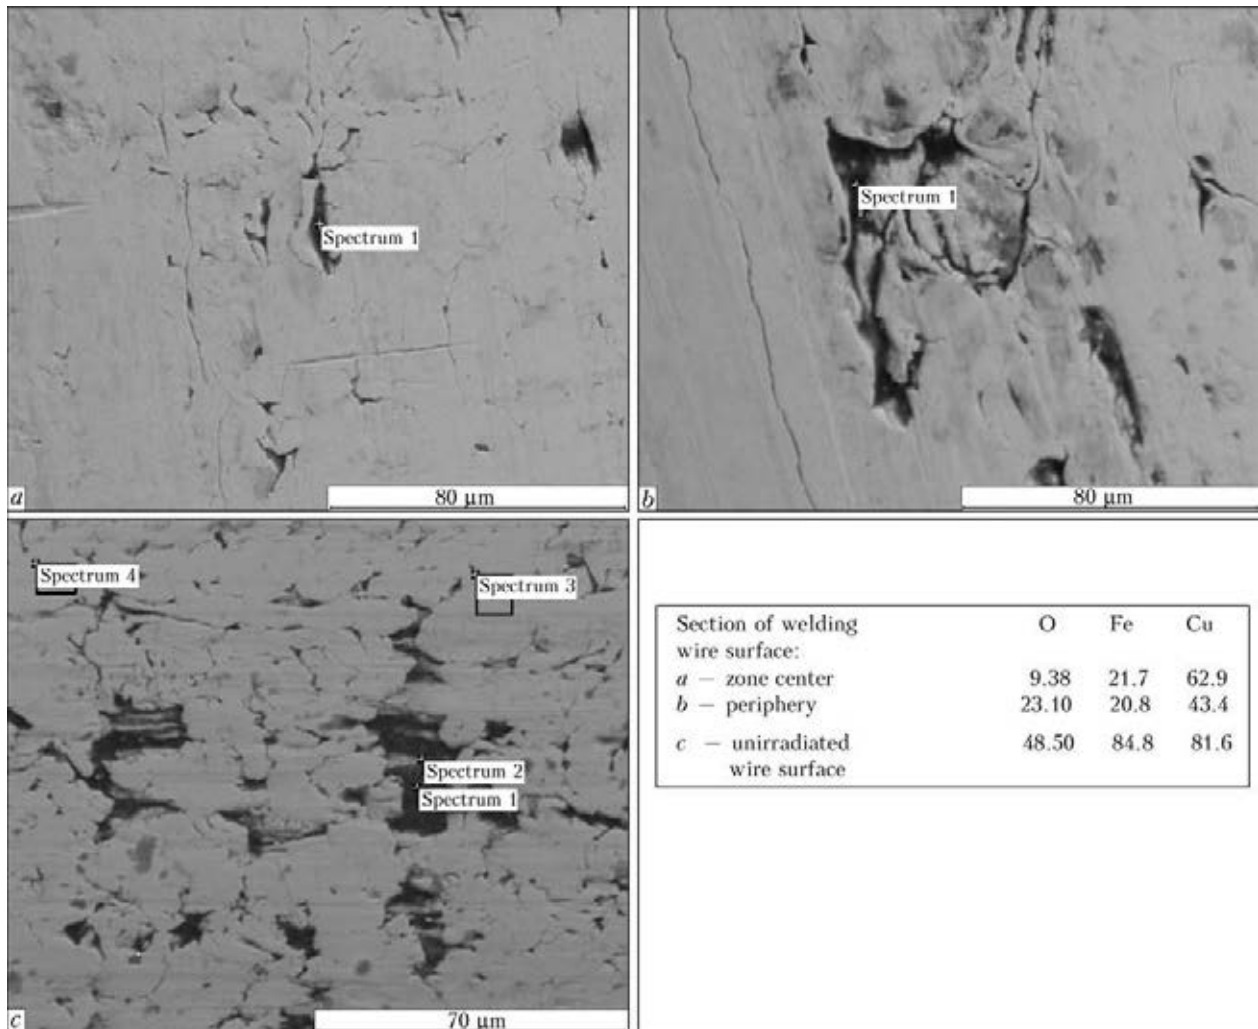
**Figure 15.** Electron micrographs of defects in zone 1 (center of wire irradiated surface) (a), in zone 2 (peripheral part of the zone) (b) and in zone 3 (unirradiated surface) (c)

Examination of defects seldom found in the center of treated wire surface (Figure 15, a) showed that they contain a small amount of iron oxides, on the surface of which copper layer was deposited. Laser treatment of the wire peripheral surface by lower-intensity radiation leads to a certain increase of defect concentration and of oxide content level (Figure 15, b). In wire sections, not subjected to laser treatment, defect concentration was by an order of magnitude higher than in the center of irradiated surface. Oxide quantity in it changes in a very broad

range (from 2 up to 48.55 %). Here, copper coating is practically absent in the majority of wire sections containing oxides. At two-sided laser treatment the number of wire sections with oxides, and, hence, without the copper coating, is essentially smaller. They, however, are present on the side surfaces.
