APPLICATION OF WELDING FOR RESTORATION OF CAST IRON RAILING OF THE KOTZEBUE BRIDGE IN ODESSA

V.D. POZNYAKOV, Yu.V. DEMCHENKO, A.M. DENISENKO, G.V. ZHUK and V.B. KOZYREV

E.O. Paton Electric Welding Institute of the NAS of Ukraine
11 Kazimir Malevich Str., 03150, Kyiv, Ukraine. E-mail: office@paton.kiev.ua

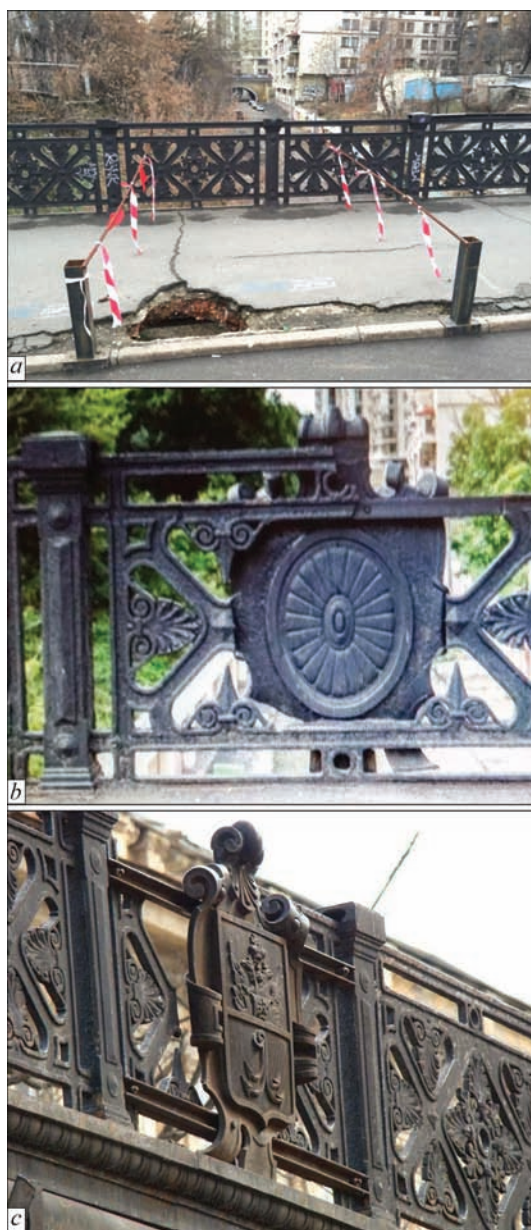
It was managed to follow the change in the appearance of the railing over a 125-year history on the basis of analysis of photos from the thematic publications on the Kotzebue Bridge in the city mass media, since technical documents were not preserved. Figure 2 shows the general unsatisfactory condition of the railing ensemble. The poles of the railing were protected against falling by pouring the inner cavity with concrete and installing the bracings (Figure 2, *a*), which prevented the movement along sidewalk. Most of the removable railings were almost lost, except of few ones, being cast together with grates, apparently during the postwar restoration as far back as in the middle of the 20th century. As for under emblem grates, they were reinforced by the channel bars (Figure 2, *b*) at the same period, which clearly reduced the artistic component in perceiving the masterpiece of casting art. The emblems lost their curling ornaments — volutes (Figure 2, *c*).

Figure 2. General view of condition of the railing of the Kotzebue bridge in 2016 (before disassembly): *a* — panoramic view; *b* — rear side of the emblem on the under emblem grate; *c* — front side of the emblem on under emblem grate

In 2011, the load-carrying structures of the bridge floor and the cast iron railing ensemble were recognized as emergency ones and those which need the major repairs, and therefore, the bridge was decommissioned and in June 2016 it began to be reconstructed. The reconstruction project envisaged the restoration and preservation of the original arched part, without its involving in the work of bridge structures. The transport load will be now undertaken by the new span structures, meeting the modern requirements. As for railing, then after restoration it must preserve its purpose in the previous appearance.

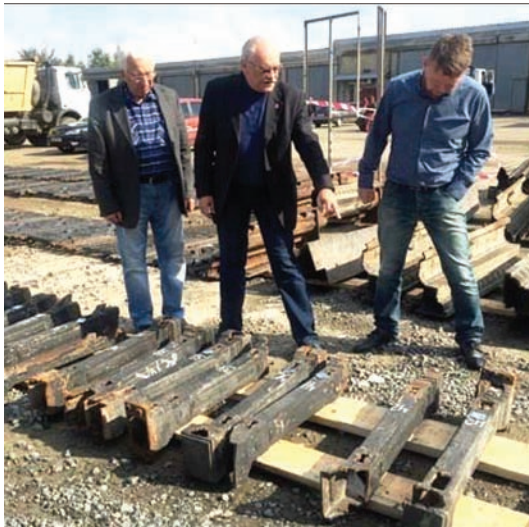
Figure 3. Working moment of the joint expert examination of architectural and decorative elements of railing of the Kotzebue Bridge with representatives of the Department of Cultural Heritage Protection of the Odessa State Administration

In September–October 2016, under the terms of the general contractor, the first stage, an expert examination of all the architectural and decorative railing elements with element-by-element visual evaluation of a real condition and with photofixation was carried out by the specialists of the PWI (Figure 3).

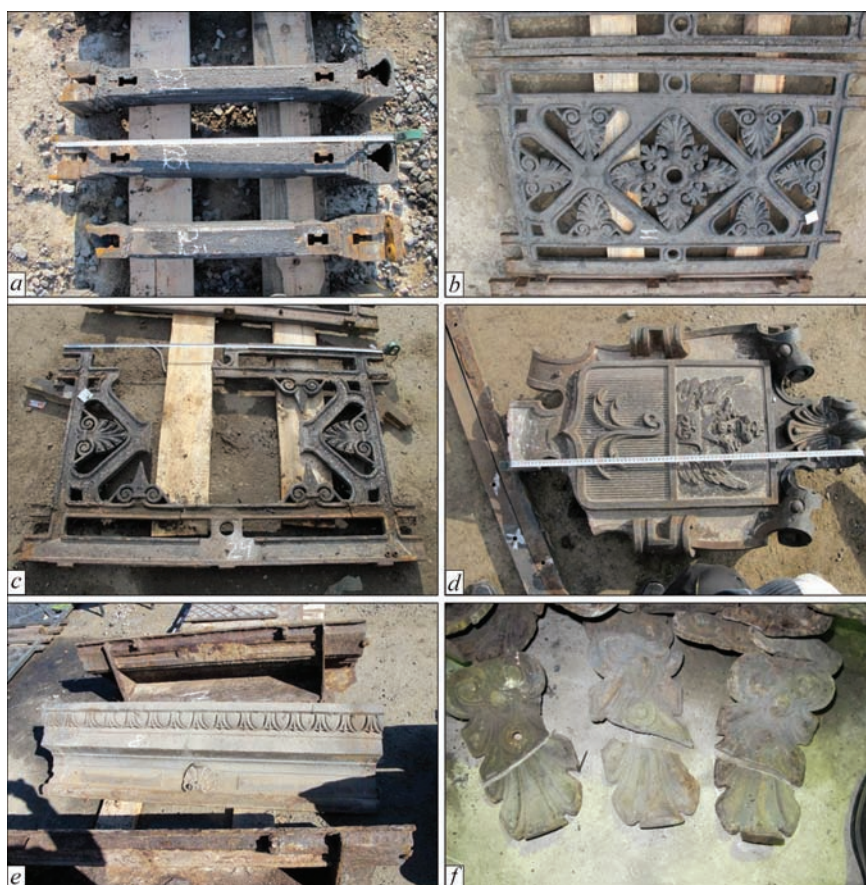
It was established in the course of examination that the mass destruction of pillars and the loss of load-carrying capacity (Figure 4, *a*) are the results of complex cause. It consists in design features, i.e. the presence of problematic corrosion zones inside the hollow structure, low mechanical characteristics of cast iron, tight fit of grates in a standard position, vibration from transport movement, aggravated by its own weight and the weight of hinged elements, rigid action of low temperatures and water in all its aspects. The most critical for destruction is the fatigue of metal structures of the bridge in the process of long service life and corrosion. Therefore, in connection with a low degree of integrity and loss of load-carrying capacity, as well as high critical importance of these elements in the composition of the railing, it was recommended to cast all the poles anew.

The analysis showed that characteristic defects on grates (Figure 4, *b*), emblems (Figure 4, *d*) and outer horizontal surface of the cornices (Figure 4, *d*) such as cracks, lost fragments, corrosion damages are exclusively the consequences of assembly errors, action of time and long-term service. They are associated with the absence of proper current maintenance, incorrect restoration operations, unsuccessful design solutions during creation of elements, especially of under emblem grating and a low ductility of structural cast iron.

**Figure 4.** Examples of condition of characteristic parts of railing, established during expert examination: *a* — poles Nos 25, 26, 27; *b* — grate No. 11; *c* — under emblem grate No. 24; *d* — emblem No. 1; *e* — cornice No. 8; *e* — corner elements of decor Nos 1, 2, 3

On the basis of comprehensive analysis of the degree of defectiveness of cornices, emblems and railing grates, taking into account the high degree of integrity of structural and artistic conditions, the conclusion was made about the potentiality of restoring their fitness for further service in the designing mode and in the same appearance using welding. To eliminate the design drawbacks of under emblem grates, taking into account

their loading, it was suggested to restore them in the form of a combined welded-cast structure. The decision making was also contributed by the research experience in welding of gray and high-strength cast irons and participation in the restoration of cast iron pillars of the Kiev Philharmonic (19th century), pilasters of the Cabinet of Ministers building (the first half of the 20th century), as well as the load-carrying parts of technical equipment (20th century) [2].

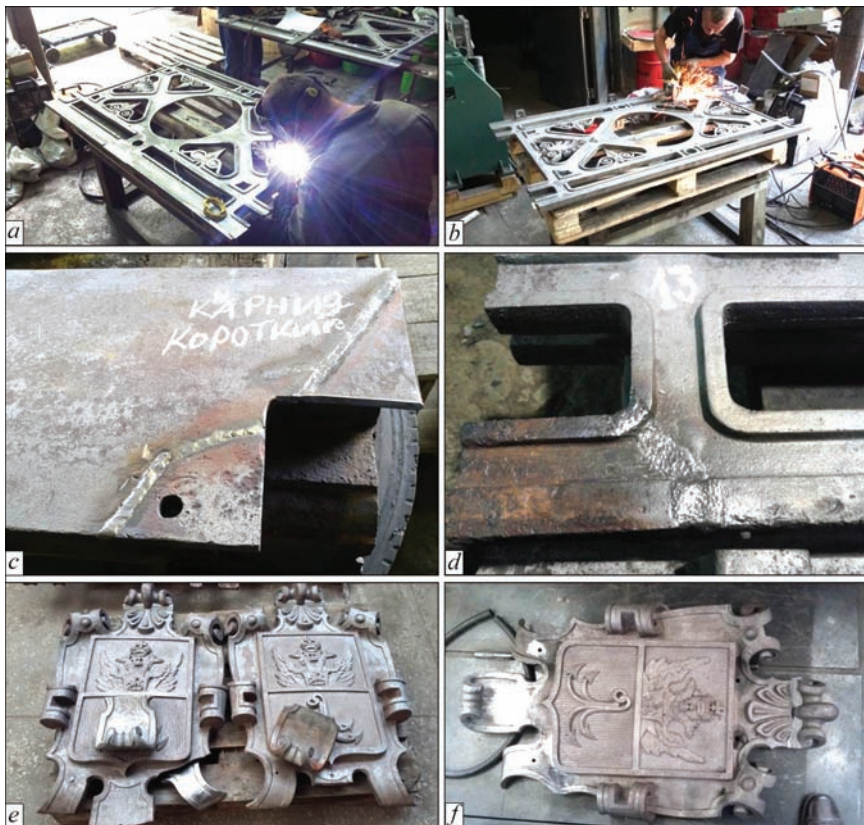
Figure 5. Fragments of restoration works: *a* — restoration of under emblem grate by welding; *b* — final cleaning of welds; *c* — type of repaired joint on short cornice; *d* — type of repaired joint on grate No. 13; *e* — type of emblems before restoration (in the foreground, newly cast fragments of lost decorations — volutes); *f* — type of emblem No. 1 after restoration

The stable process of welding using the wire PANCH-11 is easily carried out at the direct polarity and at the mode: $I_w = 110\text{--}140\text{ A}$, $U_a = 16\text{--}18\text{ V}$, which is necessary for the aims of low heat input into the base metal. The penetration depth of the base metal is 1.5–2.0 mm. The welding can be performed in all spatial positions, but the priority is given to flat and inclined positions. The weld metal is characterized by such indicators of mechanical properties as: $\sigma_y = 350\text{ MPa}$, $\sigma_t = 450\text{ MPa}$, $\delta = 15\%$. The specimens for static tension are fractured outside the weld metal. A significant advantage is the possibility of welding into a narrow gap in the form of a slot, which greatly facilitates the producing of joints without longitudinal and transverse cracks, as well as combined joints with steel.

Based on the results of investigations, an optimal welding repair technology was developed, applied for all architectural and decorative elements of railing, requiring restoration and a detailed plan for their restoration was elaborated, taking into account the real condition. The features of the technology are reflected in the instructions for each repair case (WPS) according to the requirements of GOST 30430–96 to the process of welding cast iron. The results of restoration works are shown in Figures 5, 6. In August 2017, after primer painting, the restored railing was installed on the Day of the City, celebrated in September, on the reconstructed Kotzebue Bridge, and subsequently in November, after the completion of the entire complex of finishing works at the adjacent territory and instal-

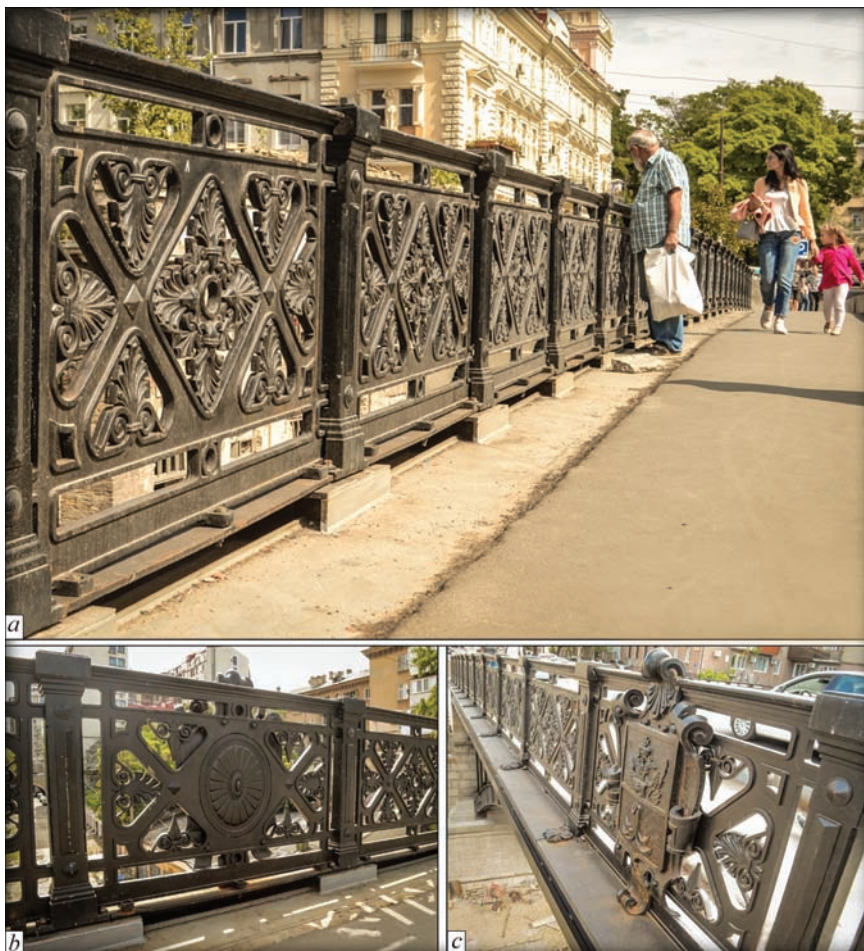
Figure 6. General view of railing ensemble (August-September 2017): *a* — appearance of renovated panel of railing grates; *b* — under emblem grate with emblem (view from the sidewalk); *c* — view from the outside of the bridge

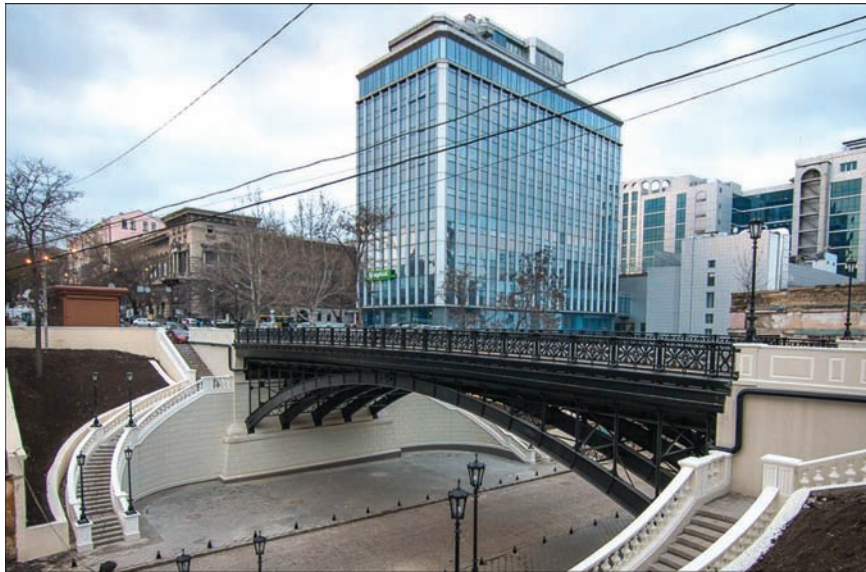
Figure 7. General view of the reconstructed bridge with the restored architectural and decorative railing elements (November, 2017)

lation of lanterns, all the metal structures were repeatedly sand blasted and painted in the color specified by the Project (Figure 7).
