# CALCULATED ESTIMATION OF LOAD-CARRYING CAPACITY OF THE MAIN SPAN BEAMS OF THE E.O. PATON BRIDGE ACROSS THE DNIPRO IN KYIV BY NONDESTRUCTIVE TESTING RESULTS

**O.O. Makhnenko, O.V. Makhnenko**

E.O. Paton Electric Welding Institute of the NASU  
11 Kazymyr Malevych Str., 03150, Kyiv, Ukraine

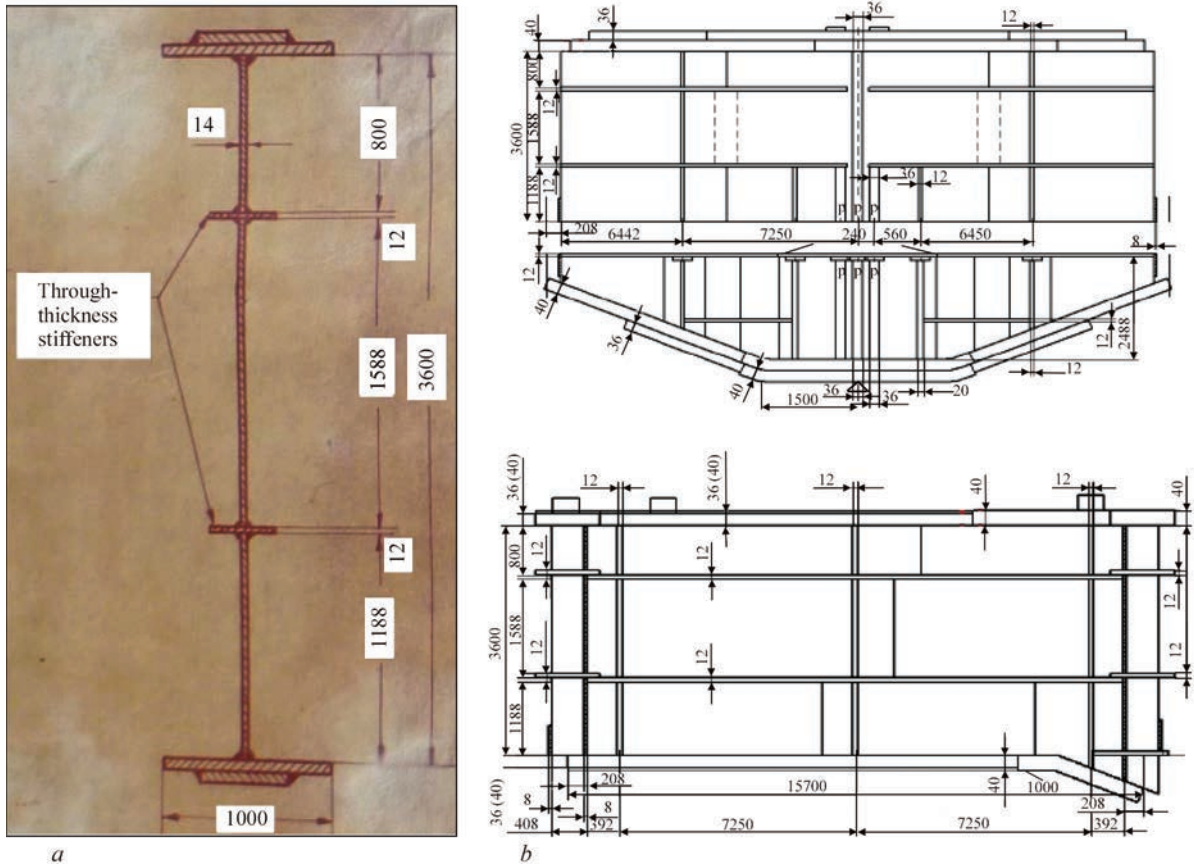
Figure 1. Transverse section of the main longitudinal I-beam (a) and drawings of fragments of the main longitudinal I-beam (b)

The Kyiv city E.O.Paton Bridge across the Dnipro, built and commissioned in 1953, is a unique engineering structure [1]. During its construction, the then advanced welding technologies were used, in particular those of mechanized submerged-arc welding. The bridge consists of 24 span structures of 58 m length in the non-navigable portion and 87 m length in the navigable portion, its total length is 1543 m. In the cross-section each of the bridge structures has four main longitudinal I-beams. The beam consists of a vertical web 3600 mm high and 14 mm thick and girths of different thickness from 30 to 80 mm at up to 1000 mm width (Figure 1, *a*). The beam web strength is additionally ensured by longitudinal and vertical stiffeners. In the 6-span structures in the bridge navigable part the height of the web above the intermediate supports was increased up to 6200 mm, due to adding the haunches (Figure 1, *b*). The beams are made from M16S carbon steel, which corresponds to VSt3sp (killed) steel by its characteristics.

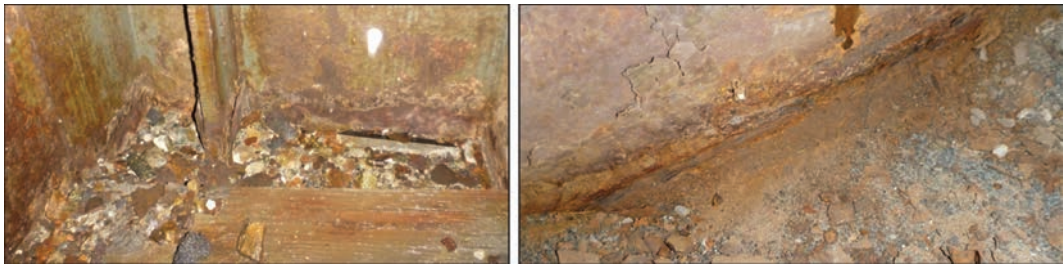
Figure 2. Ulcerative corrosion of the lower flange and the web in the span structure

beam structure as a result of seepage of water from rain and thawing snow, particularly in the lower girths, lower horizontal ribs and in the lower parts of the webs, which is also due to accumulation of debris in these areas, which retains moisture. Through-thickness corrosion damage was detected in some trusses of the main beams (Figure 2).

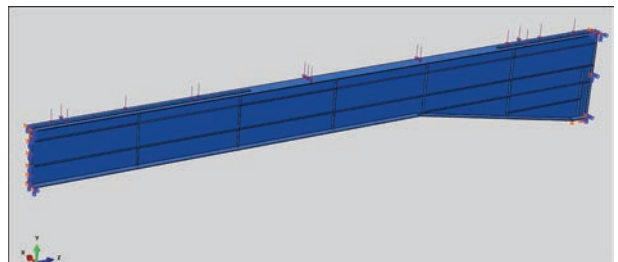
Figure 3. 3D model of the main 6-span beam

In order to perform the calculated estimation of the load level, as well as of the change of the load-carrying capacity of the beam span structure in the presence of local corrosion defects, a geometrical and finite element model of the main 6-span beam was constructed, in keeping with the design documentation. The model 43.5 m long consists of one span, from the haunch middle to the middle of the span structure, under the condition of symmetry at both ends (Figure 3). Boundary conditions for displacement are assigned on the haunch reference plane, the vertical component of which is equal to zero that corresponds to the conditions of the span beam resting on the bridge supports.

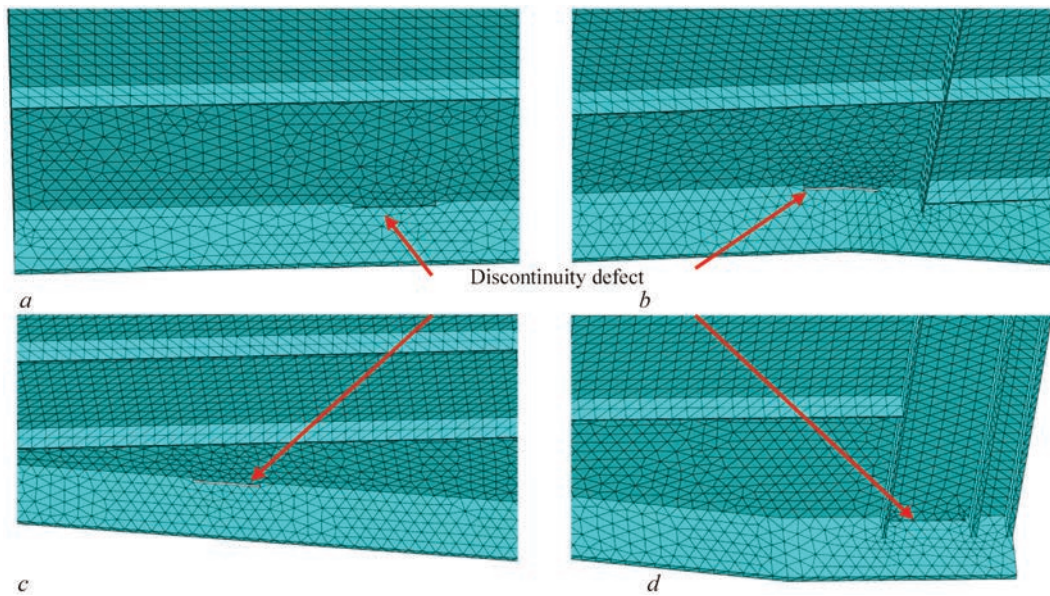
**Figure 4.** Discontinuity defects in the flange (local corrosion defect 500 mm long and 40 mm deep) in the zone of the joint of the web with the lower flange of the main 6-span beam: in the span central part (*a*); in the point of transition of the constant height beam into the haunch (through the thickness) (*b*); in the inclined part of the haunch (through the thickness) (*c*); in the central part of the haunch (*d*)

To determine the influence of typical corrosion damage of the beam in the zone of welded joint of the

lower girth and the web, through-thickness discontinuities of metal 500 mm long were introduced into the finite-element model in different points along the lower girth (Figure 4) and the web (Figure 5).

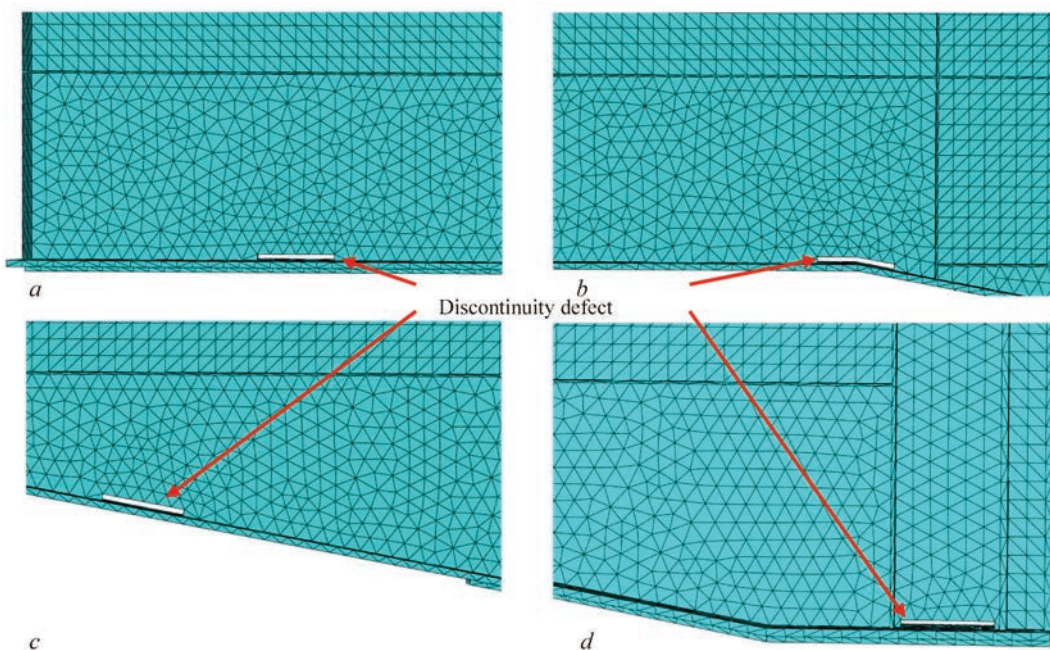
**Figure 5.** Through-thickness discontinuity defects in the web (local corrosion defect 500 mm long and 14 mm deep) in the zone of the joint of the web with the lower flange of the main 6-span beam: in the span central part (*a*); in the point of transition of the constant height beam into the haunch (*b*); in the inclined part of the haunch (*c*); in the central part of the haunch (*d*)

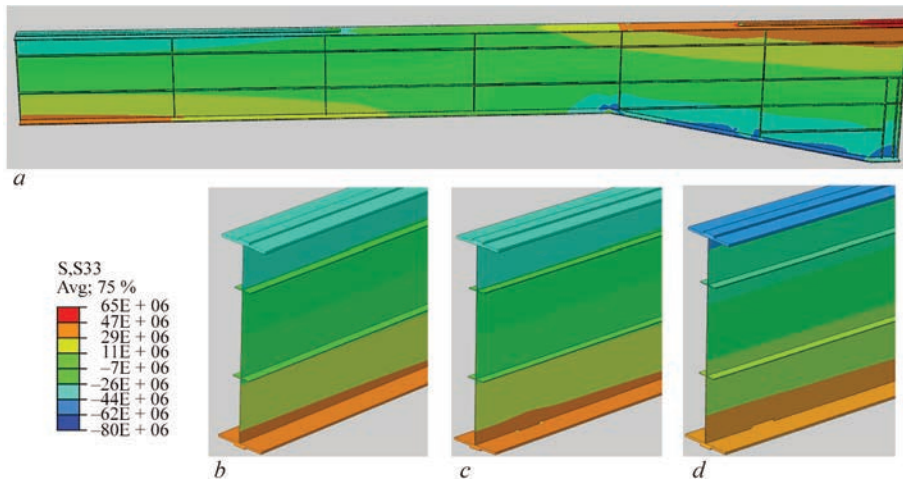
**Figure 6.** Distribution of longitudinal stresses over the span from distributed force ( $P = 0.022$  MPa), applied to the upper flange: over the entire beam (a); in the central part without a defect (up to 34 MPa) (b); with a defect in the flange (up to 37 MPa) (c); with a defect in the web (up to 35 MPa) (d)

Results of numerical determination of SSS in the 6-span beam showed that the longitudinal stress component prevails as a result of the action of a distributed force (0.22 MPa), applied to the upper flange. The maximum of longitudinal stresses, located in the up-

per girth above the haunch, does not exceed 65 MPa, and in the zone of the lower flange in the span central part it reaches 47 MPa (Figure 6). Presence of a local corrosion defect in this zone does not cause any significant increase of longitudinal stresses (maximum up to 50 MPa) (Figure 7).

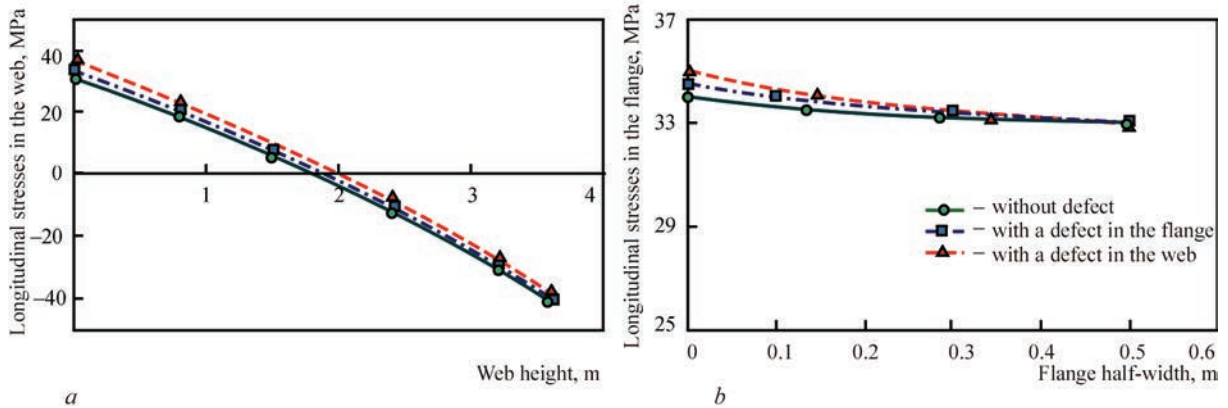
**Figure 7.** Distribution of longitudinal stresses in the central part of the span from distributed force ( $P = 0.022$  MPa), applied to the upper flange, in a defectfree beam and beam with a local through thickness defect 500 mm long in the lower flange and the web: by the beam web height (a); by the lower flange width (b)

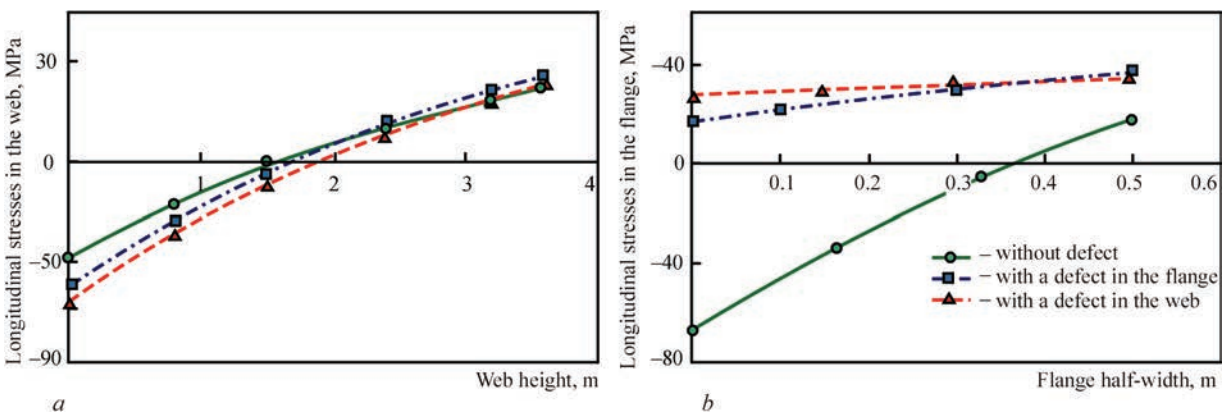
**Figure 8.** Distribution of longitudinal stresses in the zone of transition of constant height beam into the haunch from distributed force ( $P = 0.022$  MPa), applied to upper flange, in a defectfree beam and beam with a local through-thickness corrosion defect 500 mm long in the lower flange and the web: by the beam web height (a); by the lower flange width (b)

Similar results of the influence of corrosion defects are presented also for other characteristic zones along the length of the 6-span beam, namely in the point of the haunch location and beam support, where the longitudinal tensile stresses change to compressive stresses in the lower girth zone (Figures 8–10).

In the zone of transition of the constant height beam into the haunch (Figure 8), the level of maximum longitudinal stresses in the defect-free beam in the lower girth zone does not exceed 50 MPa, presence of the considered discontinuity defects causes an increase of the compressive stresses in the web up to 65 MPa (Figure 8, *a*), and in the flange in the zone of transition of constant height beam into the haunch the longitudinal compressive stresses decrease and become tensile stresses on the level of 20–37 MPa (Figure 8, *b*).

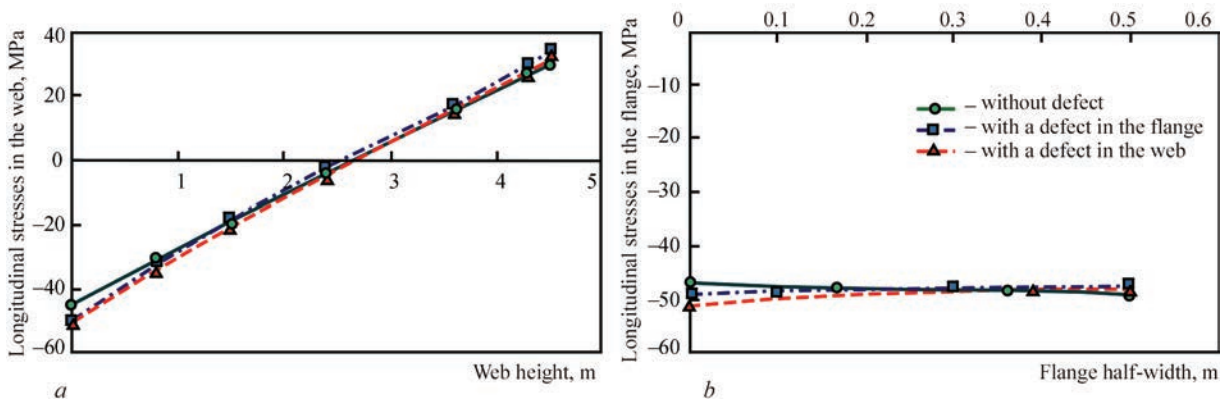
**Figure 9.** Distribution of longitudinal stresses in the haunch inclined part from distributed force ( $P = 0.022$  MPa), applied to upper flange, in a defectfree beam and beam with a local through-thickness corrosion defect 500 mm long in the lower flange and the web: by the beam web height (a); by the lower flange width (b)

In the haunch inclined part (Figure 9) and in its central part (Figure 10) in the defectfree beam in the lower girth zone the longitudinal compressive stress-

es do not exceed 50 MPa. Presence of the considered discontinuity defects may lead to a slight increase of stresses in the web and the flange up to 55 MPa.

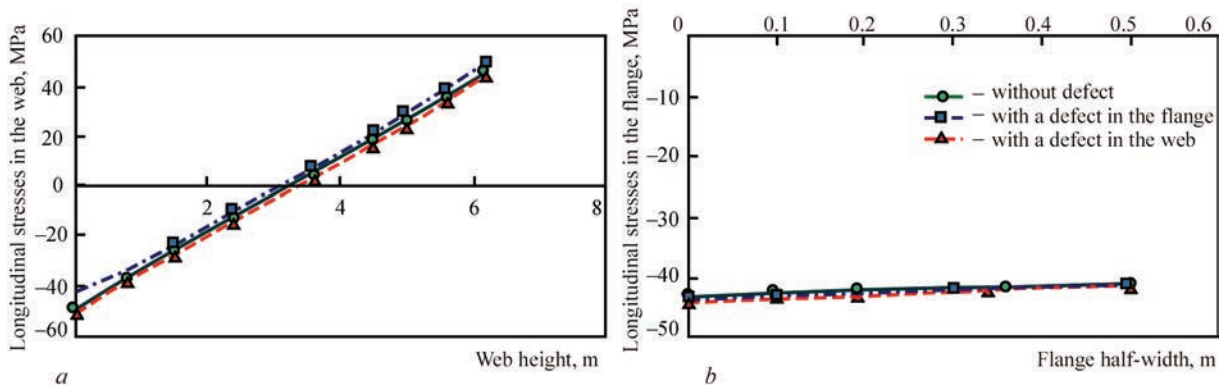
**Figure 10.** Distributions of longitudinal stresses in the haunch central part from distributed force ( $P = 0.022$  MPa), applied to upper flange, in a defectfree beam and beam with a local through-thickness corrosion defect 500 mm long in the lower flange and the web: by the beam web height (a); by the lower flange width (b)

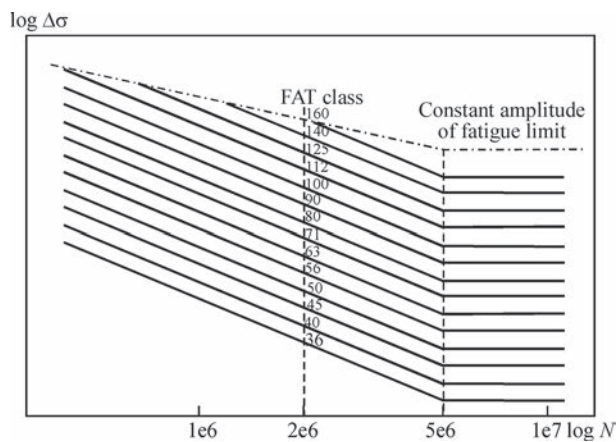
**Figure 11.**  $\sigma$ - $N$  curves of fatigue resistance for different classes of welded joints (steel) for normal stresses [5]

Considering the rather long service life of bridge structures, it is rational to ensure such conditions that the effective stress ranges in the welded joints were below the endurance limit  $\sigma_{-1}$ , then the structure can be in service for an unlimited period of time. In keeping with  $\sigma$ - $N$  curves (Figure 11) of fatigue resistance for different classes of welded joints for normal stresses [5], the endurance limit  $\sigma_{-1}$  for the considered welded joints is equal to:

- without defects (No.321, FAT = 125 MPa)  $\sigma_{-1} = 92$  MPa;
- in the presence of defects (No.324, FAT  $\leq 80$  MPa)  $\sigma_{-1} \leq 57$  MPa.
