USE OF LASER WELDING AND SURFACING TECHNOLOGIES FOR REPAIR AND MANUFACTURE OF THIN-WALLED WELDED JOINTS OF HIGH-ALLOY STEELS

A.V. Bernatskyi, O.V. Siora, V.I. Bondareva, N.O. Shamsutdinova, Yu.V. Yurchenko

E.O. Paton Electric Welding Institute of the NASU
11 Kazymyr Malevych Str., 03150, Kyiv, Ukraine

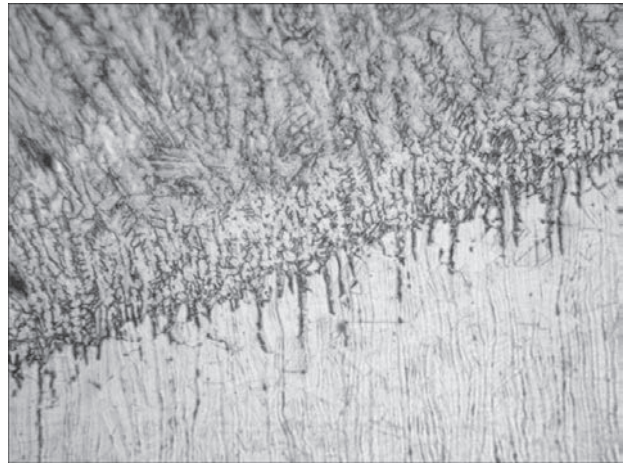
Figure 8. Microstructure ($\times 500$) of initial weld and HAZ metal in the stiffener of welded T-joint after repair welding

The structure of the weld near the fusion line with the stiffener is smaller compared to the rest of the weld (Figure 8) and represents austenite and δ -ferrite, the width of this area is $\sim 100 \mu\text{m}$. The hardness here

is slightly lower than in other areas of the weld — $HV1$ — 2740 MPa.

The structure of HAZ of the stiffener metal represents austenite and δ -ferrite. The size of the austenite grain in HAZ did not change compared to the base metal (Figure 8). At a distance of up to 50 μm from the fusion line, the amount of δ -ferrite increased. The hardness in this area is $HV1$ — 2450 MPa.

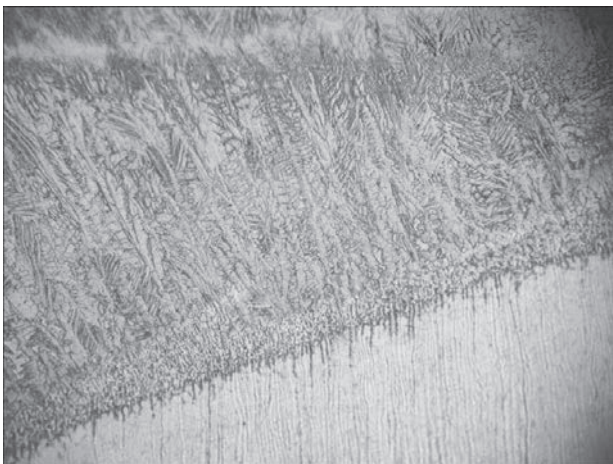
Figure 6. Microstructure ($\times 200$) of initial weld and HAZ metal in the stiffener of welded T-joint after repair welding

The structure of the base weld and the weld after repair welding is austenitic with δ -ferrite, probably contains martensite (Figures 5 and 6).

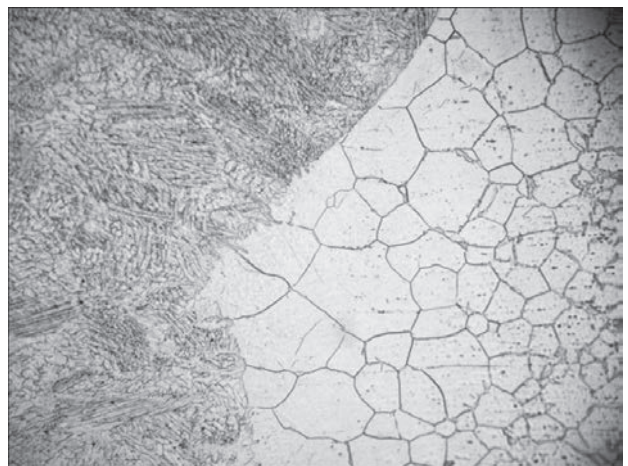
Figure 9. Microstructure ($\times 200$) of HAZ metal and fusion line with the flange of welded T-joint after repair welding

The structure of HAZ of the flange also consists of austenite and δ -ferrite (Figure 9), but differs by a coarser grain of austenite — grain size No. 4.5 (GOST 5639–82). At the boundary of the grains of austenite (Figure 10), δ -ferrite is precipitated, the width of the overheating area of a coarse grain is $\sim 400 \mu\text{m}$. HAZ hardness in the overheating area is $HV1$ — 2740–3090 MPa.

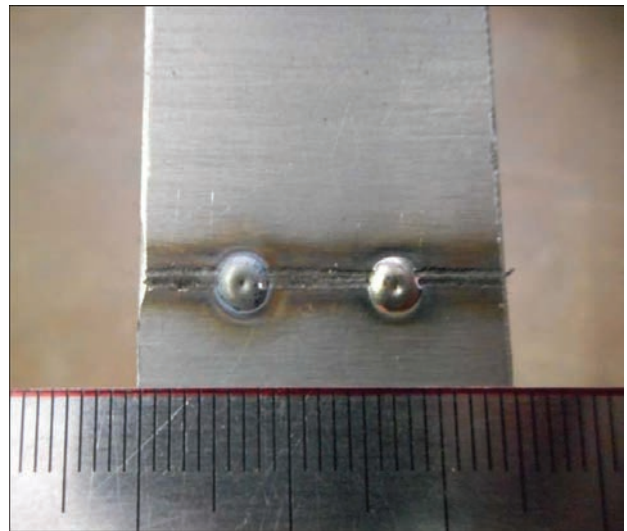
Figure 11. Photo of specimen for tests on static tension with repaired two spot defects

The tests of welded specimens on static tension were performed after repair. The tests were performed on the specimens of T-joints in a quantity of 6 pieces cut out from different tested joints. To simulate defects in the form of burn-outs, drills (from 1 to 3 pieces at a length of 20 mm) were performed in the specimens prepared for tests on static tension. Defects simulated in such a way were repaired by the spot powder laser surfacing (Figure 11).

According to the results of carried out tests of the specimens with repaired spot defects on static tension, the values of the tensile strength σ_t for all the tested repaired welded joints are not lower than the indices obtained for the base welded joints without repair and the base material of the specimens (tensile strength σ_t of the base welded joints is 665–712 MPa; tensile strength σ_t of the base material of the specimens is
