CORROSION-MECHANICAL STATE OF THE HEAT PIPELINE AFTER LONG-TERM OPERATION

**P. Yukhymets¹, L. Nyrkova¹, R. Dmytriienko¹, H. Kaminski², C. Zaruba²,
P. Linhardt², G. Ball², V. Yehorenko³**

¹E.O. Paton Electric Welding Institute of the NASU
11 Kazymyr Malevych Str., 03150, Kyiv, Ukraine

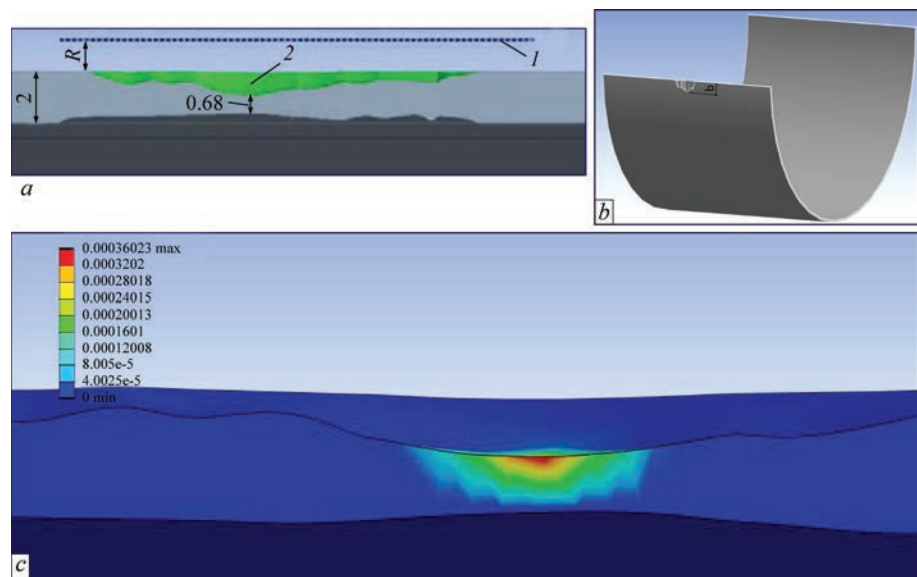
Figure 13. Model defect: *a* — application scheme: 1 — axis of rotation; 2 — complementary segment, *R* — radius of rotation; *b* — defect on outer surface (*b* — half width of defect); 3 — distribution of plastic strains

($\sigma_{02} = 334$ MPa, $\sigma_t = 516$ MPa, tangential modulus $G_t = 1200$ MPa), was used in the calculation. Table 5 presents the maximum plastic deformations of three defects with different geometric parameters under the hydraulic test pressure $P = 2$ MPa. Relatively low values of the maximum deformations on the outer surface in the zone of greatest thinning are a consequence of unloading bending caused by the action of internal pressure.
