CALCULATION PREDICTION OF FATIGUE LIFE OF FREIGHT CAR SIDE FRAME UNDER ALTERNATING CYCLIC LOADS

V.I. MAKHNENKO and I.Yu. ROMANOVA

E.O. Paton Electric Welding Institute, NASU, Kiev, Ukraine

An example of calculation prediction of fatigue crack growth in a side frame of freight cars at a preset range of random cyclic loads is considered. Relationship between exceeding design conditions of operation of the car and probable cause of its fracture was studied.

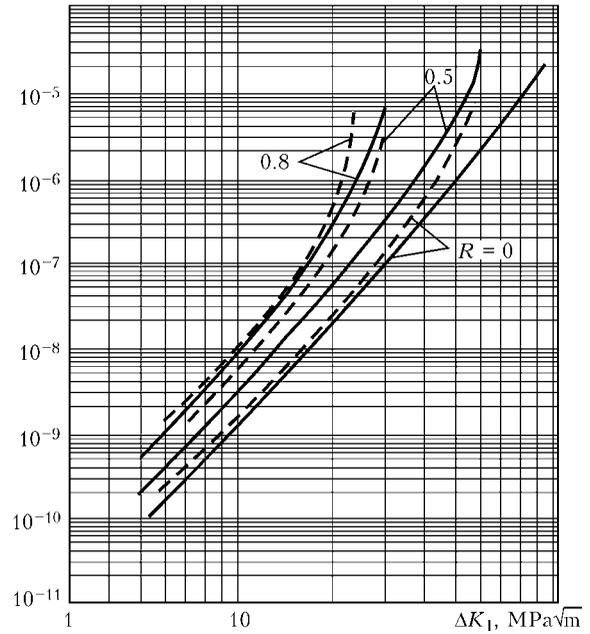
diagram of cyclic crack resistance of steel, a section of which for the considered material of the side frame is given in Figure 2, i.e. it is determined by the range of values of stress intensity factors ΔK_I and loading asymmetry R .

Dependence (4), compared to the data in Figure 2, gives somewhat higher values of the growth rate, which is quite acceptable for conservative estimates.

Figure 2. Fatigue fracture diagram of steel at different values of the coefficient of loading asymmetry R [4]
