# ASSESSMENT OF THE EFFECTIVENESS OF COMPOSITE BANDS FOR RECONDITIONING OF DEFECTIVE SECTIONS OF PIPELINES

The paper gives the results of testing 720 × 10 and 530 × 8 mm pipes with composite-polymer bands in sections with defects simulating local corrosion damage. Joint work of the band and pipe at static and cyclic loading caused by inner pressure is shown. Effectiveness of reinforcement of defective pipeline sections by composite-polymer bands is established and features of fracture of a banded pipe are noted.

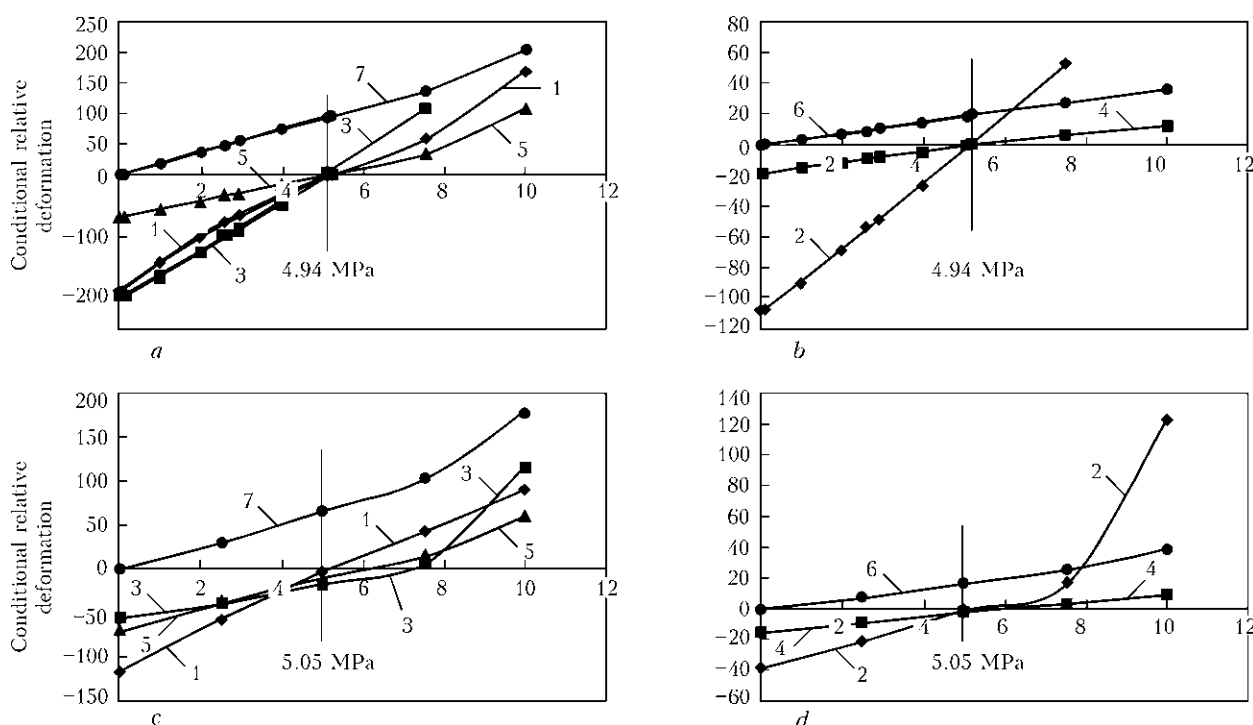
**Figure 4.** Results of measurement of circumferential (a, c) and axial (b, d) deformations of sample-stand Dn 720 (a, b) and Dn 530 (c, d): 1–7 — numbers of transducers of strain gauges

As is seen, zero deformations in the band correspond to 4.94 MPa pressure in the pipe. Zero deformations in the pipe are found in the absence of inner pressure. Compressive deformations are found in the band.

The given data indicate that band deformation occurs simultaneously with the pipe both at pressure lowering and at its increase. Deformation gradient in the defect zone (transducers 2 and 3) and in the zone of the longitudinal weld (transducer 1) is higher. This is less pronounced in sample-stand Dn 530. Circumferential and longitudinal deformations in the pipe body and on the band outside the zone of the defect and weld (transducers 5 and 7) are practically the same. At 9.81 MPa pressure a deviation of deformations from the linear law is found that is related to achievement of yield stresses in the pipe.

The band starts taking up part of the forces after the pressure rises above that at which it was applied.

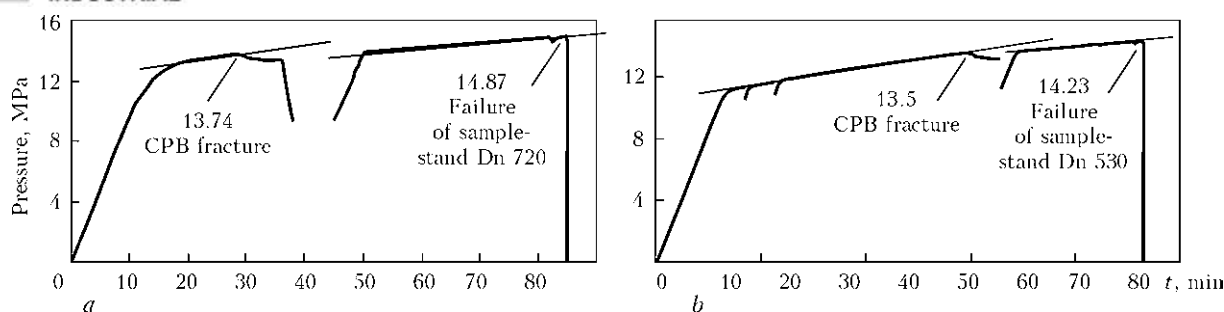
Figure 5. Diagrams of hydraulic testing of sample-stands Dn 720 (a) and Dn 530 (b) by inner pressure to fracture

pressure, pressure corresponding to material yield point; breaking pressure of sample-stand. Testing sequence required additional stops in the plastic region of pipe operation that is related to band fracture, which was observed before pipe failure. Complete diagrams of testing sample-stands are given in Figure 5.

Testing of sample-stand Dn 530 was conducted by the same schematic as that of Dn 720. At the pressure of 13.5 MPa the first rupture of part of the band occurred (about 30 % of its width). Pipe failure occurred at the pressure of 142.3 MPa (Figure 6, b).
