# DEFECTS OF JOINTS OF HIGH-STRENGTH RAILS PRODUCED USING FLASH-BUTT WELDING

S.I. KUCHUK-YATSENKO, V.I. SHVETS, A.V. DIDKOVSKY, E.V. ANTIPIN and L.M. KAPITANCHUK

E.O. Paton Electric Welding Institute, NASU

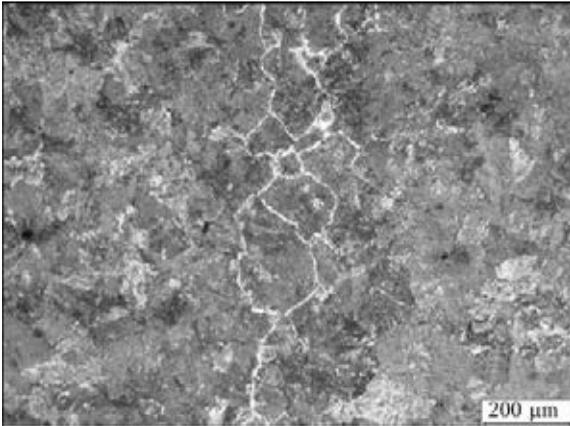
**Figure 1.** Microstructure of weld center of rail welded joint light microscope «Neophot 32» and fractographic examinations with X-ray spectral microanalysis of the fracture surface were performed using Auger-microprobe JAMP 9500F of the JEOL company (Japan). The chemical composition of rail steels is given in Table 1.

The typical microstructure of rail weld metal produced at the optimal conditions, represents a sorbitic perlite (Figure 1). Along the joint line the band of about 200 μm width with precipitations of hypoeutectoid ferrite along the boundaries of the primary austenite grains is observed, the size of which is equal to the point 2–3 according to ASTM. Depending on the gradient of the temperature field in welding the amount of hypoeutectoid ferrite can change. At the optimal rigid conditions, characterized by the high gradient of temperature field, the thickness of ferrite fringe is minimum, and it can be interrupted. Such joints are characterized by the highest plastic properties.

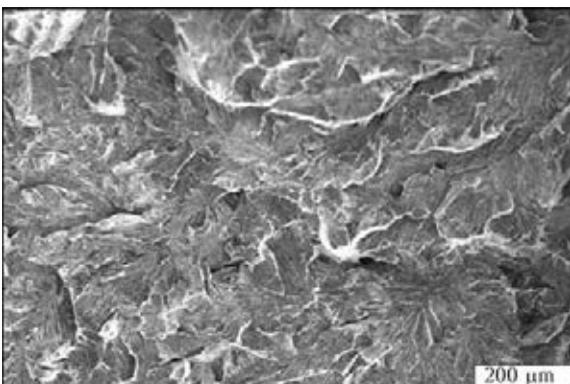
The fracture of rail joints welded at the optimal conditions has a crystalline structure. The surface of fracture consists mainly of cleavage facets with a stream-like pattern and tongues, tear crests are also present (Figure 2).

**Figure 2.** Fracture surface of rail welded joint

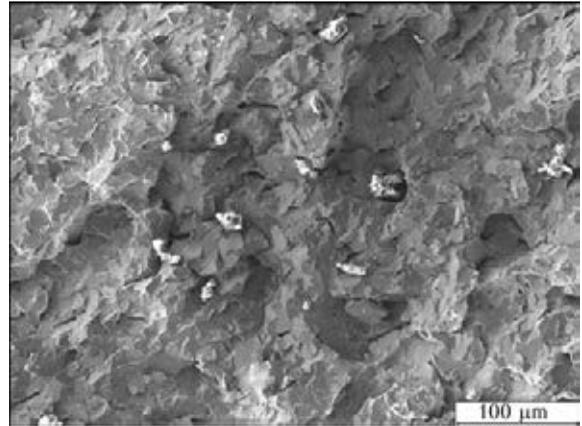
**Figure 3.** Refractory of non-metallic inclusions on fracture surface of rail welded joint

nates, manganese oxysulfides can be found (Figure 3). The size of these non-metallic inclusions is not more than dozens of micrometers. The presence of such inclusions gives a relief shape to fracture. Their presence is not critical for strength characteristics of a joint.
