SELECTION OF TECHNOLOGY FOR REPAIR WELDING OF PARTS OF TURBINE UNITS

The peculiarities of disassembly-free repair of steel grade 15Kh1M1FL body of the control valve of the medium pressure cylinder of the turbine PT-200-130 of the heat power plant, in which a crack was formed after a long-term service, are given. The repair without disassembly of the valve is possible due to the use of technology of repair arc welding by pearlite electrodes with preheating and thermal recovery. 12 Ref, 1 Table, 7 Figures.

The aim of this work was the selection of welding technology in disassembly-free repair of cast body of control valve of the medium pressure cylinder (MPC) of a 130 MW power steam turbine (Figure 1) made of steel 15Kh1M1FL.

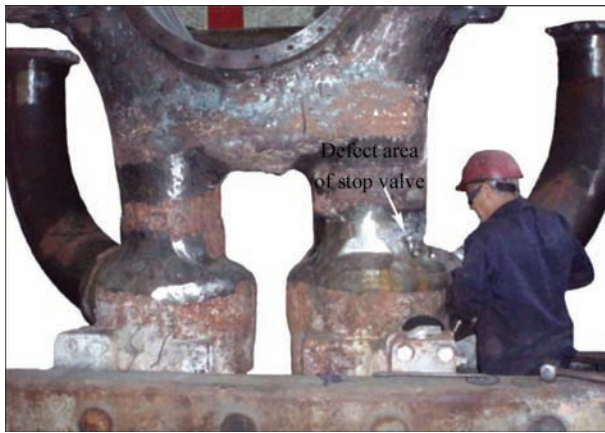
The valve body represents a large-sized casting of a complex configuration (Figure 2), which is welded-on to the case of MPC (Figure 3). The valve worked out about 300 thousand hours at the temperature of 545 °C and at the vapor pressure of 3.0 MPa. The damage in the form of a small (30–40 mm) crack in the fusion zone of austenitic deposit on its outer surface was detected during preparation of the turbine for major repairs. The deposit was located on the area of variable cross-section, in which the wall thickness varied from 60 to 140 mm. This deposit worked out without remarks about 200 thousand hours. It was made by high-nickel electrodes TsT-28 (type 08Kh14N65M15V4G2) during rewelding of removed metal area of 420×155 mm section and 45 mm depth, formed during removal of the delaminated metal deposited by austenitic electrodes of

Figure 2. MPC cover with stop valves during preparation for repair
