# EVALUATION OF LOAD BEARING CAPACITY OF CYLINDRICAL SHELL OF ABOVE-GROUND VERTICAL STEEL WELDED TANK FOR OIL STORAGE AFTER REPAIR

A. Barvinko, Y. Barvinko, A. Yashnik, O. Kostenevich

E.O. Paton Electric Welding Institute of the NAS of Ukraine. 03150, Kyiv, 11 Kazymyr Malevych Str.  
E-mail: tanksweld@gmail.com

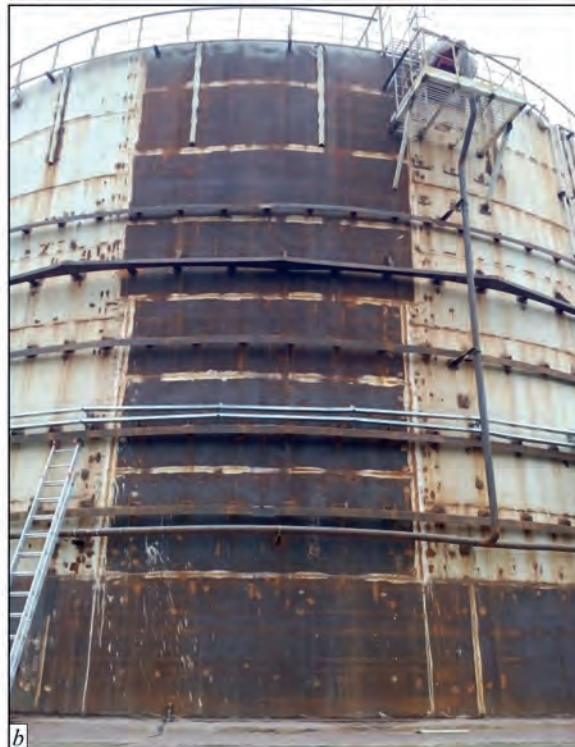
Fig. 1. Process of tank repair: *a* – design schema; *b* – shell after installation stiffening rings, tank is empty

**Design solutions for repairing and defect tolerance assessment.** The vertical steel tank (Fig. 1) consisted of a cylindrical shell, a bottom, and a conical panel-frame roof with a central support column. By the time of the repair, the tank had been in operation for 58 years. According to the repair project, it was planned to replace the entire 1<sup>st</sup> course and the defective section from the 2<sup>nd</sup> course and to the full height of the shell (Fig. 1). The lower part of the insert from the 2<sup>nd</sup> to the 5<sup>th</sup> course was ~ 4.5 m high and was welded to the shell with a vertical flat butt weld, while for the upper part,

For welding repair insert it was used the process 135 in the mix M21 with the solid electrode wire G3Si1. Vertical butt welds in insert had X-joint preparation, horizontal welds had X-joint preparation (see Fig. 1). Existing shell welds were welded with using process 121.
