IMPROVEMENT OF THE MECHANICAL PROPERTIES AND CORROSION RESISTANCE OF LASER WELDS ON THICK DUPLEX PLATES BY LASER CLADDED BUTTERING

A. StraÙe, A. Gumenyuk, M. Rethmeier

Bundesanstalt für Materialforschung und -prüfung (BAM)
Unter den Eichen 87, 12205 Berlin, Germany

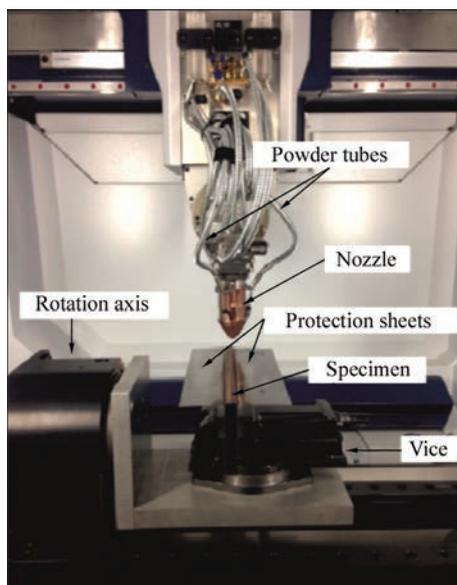
**Figure 1.** Experimental setup for the coatings

Table 1 shows the chemical composition of the base material and the powders. The resulting powder mixture contained a 12 % total amount of nickel. The coatings of the plates' edges were produced in a five-axis laser cell (TruLaser Cell 3000, Trumpf), that is coupled with a 16 kW Yb:YAG-disk laser (TruDisk 16002, Trumpf) with a wavelength of 1030 nm. A three-jet nozzle with a working distance of 16 mm and a powder feeder (Flowmotion Twin, Medicoat) were used.

The cladding was done with a laser spot diameter of 1.6 mm, a constant powder mass flow of 15 $\text{g}\cdot\text{min}^{-1}$, a laser power of 0.8 kW, a velocity of 0.8 $\text{m}\cdot\text{min}^{-1}$ and a stepover of 1.5 mm. For all experiments the carrier gas was helium with a gas flow of 4 $\text{l}\cdot\text{min}^{-1}$ and shielding gas was argon with 10 $\text{l}\cdot\text{min}^{-1}$. The experimental setup is shown in Figure 1 and chemical composition in Table 1.

For a longer coverage of the edges with shielding gas, protection sheets were used on either side of the plate. Those were clamped in the vice about 1–2 mm under the base plate. One layer per edge was cladded using a bidirectional strategy. The stepover was chosen in respect with the intention to produce preferably smooth coatings for the following laser beam welding process. The tacking was done with a cladding track on the upper and the lower side of the weld seam. For

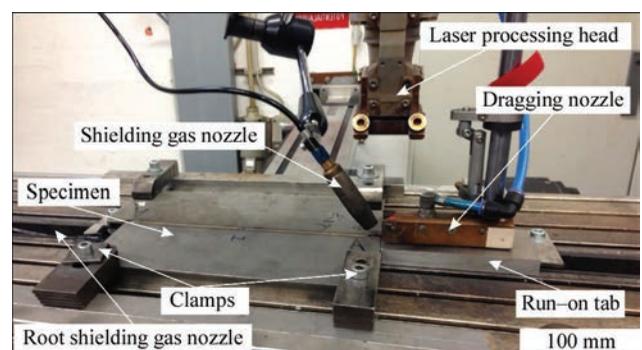
**Figure 2.** Experimental setup for the laser welds

The laser beam welding was performed with a 20 kW Yb-fiber laser (YLR-20000, IPG) with a wavelength of 1064 nm, a focus diameter of 0.56 mm and a beam parameter product of 11.2 mm·mrad.

After the coating of the edges and the tacking, the plates were welded with different welding gases. Shielding gas and the gas in the dragging nozzle was always argon, for the root shielding nozzle the influence of argon was tested as well as nitrogen. The laser power was 14.3 kW by a speed of 1.5 $\text{m}\cdot\text{min}^{-1}$ with a defocusing of –5 mm. The experimental setup is shown in Figure 2.

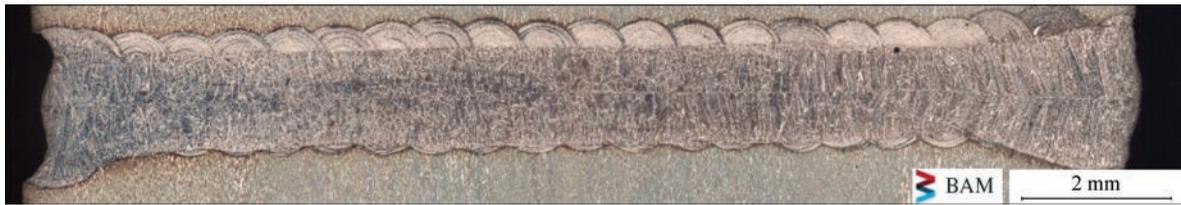
Figure 4. Microsection of weld seam with LMD-tacking

pothers with a more moderate space between the lines were tested as well, but they resulted in surfaces, that were too uneven for the laser welding process. However, the edges display a certain waviness and a dipping at the corners, which proved to be problematic with the laser beam welding, were a technical zero-gap is preferred. Thus, the weld seams showed irregularities in the upper and the root side. To overcome this problem, LMD-tacking with the same parameter set as the buttering was applied on both sides of the coated plates to fill the gaps instead of the typical tacking with laser beam at the beginning, in the middle and at the end of the plates. The weld seam with this tacking showed a good appearance with only minimal relapse on the root side, shown in Figure 4.

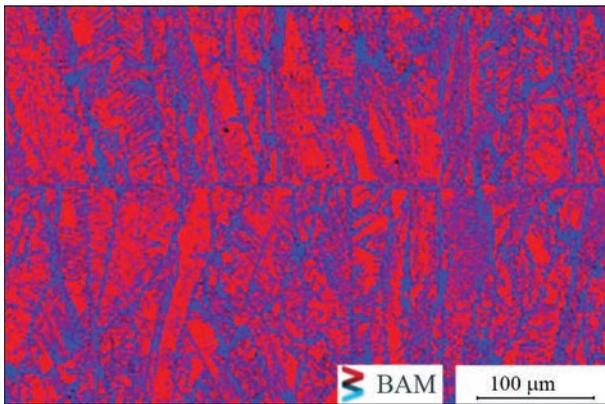
Figure 5. EBSD-analysis of weld seam with argon as root shielding gas (blue (light): austenite, red (dark): ferrite)

The optical and EBSD-analysis of the weld seams with coated edges displayed a significantly better austenite-ferrite ratio than the ones which were welded without any filler material. For the last ones, the seams showed an austenite content below 10 %, whereas the austenite-ferrite ratio of the welds with the coated edges was balanced, with 40–50 % austenite, depending on the root shielding gas. Figure 5 shows a part of an EBSD-analysis of one of the weld seams. The ferrite phase was colored red, while the austenite is shown in blue. The amount of austenite measured with EBSD for this weld was 41.8 %. Those, that were performed with nitrogen as root shielding gas, displayed a higher austenite content up to 56.8 %, which affirms the discoveries of Lai et al.

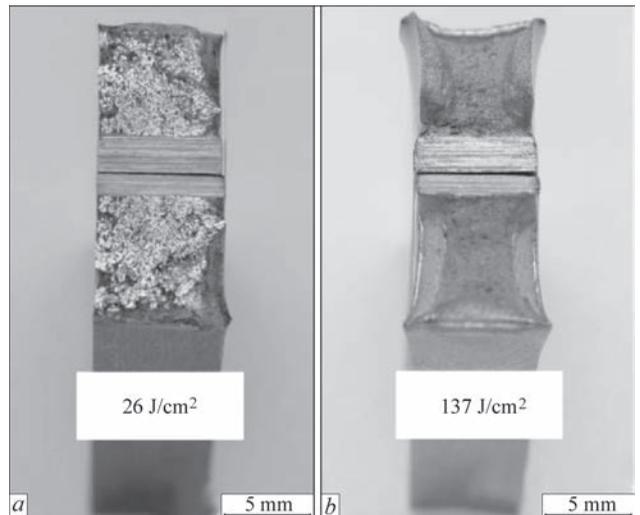
Figure 6. Broken impact testing specimen; with coated edges (a), without coating (b)

Impact testing was executed by means of undersize Charpy-V samples with the dimensions 7.5×10×55 mm. The notch was placed in the middle of the weld seam and the testing performed at a temperature of –20 °C. Specimens welded with and without buttering were compared. The surface of the unbuttered ones implied brittle fractures (Figure 6, a) with an average impact toughness of 29 J·cm⁻², whereas the buttered ones displayed a far more ductile fracture behavior with values of 140 J·cm⁻² (Figure 6, b). The results show, that due to the buttering the weld seams show satisfactory ductility in contrast to that of unbuttered ones.

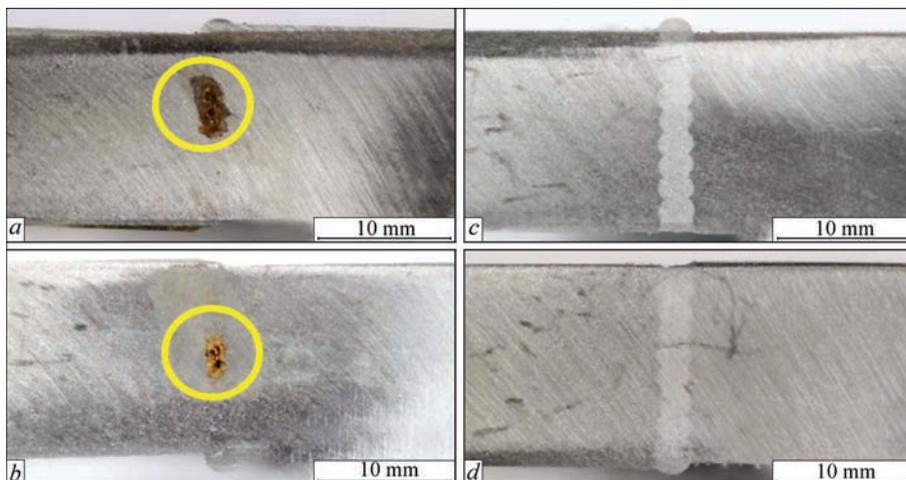
Figure 7. Corrosion specimens; without coated edges (a) and (b), with coating (c) and (d)

The corrosion testing was done with the standard testing method according to ASTM G48 for pitting corrosion for stainless steels in chlorite containing

environments. The testing was done at 25 °C for 24 hours in a FeCl₃·6H₂O (6 % FeCl₃ by mass)-testing solution. The specimen size was 55×25×15 mm. No corrosion was observed in the base metal in any of the tests. The ferritic weld seam of the uncoated specimen (Figure 7, a, b) showed corrosion in the weld metal. While the coated test pieces showed no corrosion, neither in the base metal nor in the weld seam (Figure 7, c, d). The proposed two-step process with the LMD-coated edges of the plates with a powder mixture containing 12 % nickel is able to form weld seam that are corrosion resistant.
